SUBJECT: Submits supplemental info to 850222 ltr re technique for:
 detecting tubesheet crevice corrosion & sleeves, per 850313
 telcon w/NRC.NRC concurrence to proceed w/installation of up
 to 65 tubesheet sleeves in facility inlets requested.

Subject: Steam Generator Tubesheet Crevice Corrosion and Sleeves
R.E. Ginna Nuclear Power Plant
Docket No. 50-244

RG&E Steam Generator "A" Inlet
Crevice Indications

RG&E Steam Generator "B" INLET (HOT LEG)

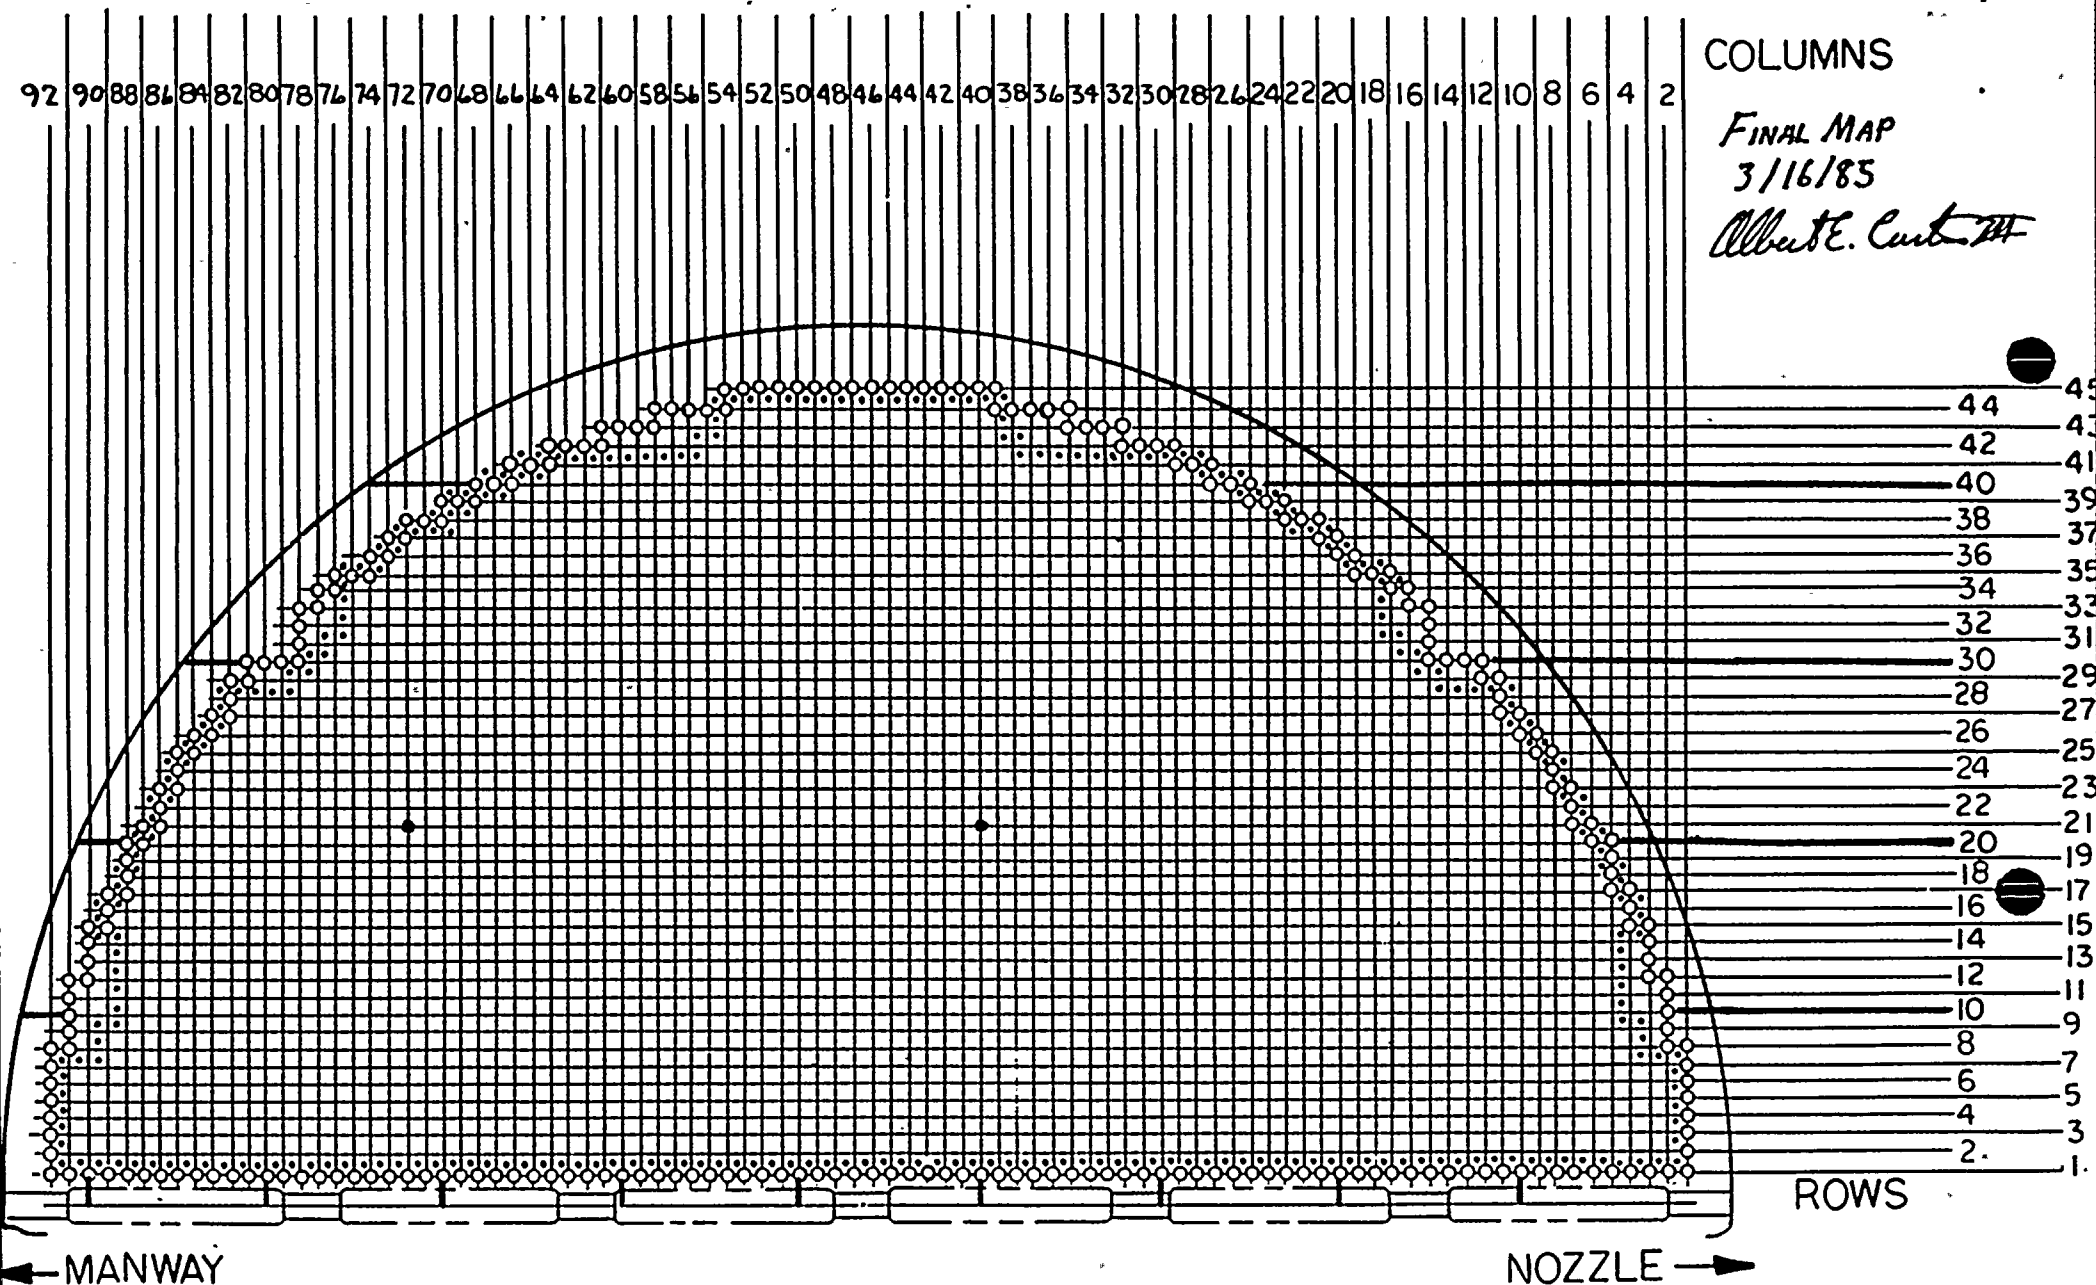
On Friday, March 15, 1985 and Saturday March 16, 1985 the steam generator inlet (hot leg) inspection data was fully analyzed and given a complete second level review for the B- and A-Steam Generators, respectively. These analyses resulted in 2 crevice corrosion indications in the A-Steam Generator and 69 crevice corrosion indications in the B-Steam Generator as tabulated above. A listing of crevice indications and tubesheet maps

SG	ROW	COL	VOLTS	DEG	%	CH#	LOCATION	REPAIR	INDEX
LIST OF CREVICE INDICATIONS A S/G INLET 03-16-85									
11	021	072	01.33	042	099	1	HTS	-0017.3 TS	00077-11
11	021	040	00.78	094	072	1	HTS	-0017.3 TS	00201-05

As an alternative, tubesheet sleeves would allow for the repair, and maintaining inservice, of 56 tubes in the B-Steam Generator and 2 tubes in the A-Steam Generator with crevice indications. Three other tubes in the B-Steam Generator would require plugging because there is minor intergranular attack indications near the location of the tube sheet sleeve upper explosive weld. Attachment IV illustrates the position of the explosive weld relative to the secondary face of the tube sheet and provides the basis for the acceptability for the upper explosive weld to be made in that area of the tube sheet.

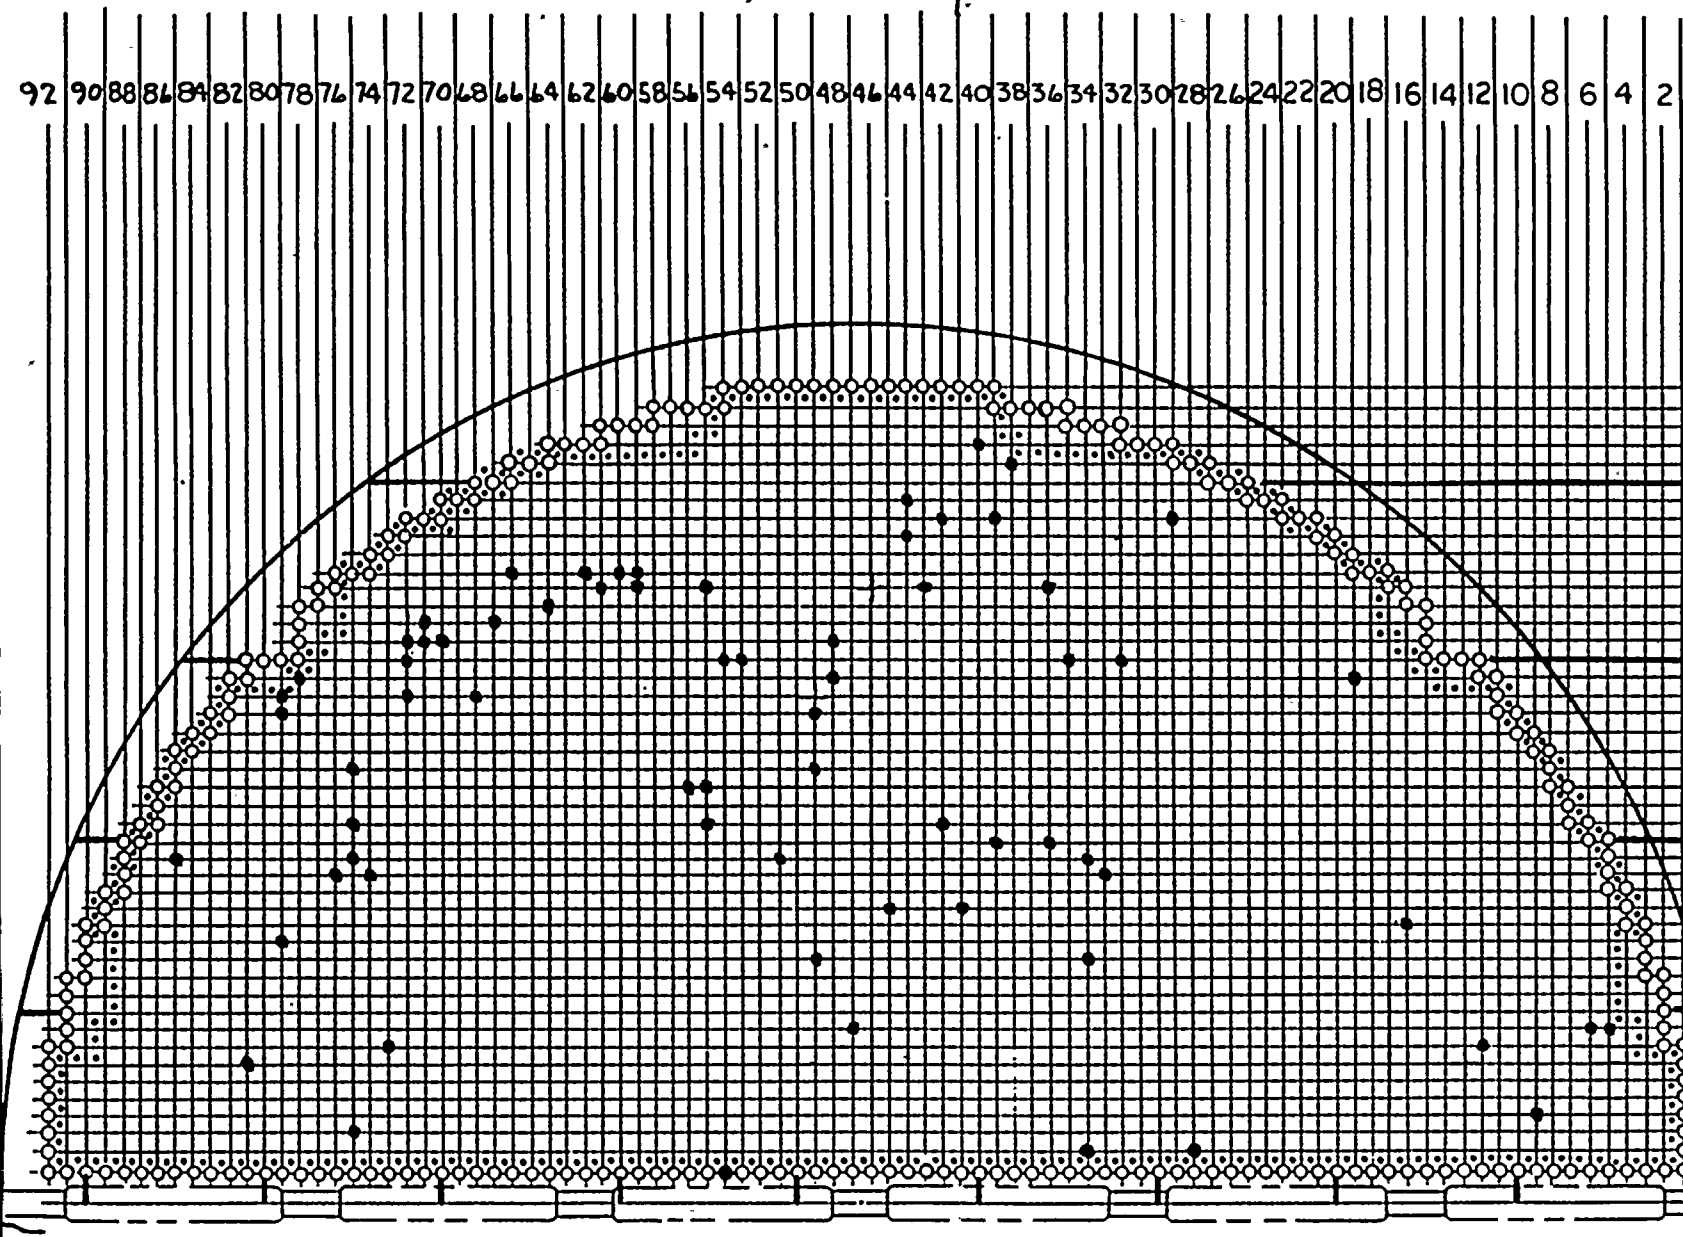
PLANT				UNIT#	S/G	LEG	REEL	TO	REEL	DATE
GINNA STATION				1	B	HOT				03/15/85
SG	ROW	COL	VOLTS	DEG	%	CH#	LOCATION		REPAIR	INDEX
FINAL LIST OF ZETEC AND RG&E CREVICE INDICATIONS										
1	9	5	3.27	69	85	1	HTS	-	18.3	TS 16-15
2	9	6	1.91	73	83	1	HTS	-	17.8	TS 44-12
3	4	9	1.57	169	<20	1	HTS	-	17.4	TS
4	8	12	1.37	139	33	1	HTS	-	17.9	TS 77-20
5	15	16	2.12	77	83	1	HTS	-	18.5	TS 149-10
6	29	19	2.30	95	68	1	HTS	-	15.4	TS 177-17
7	2	28	12.20	56	>40	M 2	HTS	-	17.6	TS
8	38	29	2.65	70	83	1	HTS	-	18.4	TS 520-14
9	30	32	2.05	82	76	1	HTS	-	17.8	BZ 542- 7
10	18	33	1.50	155	<20	1	HTS	-	13.1	BZ 569- 6
11	19	34	1.61	98	66	1	HTS	-	7.8	PLUG 585- 9
12	13	34	1.52	85	75	1	HTS	-	6.1	TS 609-14
13	2	34			SQR		HTS	-	16.5	TS
14	30	35	1.98	45	97	1	HTS	-	18.3	TS 634-10
15	20	36	0.89	139	33	1	HTS	-	9.1	BZ 654- 9
16	34	36			SQR		HTS	-	18.7	TS
17	41	38	4.76	62	88	1	HTS	-	18.8	TS 677-13
18	20	39	19.82	46	>40	M 2	HTS	-	11.1	TS 751-60
19	38	39	2.70	49	95	1	HTS	-	18.4	TS 830-18

20	42	40	1.34	134	40	1	HTS	-	18.3	TS 857- 8
21	16	41	1.74	57	92	1	HTS	-	5.8	BZ 874- 8
			2.29	49	96	1	HTS	-	9.9	TS 891- 8
22	38	42	2.46	55	93	1	HTS	-	18.0	TS 1027- 9
23	21	42	10.57	54	>40	M 2	HTS	-	8.7	PLUG 1071-34
24	34	43			SQR		HTS	-	18.3	TS
25	39	44	1.34	96	68	1	HTS	-	17.4	TS 1118-12
26	37	44	0.93	120	52	1	HTS	-	17.2	TS 1138- 7

1.41	130	44	1	HTS	-	17.6	TS 1153- 7
			1.45	44	98	1	HTS	-	18.4	TS 1169- 8
27	16	45	0.91	116	55	1	HTS	-	5.2	BZ 1192-14
28	9	47	1.47	77	80	1	HTS	-	17.8	TS 1221-14
29	29	48	6.47	50	>40	M 2	HTS	-	7.1	TS 1284-48
30	31	48			SQR		HTS	-	17.3	TS
31	13	49	7.40	51	>40	M 2	HTS	-	9.2	TS 1387-54
32	24	49	2.05	70	84	1	HTS	-	17.8	BZ 1457-15
33	27	49			SQR		HTS	-	18.1	BZ
34	19	51	1.11	148	29	1	HTS	-	15.2	BZ 1482- 9
35	30	53	1.20	112	58	1	HTS	-	17.4	TS 1509-17
36	30	54	0.74	127	47	1	HTS	-	17.8	TS 1536- 9
37	1	54	1.63	88	74	1	HTS	-	18.5	TS 1553- 7
38	21	55			SQR		HTS	-	4.9	PLUG 1587-26
39	23	55			SQR		HTS	-	12.0	BZ 1640-26
40	34	55			SQR		HTS	-	17.6	TS 1693-26
41	23	56	1.56	69	85	1	HTS	-	13.4	TS 1728- 8
42	34	59	0.74	79	79	1	HTS	-	17.9	TS 1749-12
PAGE 1 OF 2			LIST OF DATA STORED ON DISK

PLANT				UNIT#	S/G	LEG	REEL	TO	REEL	DATE
GINNA STATION				1	B	HOT				03/15/85
SG	ROW	COL	VOLTS	DEG	%	CH#	LOCATION		REPAIR	INDEX
43	35	59	1.28	107	61	1	HTS	- 17.9	TS	1769- 7
44	35	60			SQR		HTS	- 18.2	TS	1790-13
45	34	61	1.80	133	41	1	HTS	- 17.6	TS	1817-13
46	35	62	7.80	84	>40	M 2	HTS	- 16.9	TS	1875-44
47	33	64	2.26	72	83	1	HTS	- 14.2	TS	1948-28
48	35	66			DS	1	HTS	- 18.1	TS	2006-29
49	32	67			DS		HTS	- 17.9	TS	2065-29
50	28	68			SQR		HTS	- 8.8	TS	2140-45
51	31	70	1.81	75	81	1	HTS	- 16.9	TS	2201-15
52	31	71	2.32	81	78	1	HTS	- 16.8	TS	2228-11
53	32	71	3.51	81	78	1	HTS	- 18.1	TS	2252-12
54	31	72	3.05	78	79	1	HTS	- 17.6	TS	2282-17
55	30	72	0.84	87	74	1	HTS	- 17.6	TS	2312-12
56	28	72	1.96	50	95	1	HTS	- 17.7	TS	2337-12
57	8	73	10.91	45	>40	M 2	HTS	- 14.3	TS	2374-24
58	18	74	7.75	52	>40	M 2	HTS	- 17.5	BZ	2415-16
59	3	75	5.50	67	>40	M 2	HTS	- 17.8	TS	2448-16
60	19	75	6.30	71	>40	M 2	HTS	- 16.3	TS	2516-51
61	21	75			SQR		HTS	- 17.8	TS	2591-23

62	24	75	2.91	48	95	1	HTS	- 17.8	TS	2631-16
63	18	76	1.36	46	96	1	HTS	- 15.6	TS	2673-25
64	29	78	4.61	63	88	1	HTS	- 18.1	TS	2716-17
65	14	79	4.42	78	80	1	HTS	- 16.6	TS	2754-20
66	27	79	1.94	46	96	1	HTS	- 18.4	TS	2787-12
67	28	79	6.48	42	>40	M 2	HTS	- 17.8	TS	2812-12
68	7	81			SQR		HTS	- 17.1	TS	2845-20
69	19	85	2.84	43	98	1	HTS	- 18.2	TS	2886-20

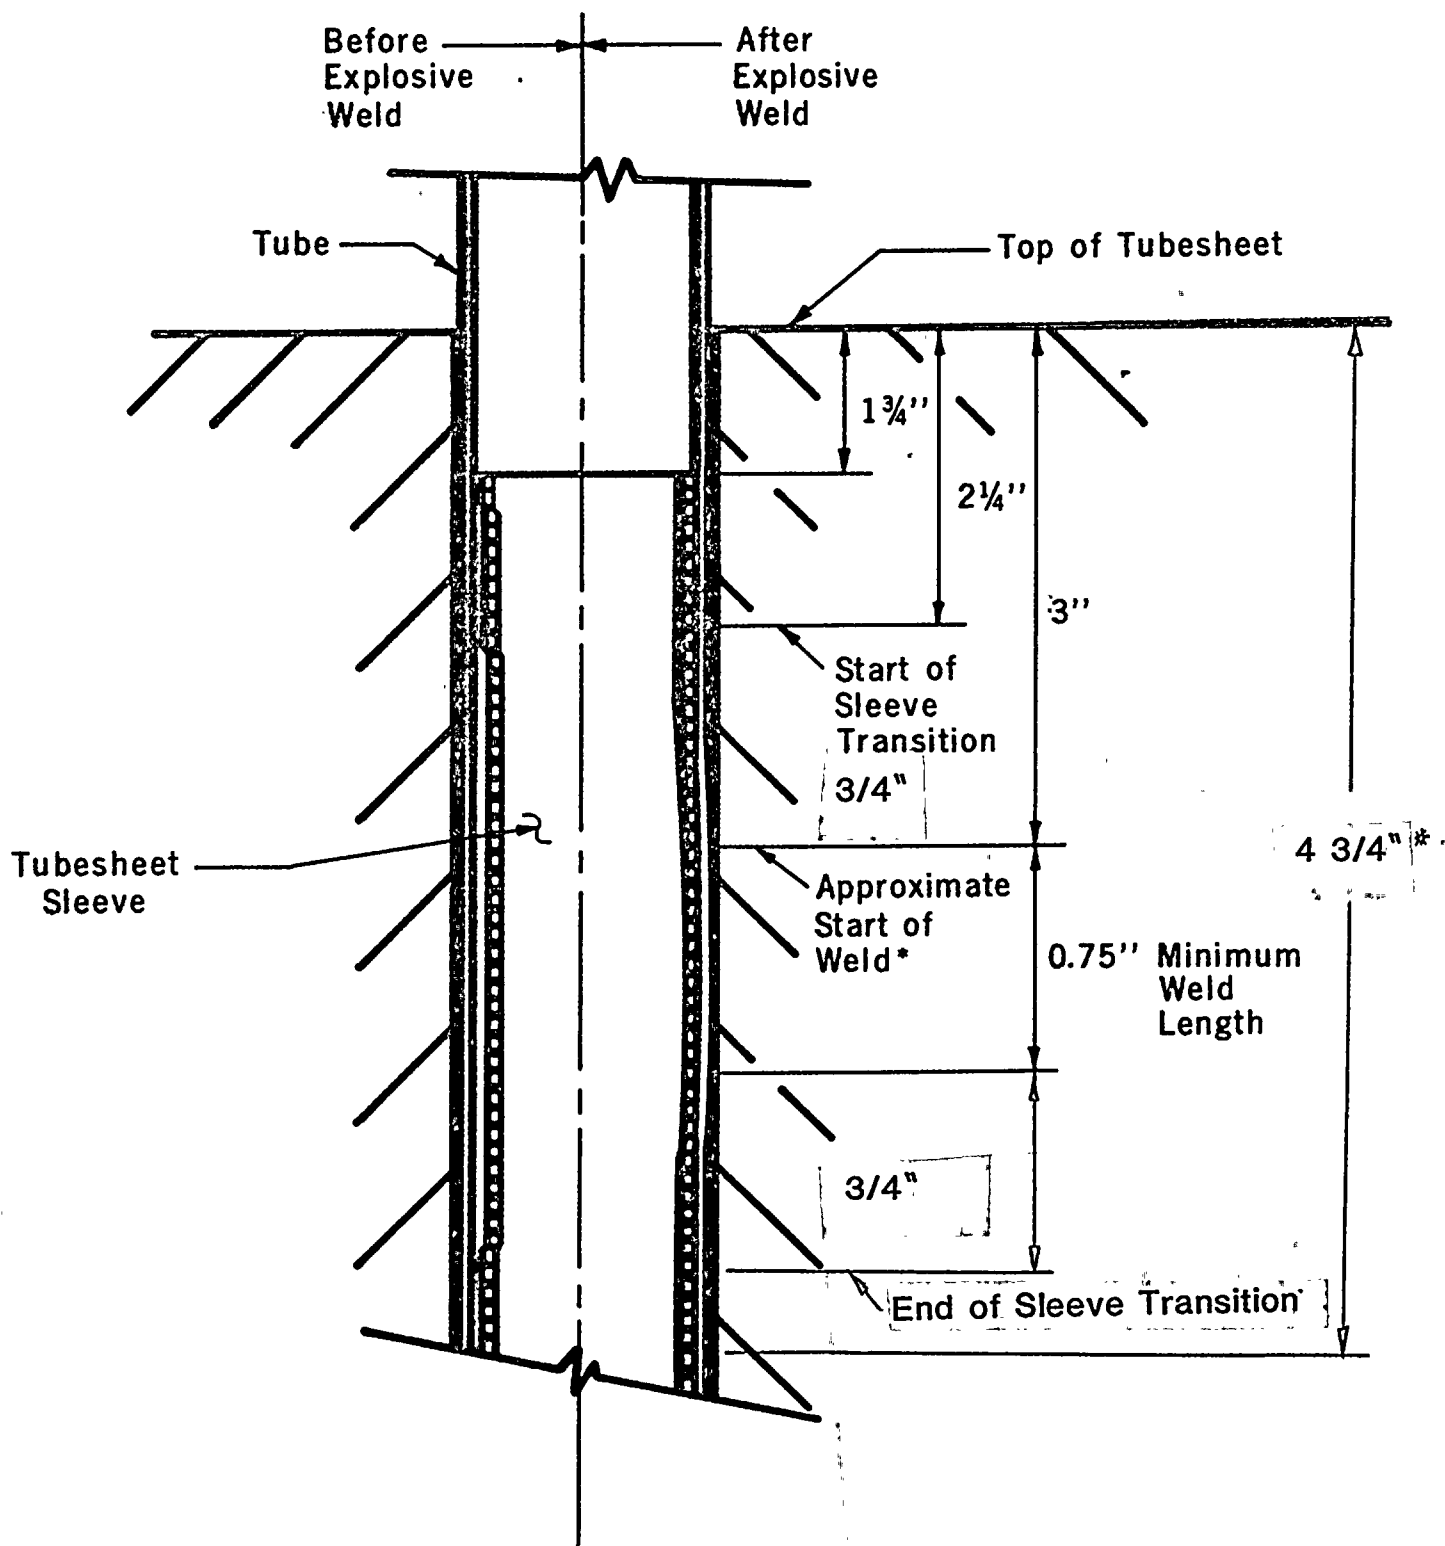
TUBESHEET SLEEVE UPPER END

* Minimum Depth of Defect for Installation of Tubesheet Sleeves
