SUBJECT: Discusses installation & NDE of steam generator tubesheet sleeves. Approval to install 10 addl sleeves, based on insp results, requested.

March 23, 1984

Subject: Steam Generator Tubesheet Sleeves
R. E. Ginna Nuclear Power Plant
Docket No. 50-244

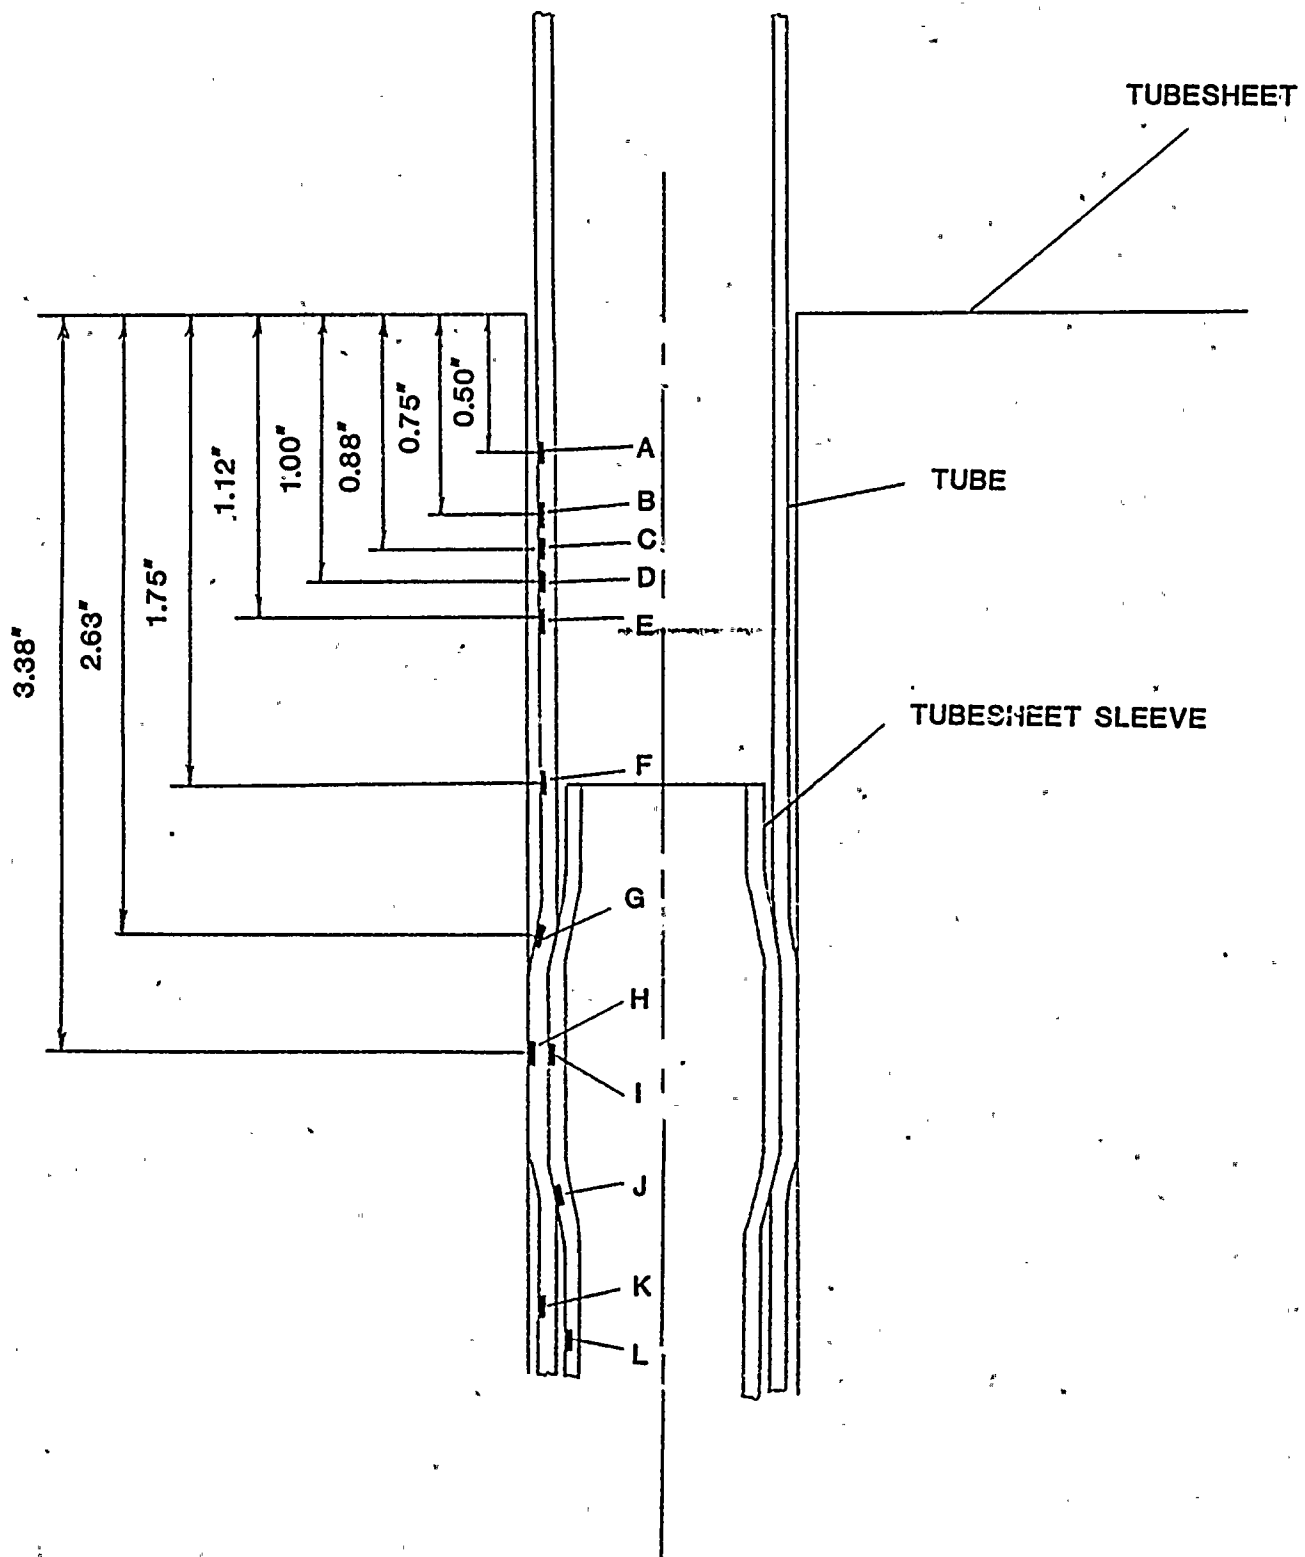
ATTACHMENT 1
TUBE / SLEEVE EDDY CURRENT
INSPECTION CAPABILITY

Although improvements have been made in the eddy current inspection techniques, there are still some areas of the tubesheet sleeve/tube combination where detection and sizing of defects at the 20% level is not possible. These areas are at the weld transitions and at the upper end of the sleeve. The eddy current coil now in use is an annular differential type with magnetic bias and operates on multiple frequencies including 50 and 150 kilo hertz. Use of the above coils will allow 20% thru wall defects to be seen 1 inch above the top of the tubesheet sleeve and at the lower transition as shown on Attachments 1 and 2. Larger defects can be seen at some intermediate locations.

To further minimize the consequences of potential defects, the tubesheet sleeves have been shortened approximately 1.25 inches. This will provide a minimum of 0.75 inches of tube within the tubesheet which can be inspected to the 20% thru wall criteria. A 0.75 inch length of tubing within the tubesheet will restrict the maximum achievable flow rate should a leak occur at this location. Even under postulated accident conditions, the tube will remain engaged in the tubesheet and the maximum flow rate would be well less than the capacity of one charging pump and, therefore, is acceptable.
