SUBJECT: Documents tube R34C54 removal from B steam generator 2 hot
 leg. Results of BMI analyses will be submitted in Fall 1983.
 Sequence of events & eddy current insp encl.

Subject: Steam Generator Tube Pull
R. E. Ginna Nuclear Power Plant
Docket No. 50-244

This letter is in response to a request from the NRC Staff to document the pulling which was performed during the current outage of tube R34C54 from the B Steam Generator hot leg. Based on eddy current indications of stress corrosion cracks at or just above the tube roll transition termination point in the tube sheet seen in the Fall 1982 and the Spring 1983 inspections, the decision was made to remove the portion of R34C54 between the tube sheet and the first support plate. The objective was to remove this rolled area for chemical and metallurgical evaluation.

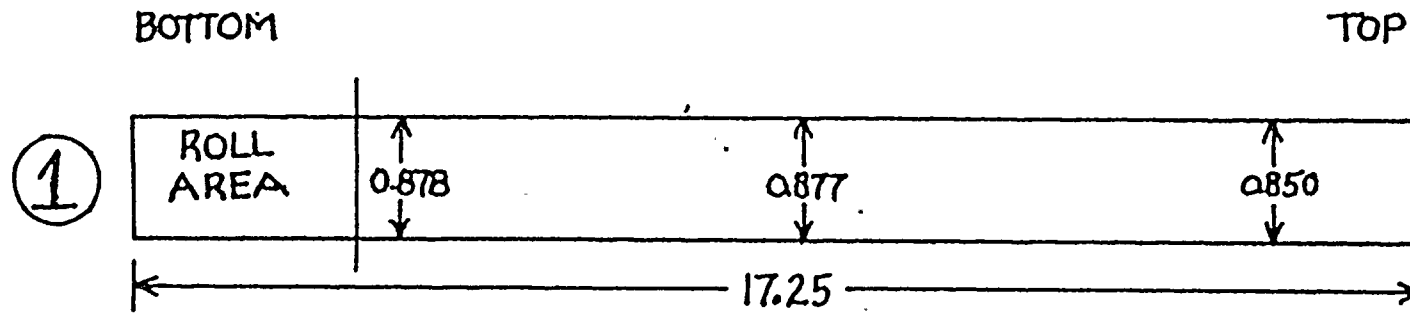
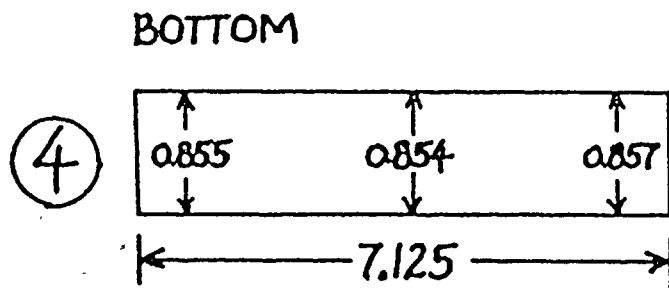
FIGURE A1

Following the eddy current inspection, R34C54 was cut approximately 4 inches below the first support plate and was removed by hand in three additional pieces. Dimensions of the four sections of tubing are provided in Figures A1 and A2 and show a uniform O.D. reduction from the original 0.875 inch nominal to approximately 0.855 inches. No reduction was seen in the lowest 13½" inches of tubing since the pulling technique was designed to preclude any stretching of that portion of the tubing. No visual signs of tubing distress were apparent on the tubing.

① TUBE SPECIMEN IS 17.25" LONG. MEASUREMENTS WERE TAKEN ABOVE ROLL AREA, MIDDLE OF SPECIMEN AND ONE INCH BELOW TOP OF SPECIMEN. SCALE FOR NO. 1 AND NO. 4 - $\frac{1}{2}" = 1.0"$

④ TUBE SPECIMEN IS 7.125" LONG MEASUREMENTS TAKEN TOP, MIDDLE & BOTTOM

TUBE SPECIMENS PULLED FROM B $\frac{1}{4}$ R34 C54 - O.D MEASUREMENTS

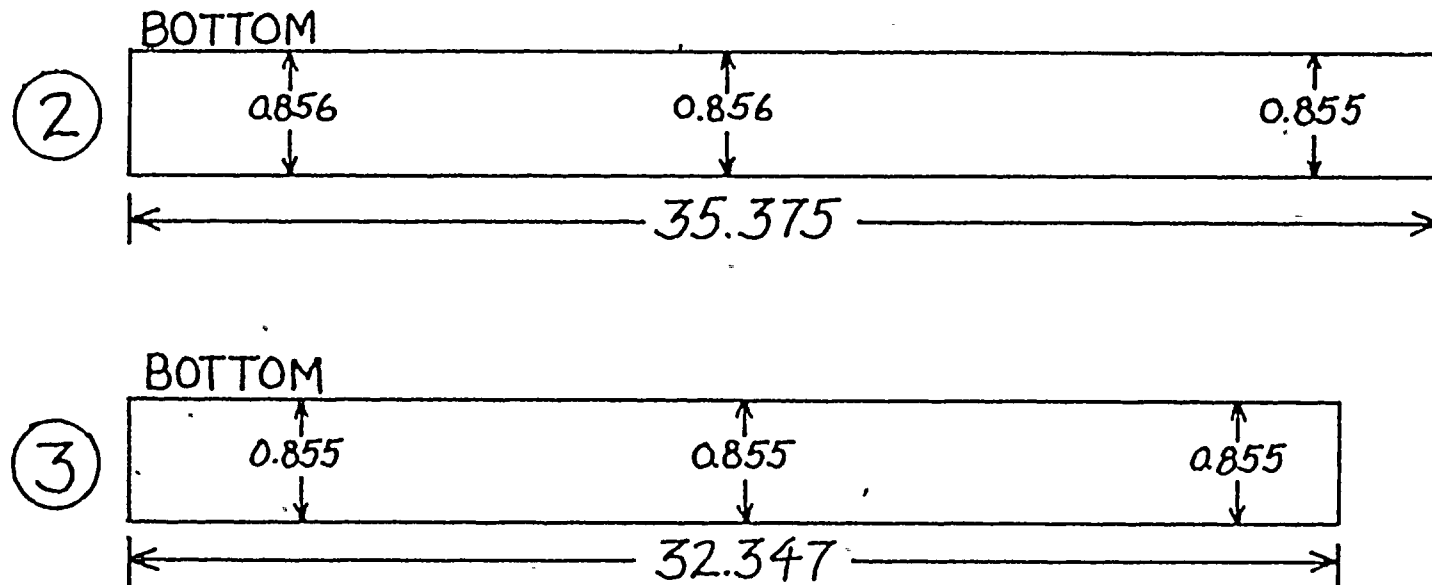
FIGURE A2

- ② TUBE SPECIMEN IS 35.375 INCHES LONG MEASUREMENTS TAKEN ONE INCH ABOVE BOTTOM, MIDDLE AND ONE INCH BELOW TOP.
SCALE - $\frac{1}{4}'' = 1.0''$
- ③ TUBE SPECIMEN IS 32.437 INCHES LONG MEASUREMENTS TAKEN SAME LOCATION AS SPECIMEN NO. 2

TUBE SPECIMENS PULLED FROM B $\frac{5}{16}$ R34C54 - O.D. MEASUREMENTS
