GINNA STATION
B-STEAM GENERATOR
NRC MEETING
MARCH 23, 1982

INSPECTION UPDATE
NO. 4 WEDGE AREA

R. E. GINNA S/G B - POSTULATED TUBE RUPTURE MECHANISM.

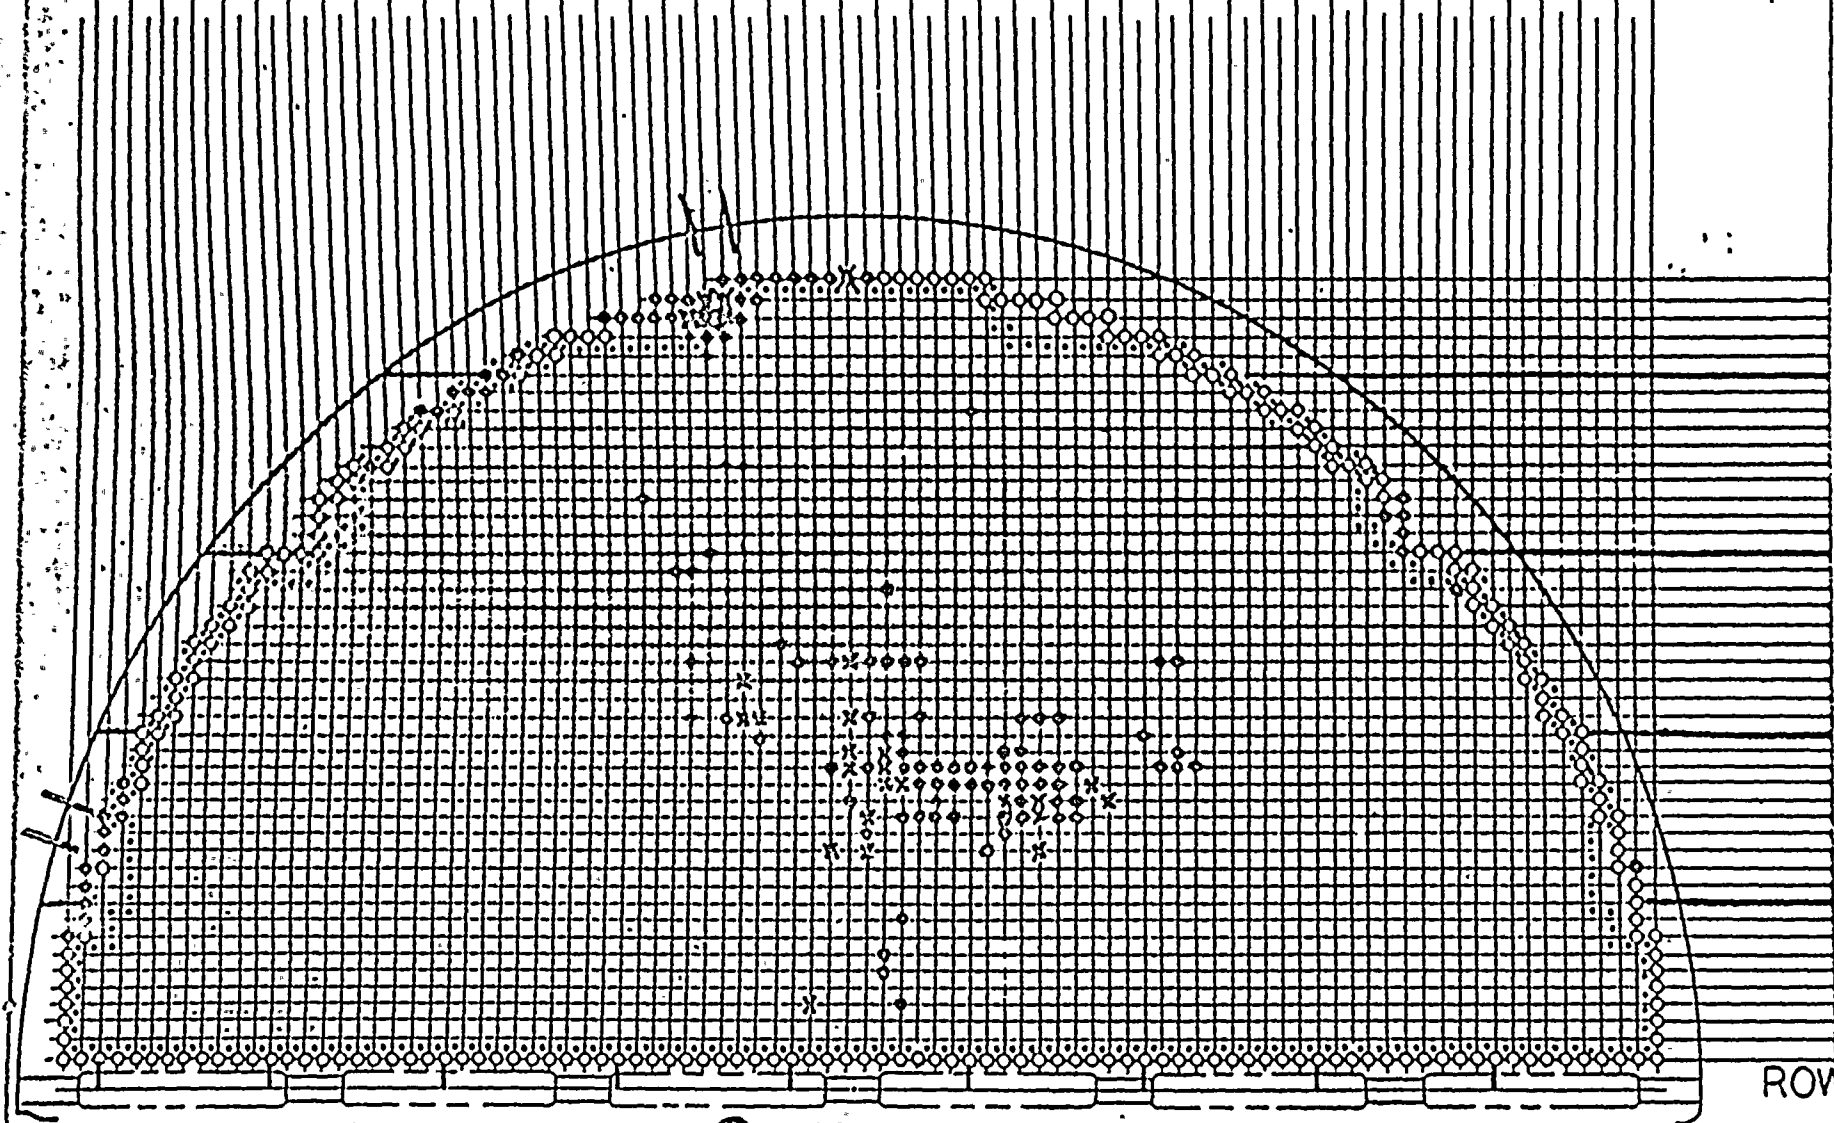
RG&E Steam Generator

PLUGGED TUBES

SLEEVED TUBES

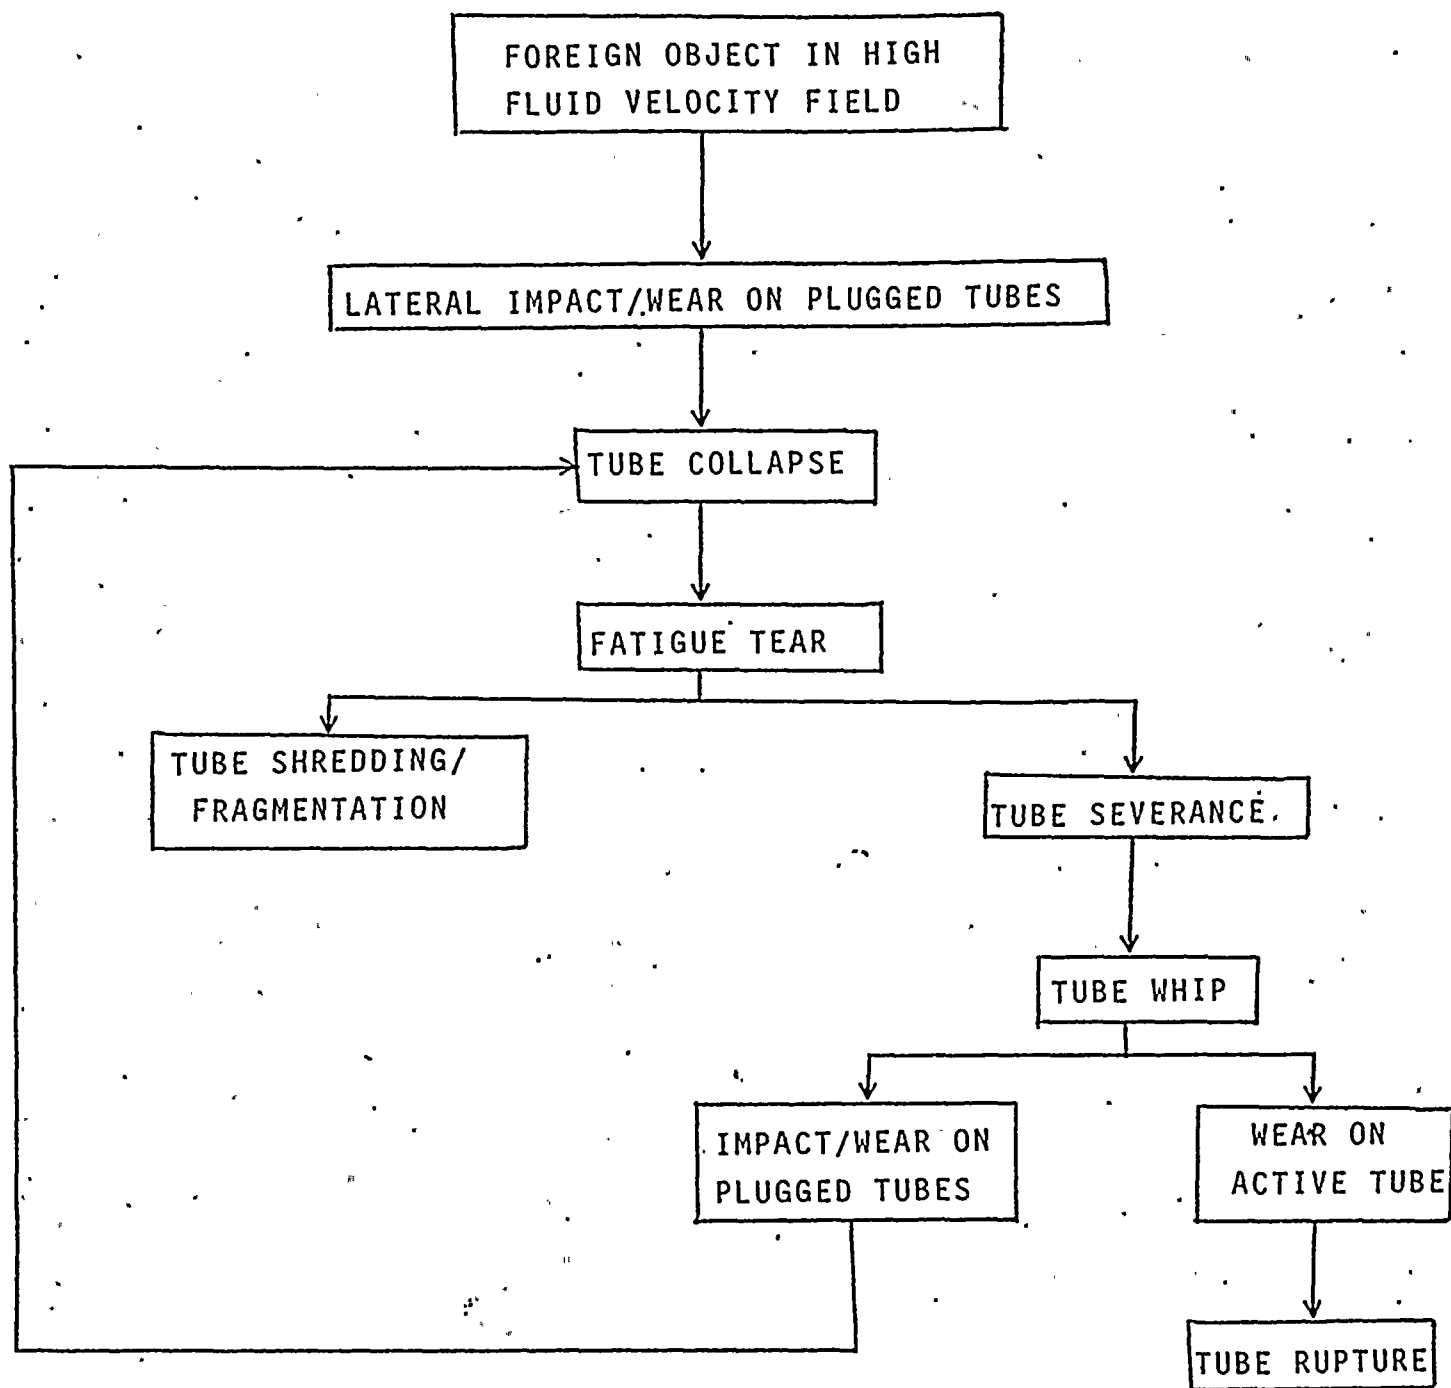
- WEAR SURFACES
- PRIMARILY RUBBING WEAR CIRCUMFERENTIAL DIRECTION
- NO EVIDENCE OF CORROSION INVOLVEMENT
- EVIDENCE OF SURFACE COLD WORKING
- FATIGUE STRIATION ON FRACTURE SURFACE
- TENSILE OVERLOAD BURST TUBE FAILURE SURFACE.

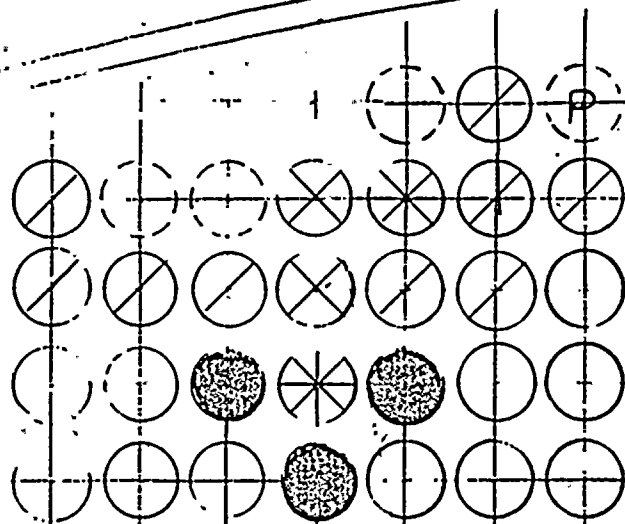
NO. 4 WEDGE AREA

- o R45C54
-missing and severed at first support plate
- o R44C54
-severed at top of tubesheet
- o R44C55
-severed at top of tubesheet
-partially severed at first support plate
- o R43C55
-severed at top of tubesheet
- o R44C56
-missing and severed at first support plate
- o R44C57
-missing and severed at first support plate

Structurally Degraded (19 tubes)

Eddy Current Signal (5 tubes)

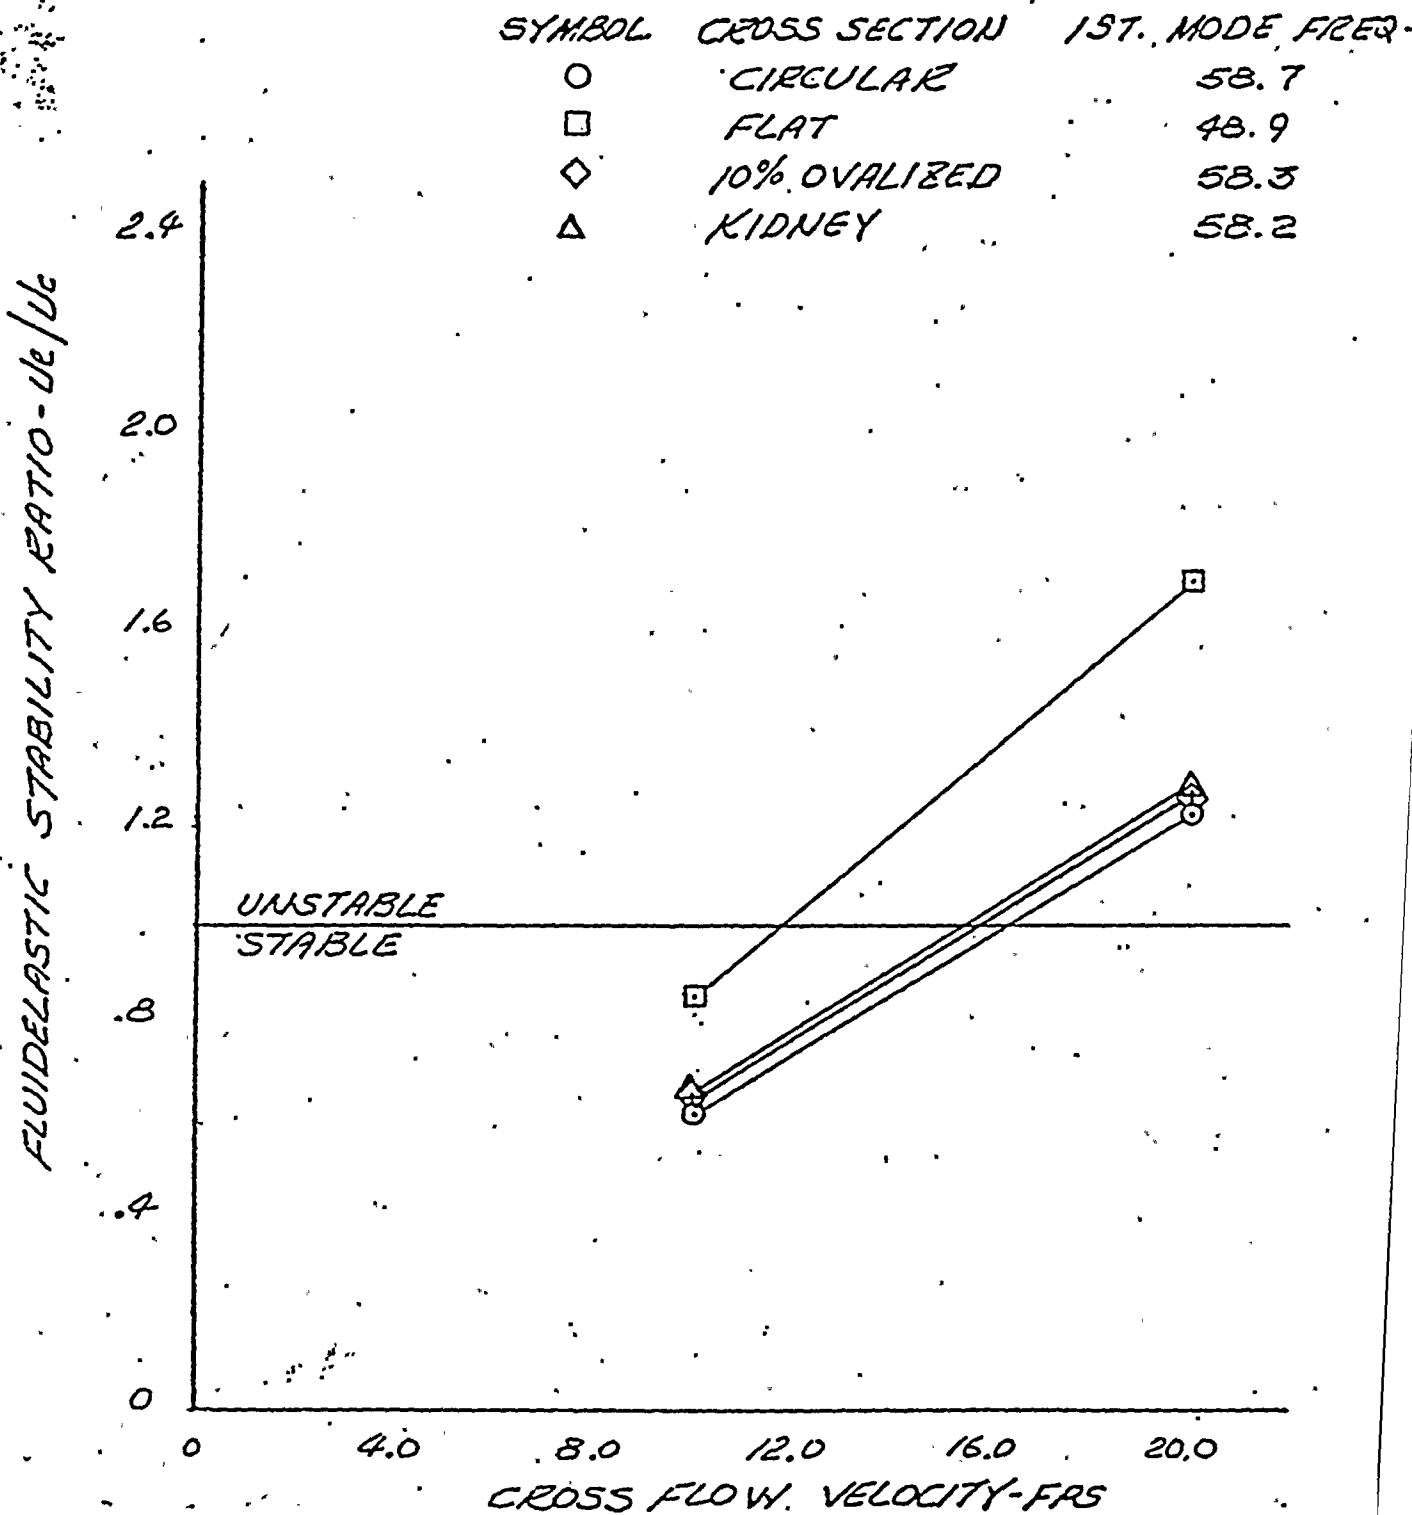
SUMMARY OF VORTEX SHEDDING AND TURBULENCE
ANALYSES

CROSS SECTION OF DISTORTED ZONE	VIBRATION AMPLITUDES, MILS	
	VORTEX SHEDDING	TURBULENCE
CYLINDER (NOMINAL)	0.77	0.81
10% OVALITY	0.79	0.83
KIDNEY	0.79	0.83
FLAT	2.13	1.53

VIBRATION AMPLITUDE DUE TO VORTEX SHEDDING AND CROSS-FLOW TURBULENCE
ARE RELATIVELY UNAFFECTED BY SMALL DISTORTIONS AND SURFACE IRREGULARITY

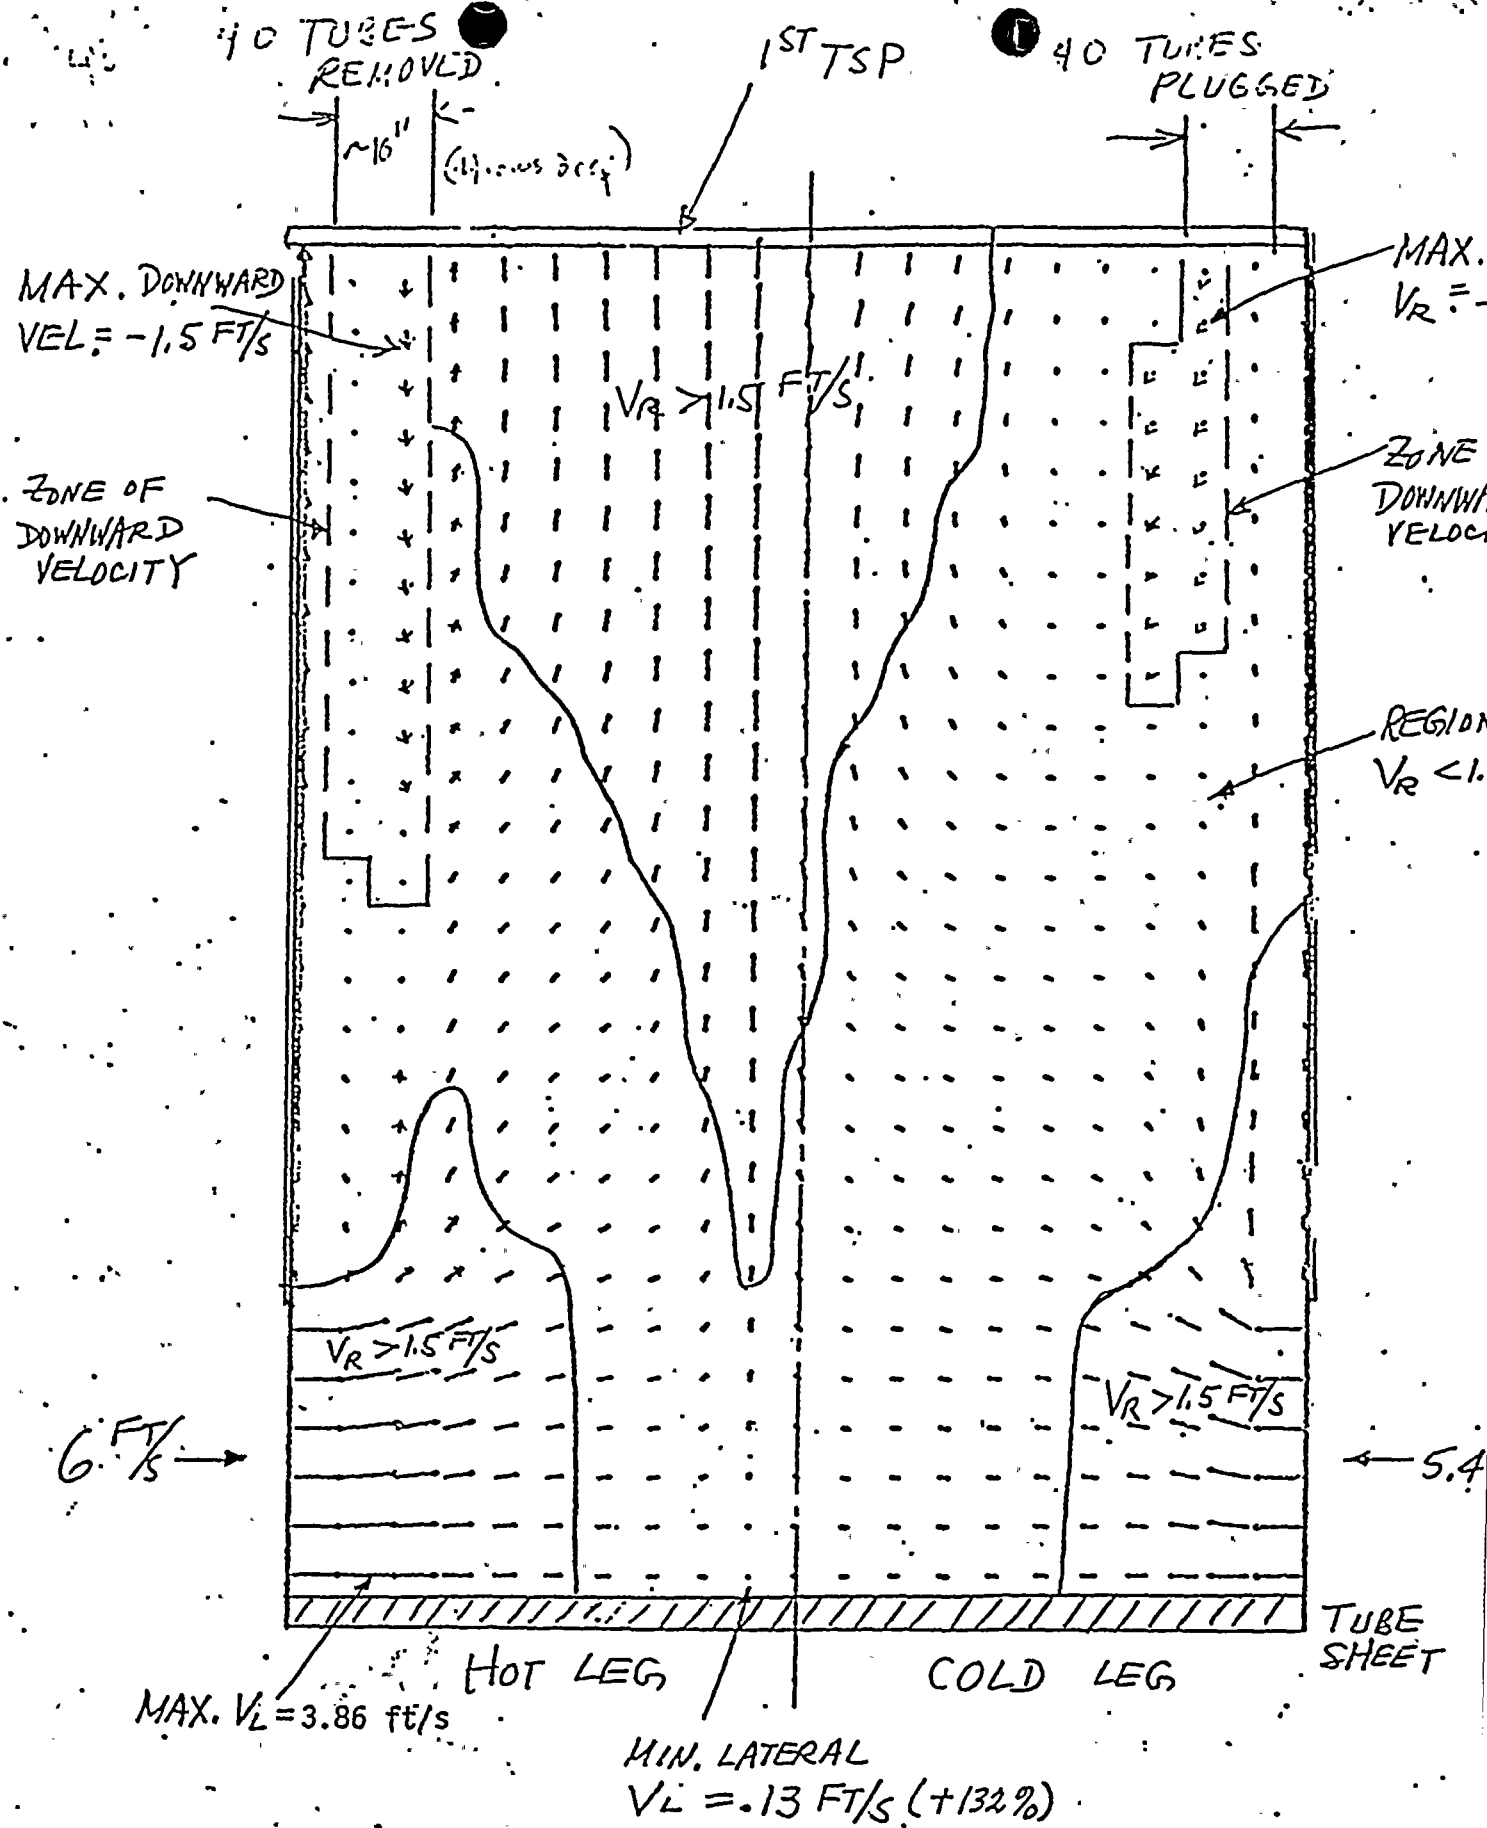
VELOCITY PATTERN OF ⁴⁰ TUBES REMOVED AT HOT SIDE AND PLUGGED AT COLD SIDE

CASE	AVERAGE VELOCITY IN TUBE REMOVAL REGION	MAX. GAP VELOCITY IN FIRST TUBE ROW DOWNSTREAM
NOMINAL	5.30	19.40
10 TUBES REMOVED	3.69	13.50
40 TUBES REMOVED	3.86	14.14

0 TUBE REMOVAL DOES NOT ADVERSELY AFFECT FLOW VELOCITIES

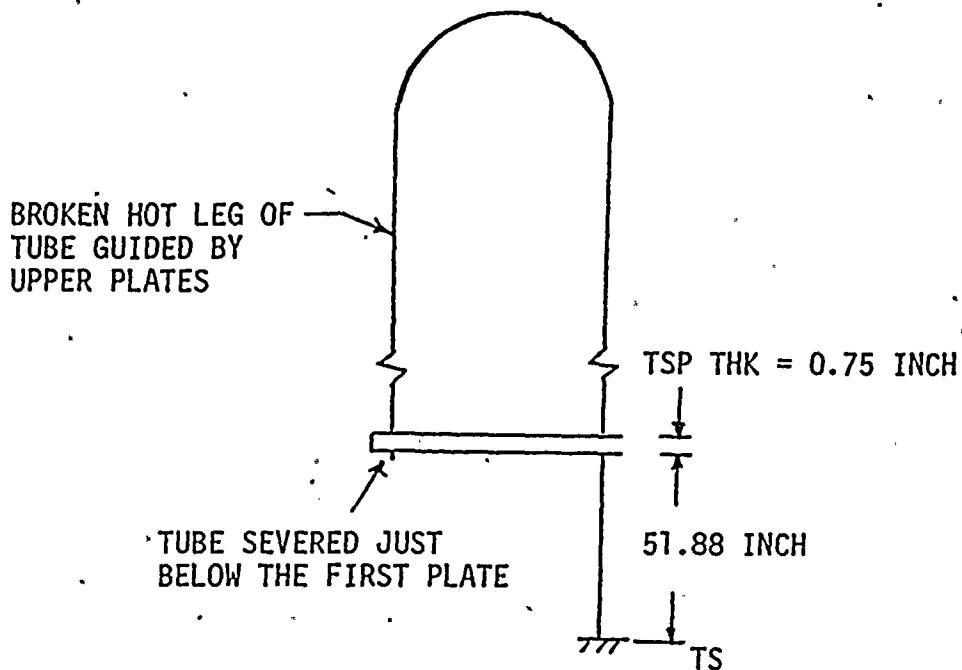
STABILITY OF TUBES SEVERED BELOW TSP

- MAXIMUM TUBE BUNDLE STRETCH = 0.12 IN. DURING FLB,
 $\Delta p \approx 2560$ psi
- Prior-to-sec thermal growth mismatch

FOR PULL OUT* THRU 0.75 INCH THICK PLATE, REQUIRED $\Delta T = 1900$

MAX. EXPECTED ΔT $\left\{ \begin{array}{l} < 100F \text{ DURING OPERATION} \\ < 400F \text{ DURING A LOCA} \end{array} \right.$

- TUBE PULL-OUT DUE TO TUBE SWING OR ROTATION AT U-BEND NOT
POSSIBLE SINCE BROKEN LEG OF THE TUBE IS GUIDED THRU UPPER
PLATES
