Subject: Steam Generator Tube Metallurgical Examination
R. E. Ginna Nuclear Power Plant
Docket No. 50-244

Metallurgical Examination of Ginna Steam Generator Tubes

On January 25, 1982, a tube ruptured in the "B" nuclear steam generator of the Rochester Gas and Electric Corporation (RGE) R. E. Ginna Power Plant.

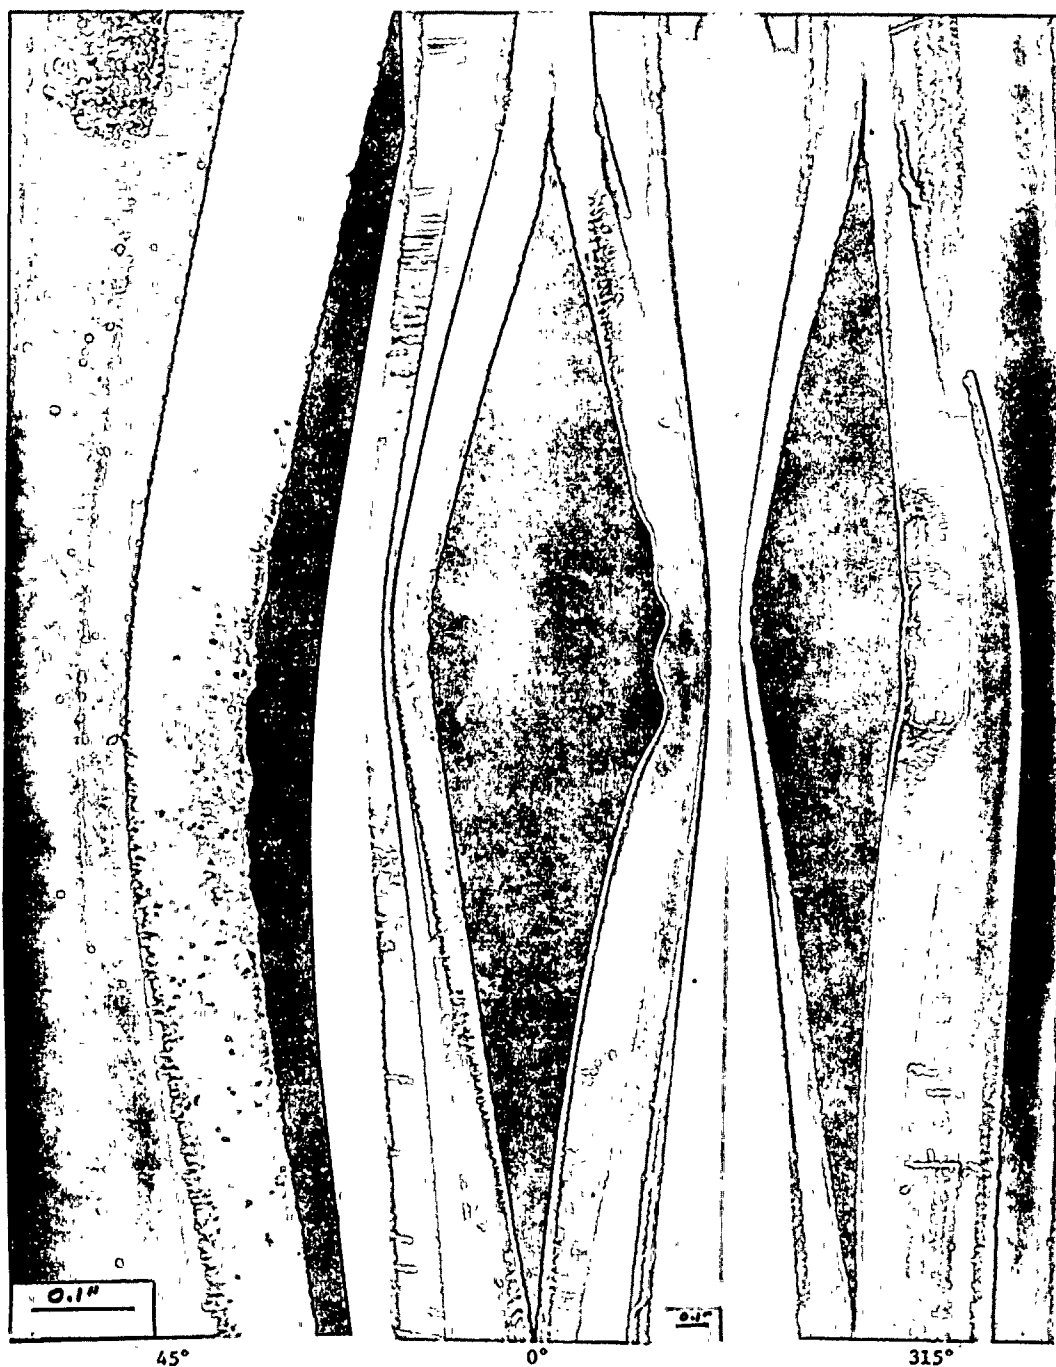
Photographs of the leaking tube from Row 42 - Column 55 (R42-C55) show a "fish-mouth" opening at 0° and axially oriented flats at 0, 60 and 315°. These flats had circumferential striations, Figures 2-1 and 2-2. Photographs in Figures 2-3 to 2-8 are of the neighboring previously plugged tubes: R43-C55, R44-C55, R43-C54, R44-C54 and R43-C56. Similar flats were observed on all tubes at various angular positions. There is extensive metal loss and apparent deformation on all tube sections. Tubes from R44-C55 and R44-C54 arrived in two sections.

6. The fracture of the "fish-mouth" was consistent with a tensile overload failure.
7. The most severe cold work was observed on a concave indented surface at the bottom of a peripheral tube R44-C55.
8. Fatigue striations were identified on fractures associated with breakage of two of the previously plugged tubes.

Fig. 2-1. Fish mouth crack at near 0° on Tube R42-C55 from RGE (GINNA), SGB, hot leg

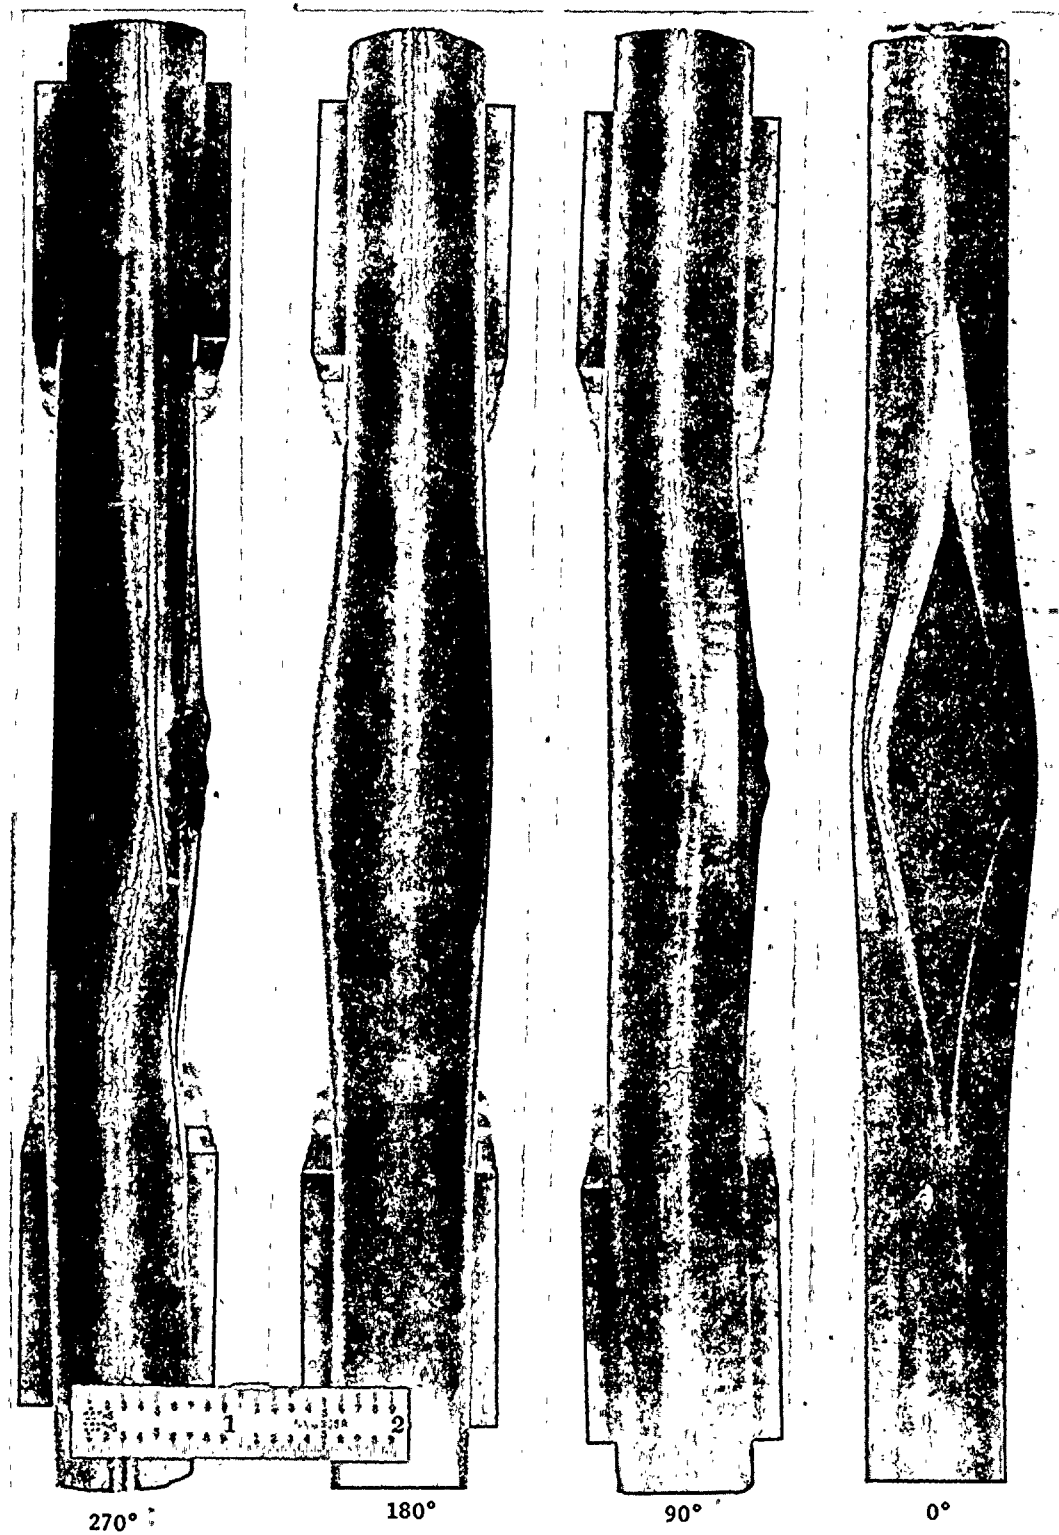
Fig. 2-2. Tube R42-C55 from RGE (GINNA), SGB, hot leg

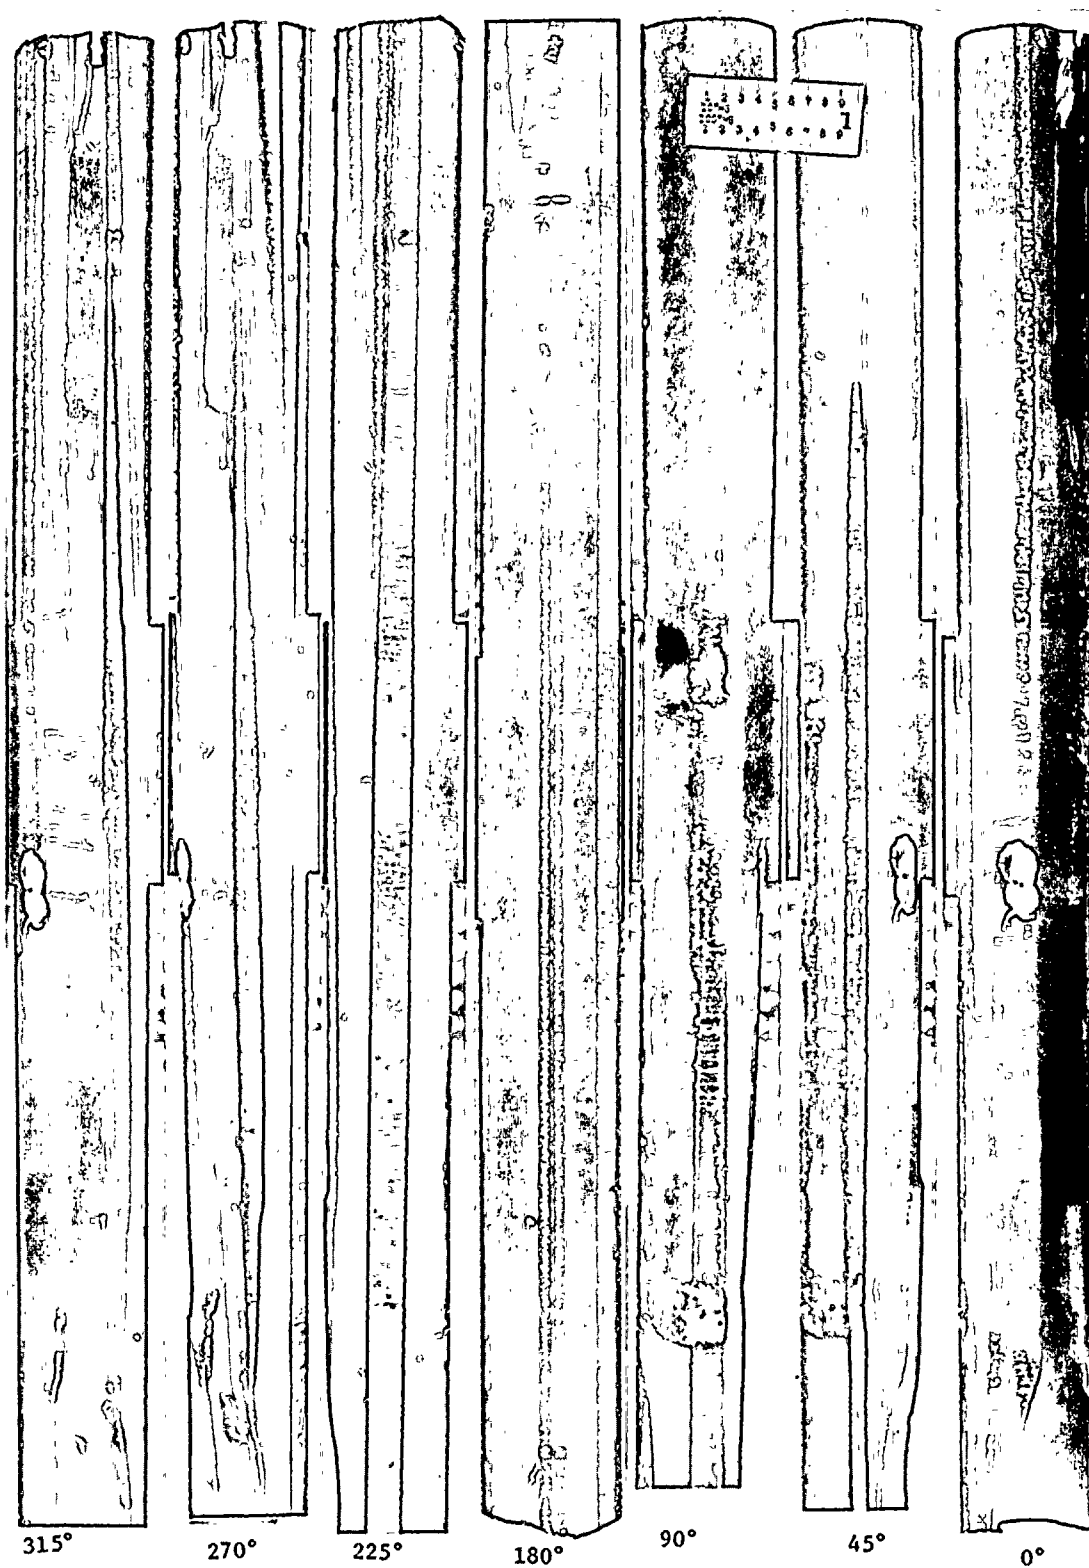
Fig. 2-3. Tube R43-C55 from RGE (GINNA), SGB, hot leg

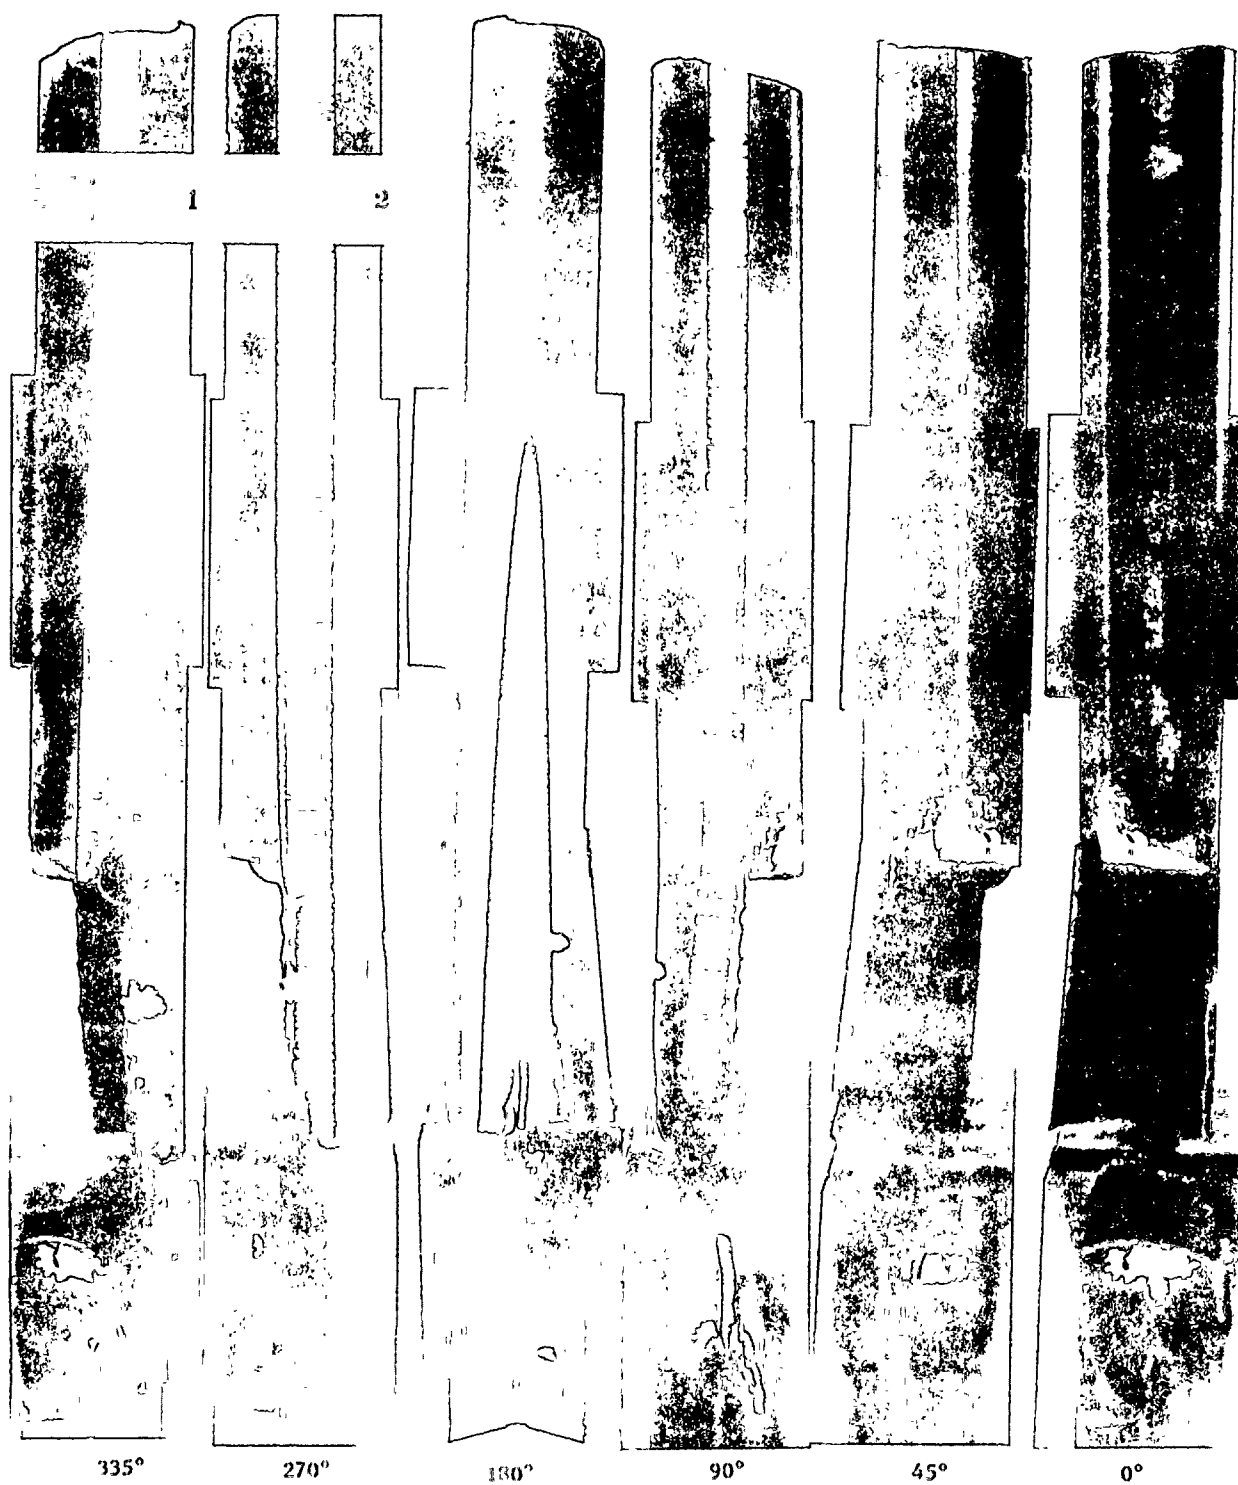
Fig. 2-7. Tube R44-C54 from RGE (GINNA), SGB, hot leg

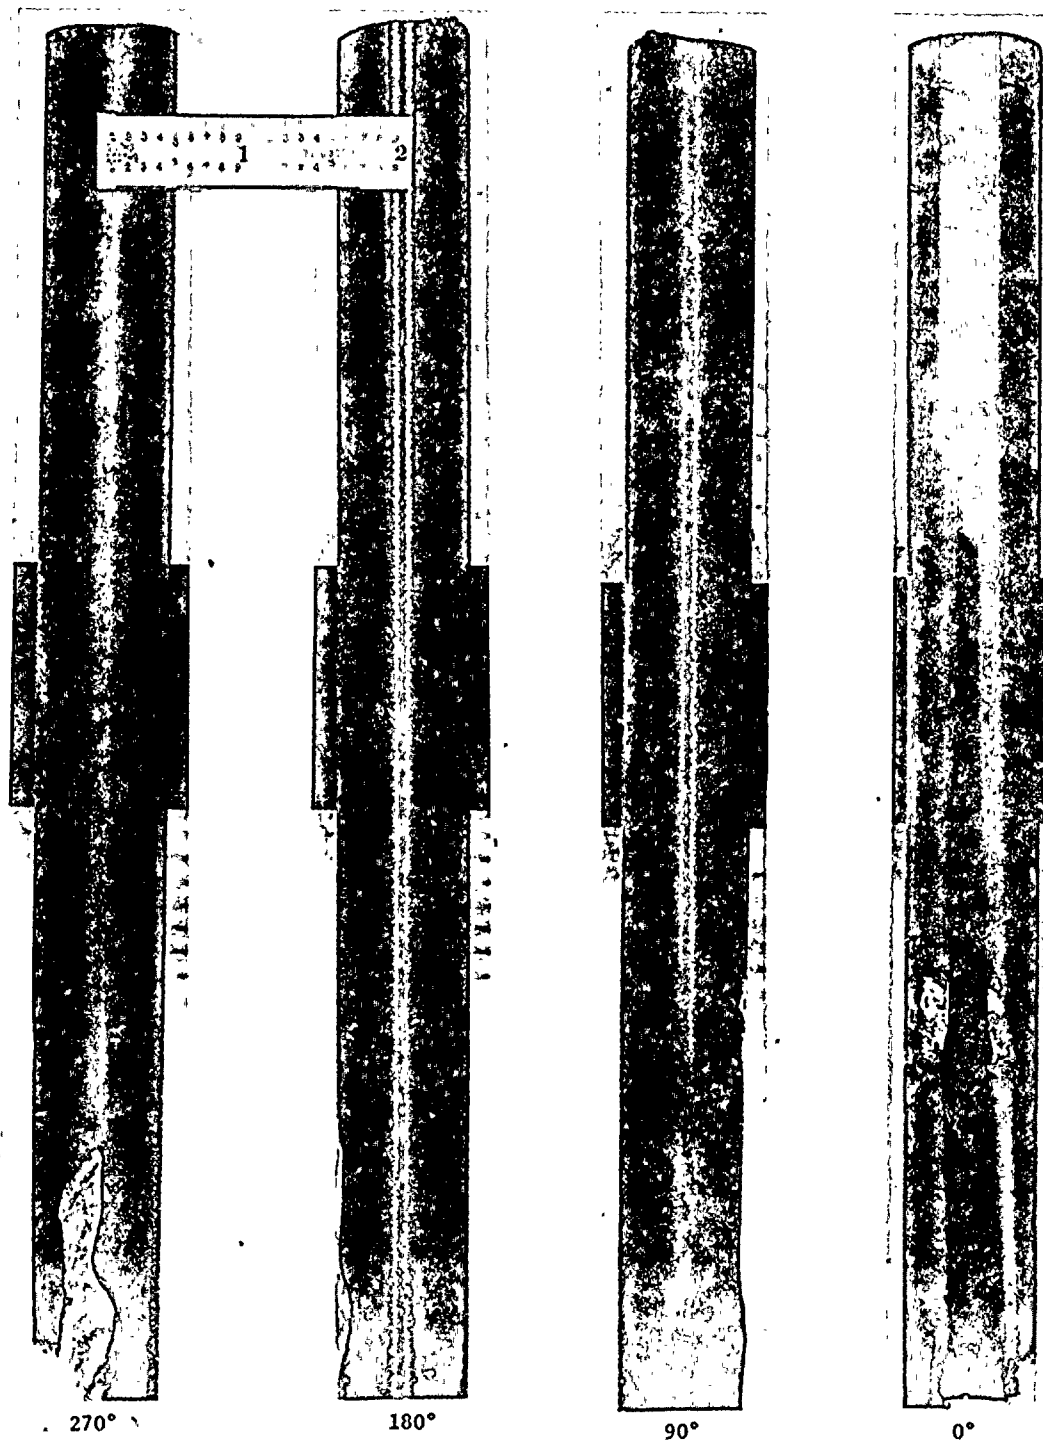
Fig. 2-8. Tube R43-C56 from RGE (GINNA), SGB, hot leg

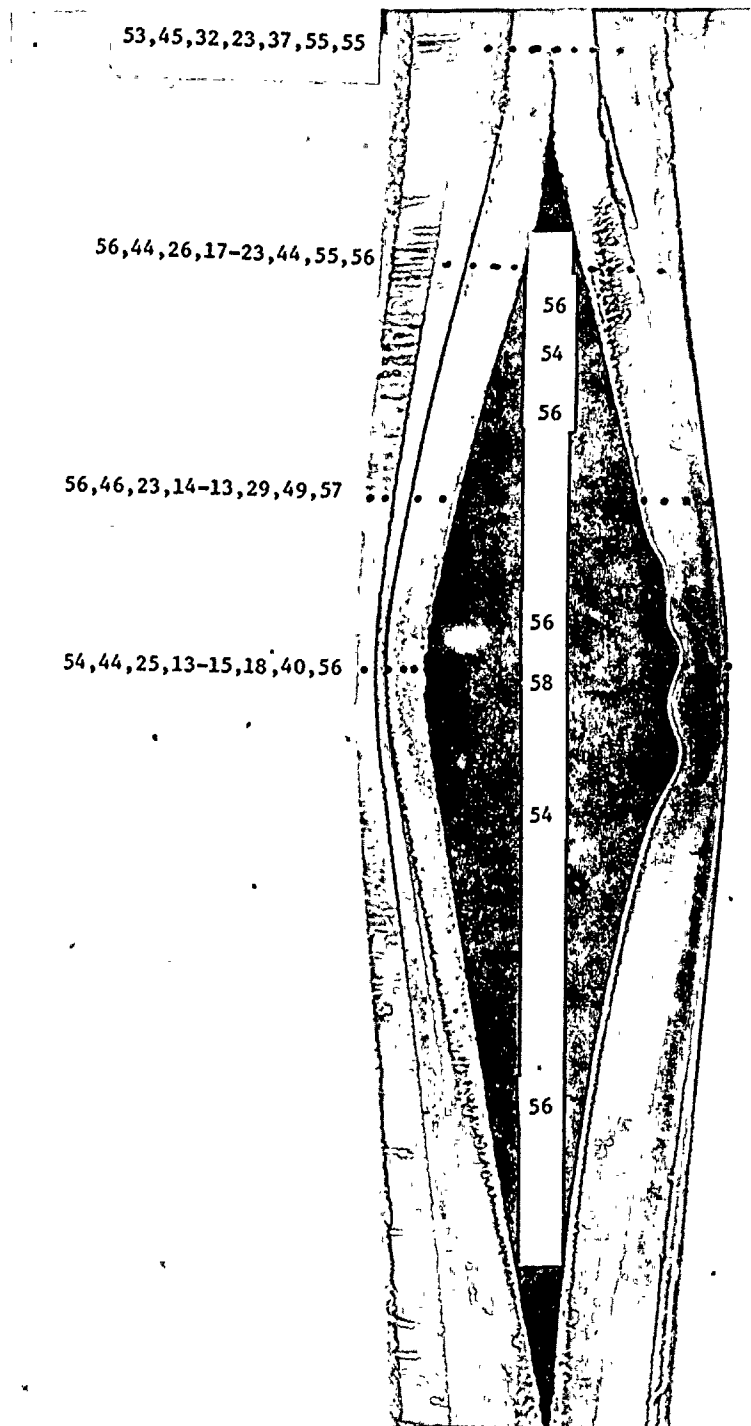
Wall thickness measurements were consistent with a nominal 50 mil wall away from the flats and a wall thickness reduction at the flats, Figure 2-9, Table 2-1.

Fig. 2-9. Wall thickness measurements (mils) superimposed on 0° photograph of R42-C55

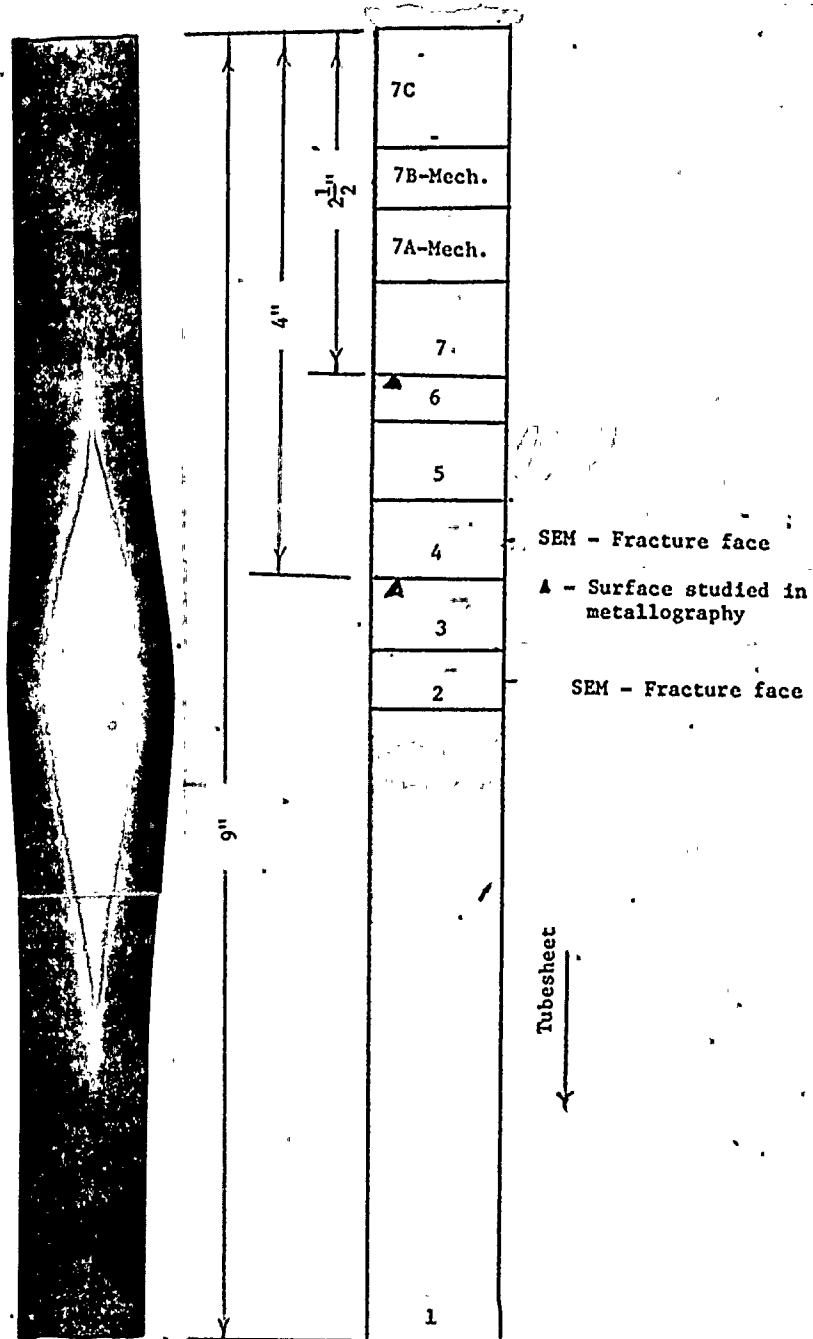
Double wall x-ray radiographs were made of all tube sections at 0, 45, 90 and 315°. A Seifert Industrial X-ray unit was used with the following settings: 5 min. exposure time, 110 to 70 kV, 10 milliamperes, 60 in. source-to-film distance, large focal spot, and Kodak M-8 lead pack film. Wall thickness reductions were easily seen; however, there was no evidence of intergranular attack or stress corrosion cracking.

Fig. 2-10. Print of double wall X-ray radiograph at 0° for Tube R42-C55 and diagram showing cuts, section identification, and sample use.

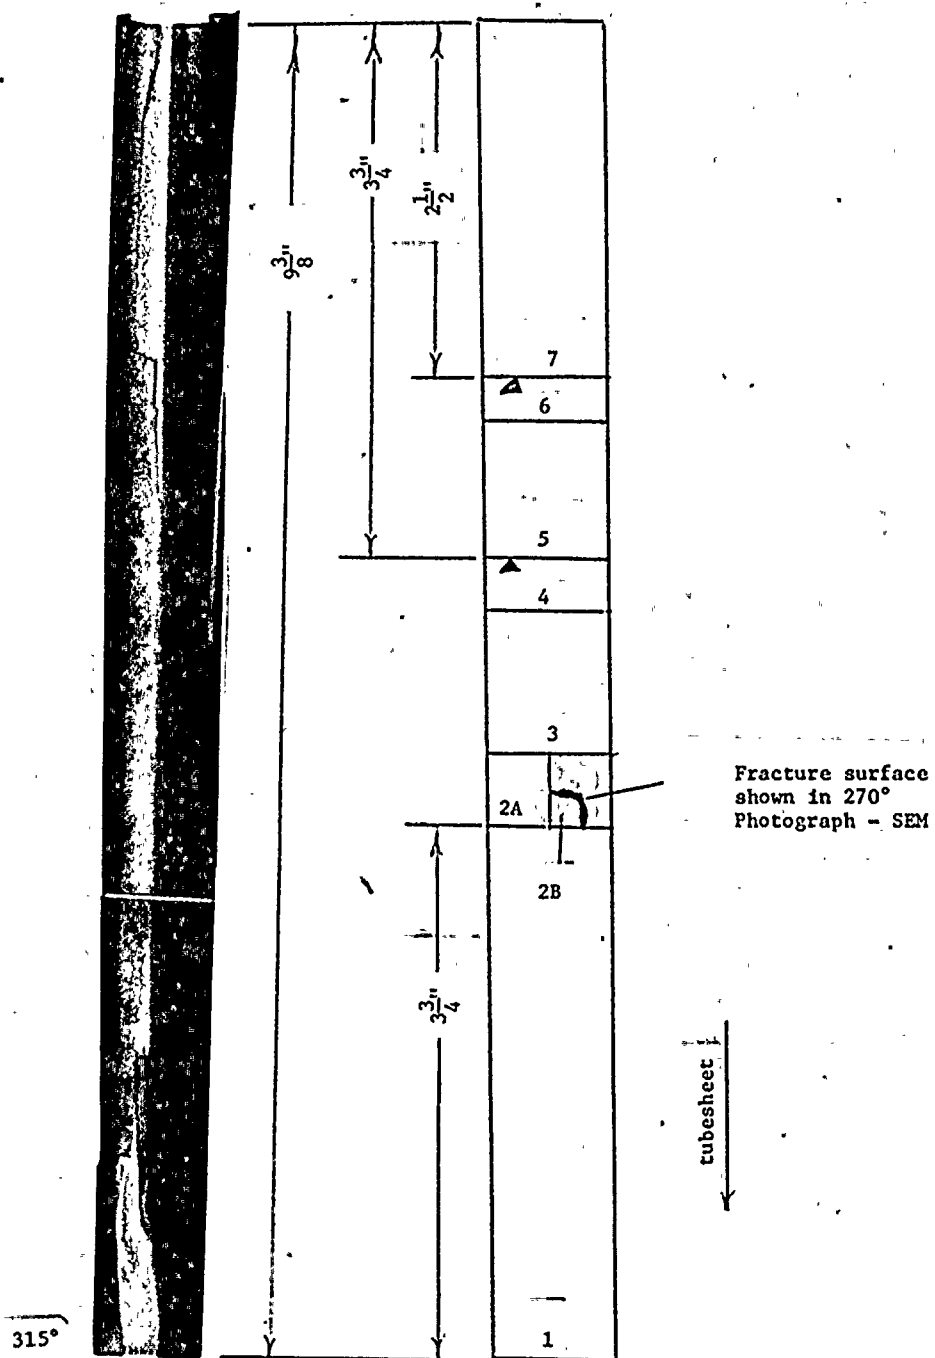
Fig. 2-11. Print of double wall X-ray radiograph for Tube R43-C55 and cutting diagram

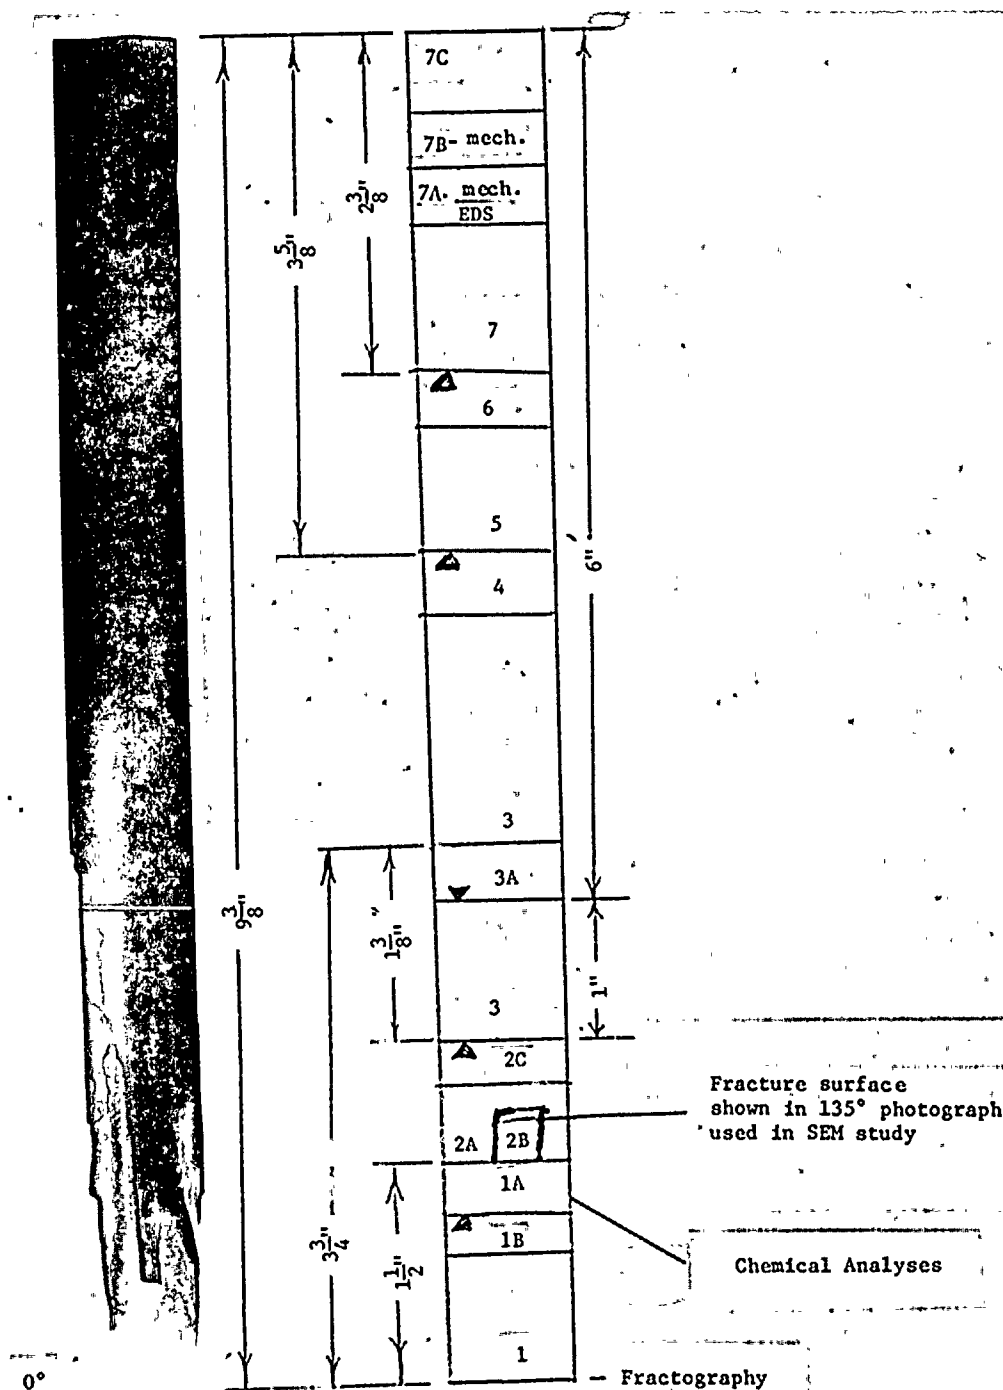
Fig. 2-12. Print of double wall X-ray radiograph at 0° for top portion of Tube R44-C55 and cutting diagram

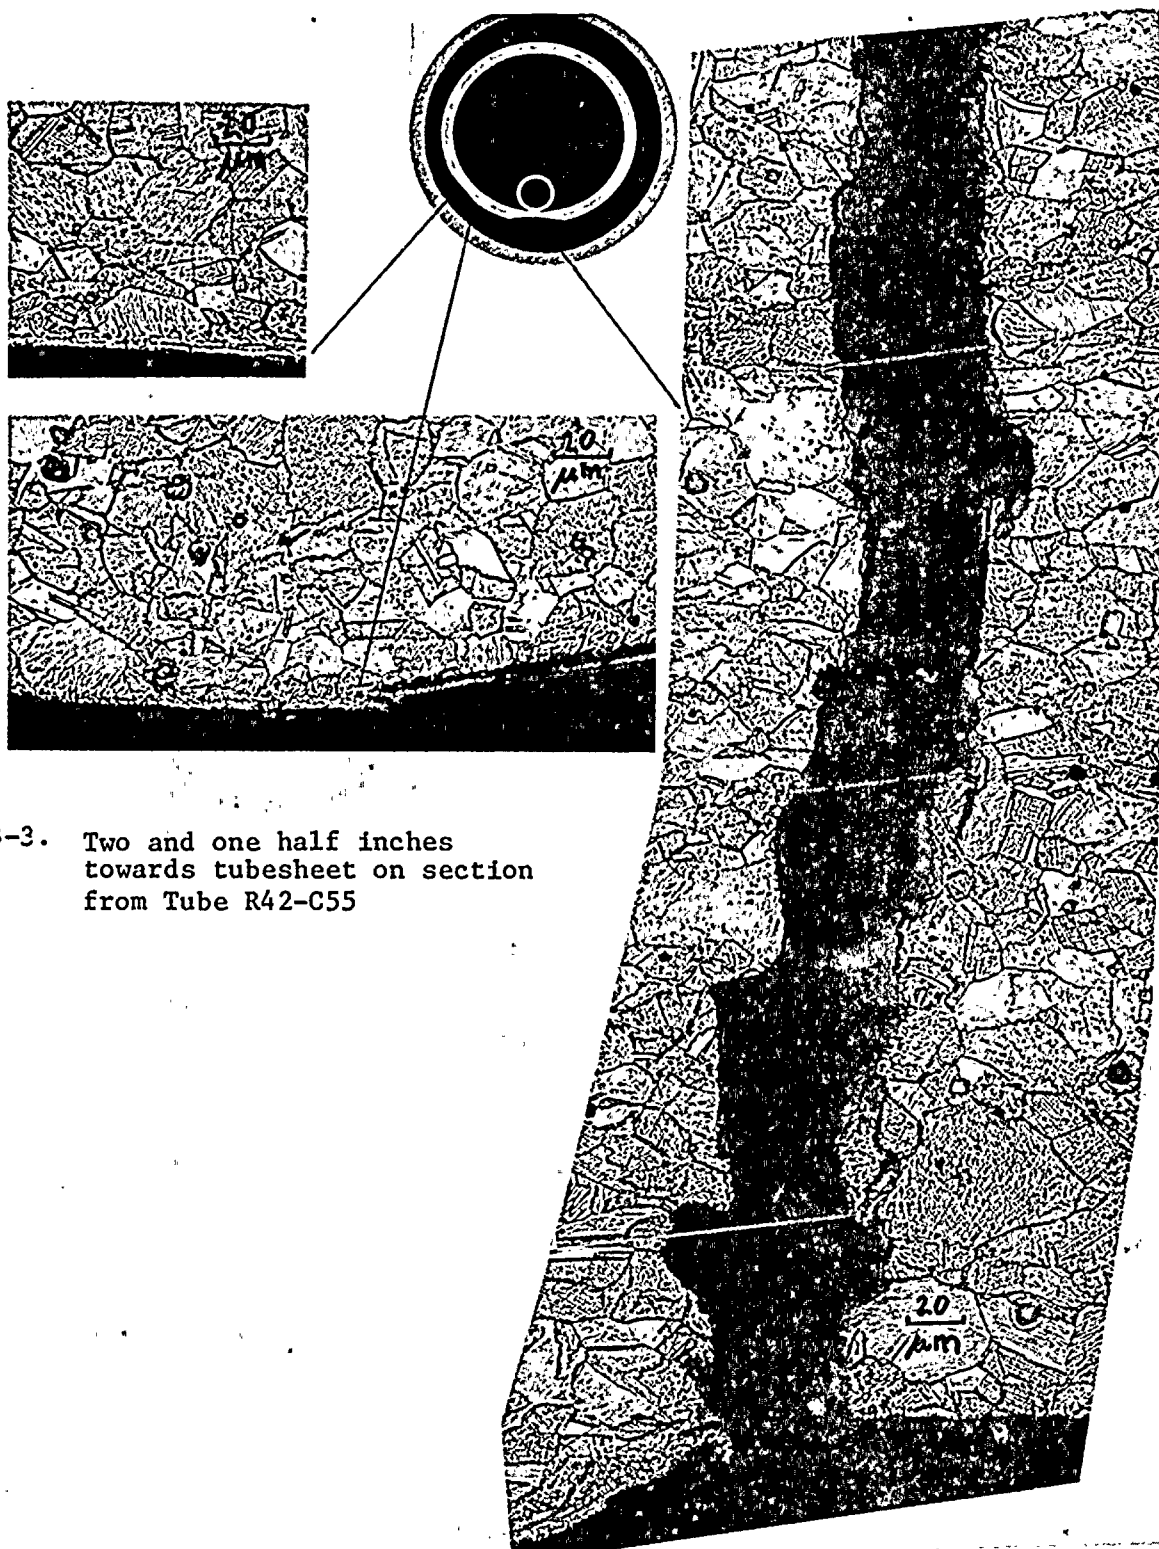
Microstructures through the leaking tube R42-C55 are shown in Figures 3-3 and 3-4. These microstructures were etched with two percent bromine-methanol solution (only etchant used in this study). Cold work was not evident on the flat that burst, but was apparent on the 60° flat. The fracture face was not intergranular and was of the tensile overload type. The microstructure appeared normal and had carbide banding occurring to a greater degree near the I.D. At O.D. surfaces away from the flats, shallow amounts of cold work were observed and probably resulted from belt polishing in the manufacture of the tubing, e.g., 0.2 mils depth of cold work at 270° in Figure 3-4.

Fig. 3-3. Two and one half inches
towards tubesheet on section
from Tube R42-C55

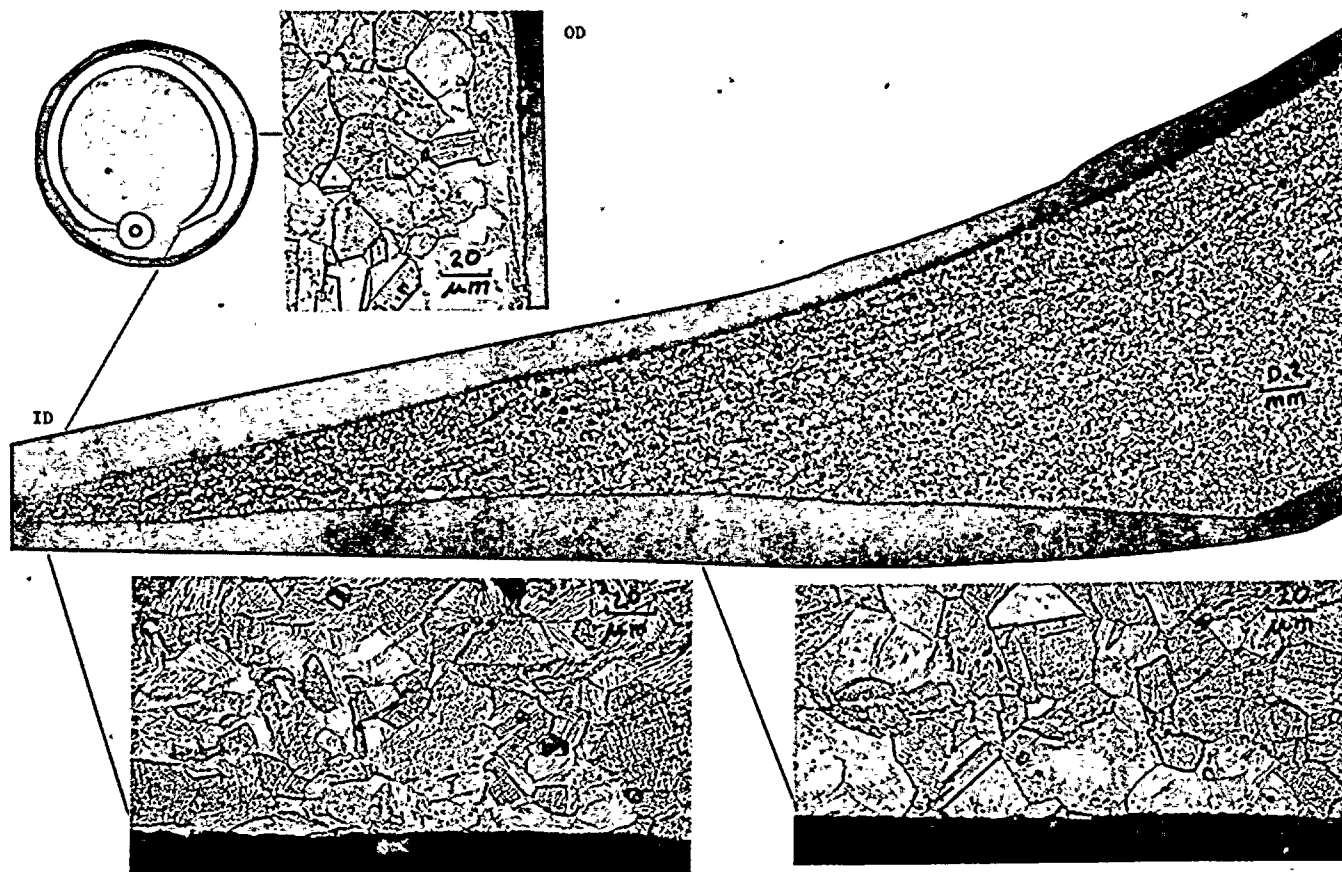
Fig. 3-4. Metallography on transverse cross-section ~4" towards tubesheet
on section from Tube R42-C55

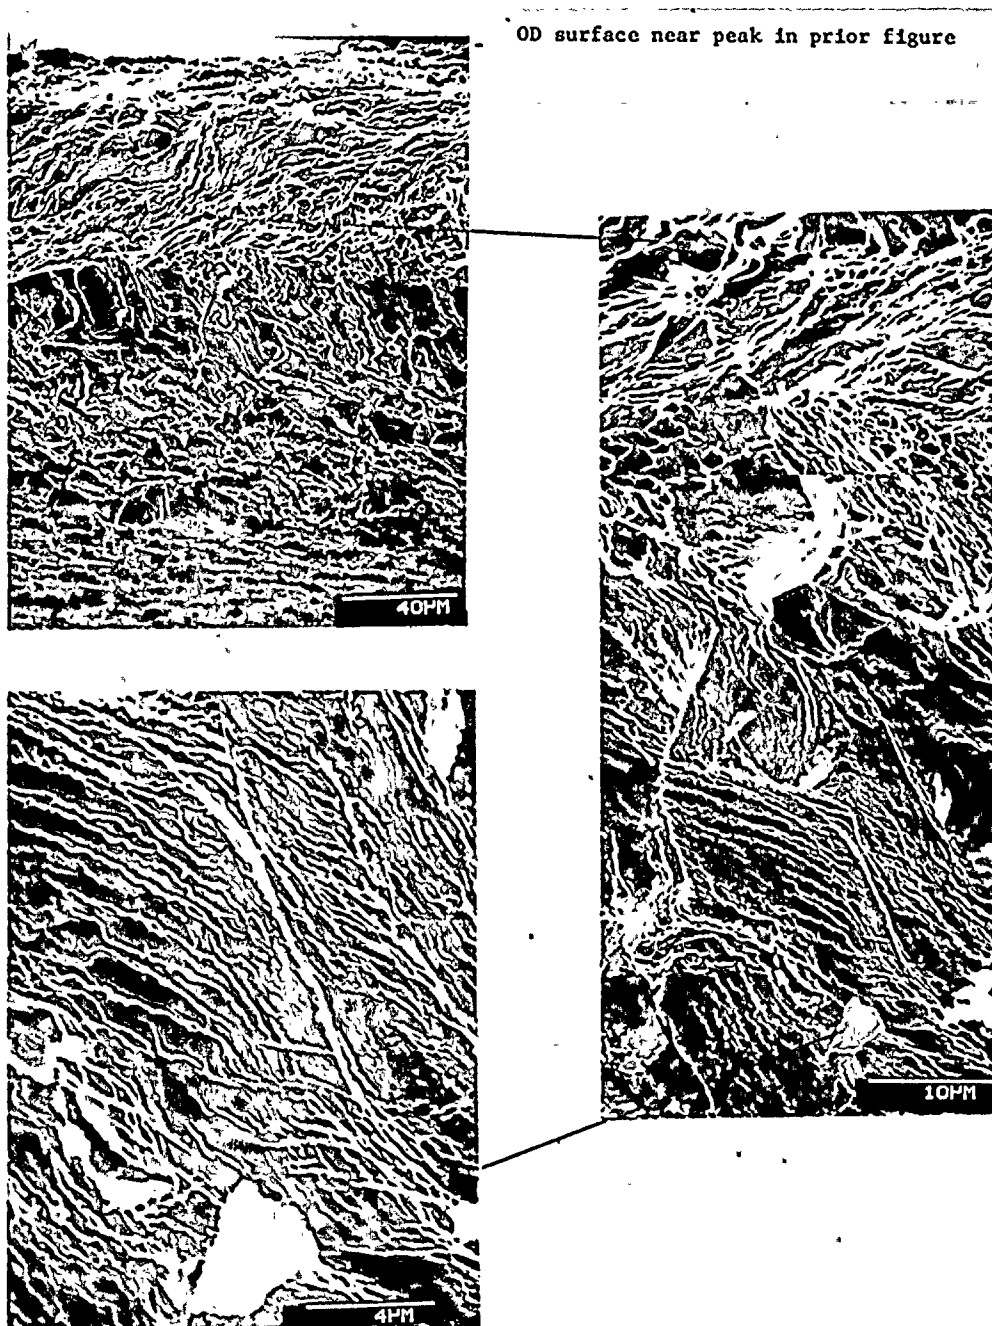
Fractography on a horizontal fracture near the center of R43-C55 suggested that fatigue contributed to cracking, Figures 4-3 and 4-4.

Fig. 4-4. SEM's near peak in prior figure and on fracture face.

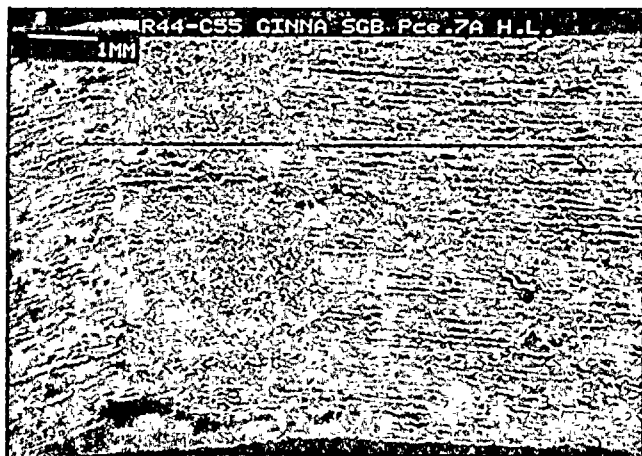
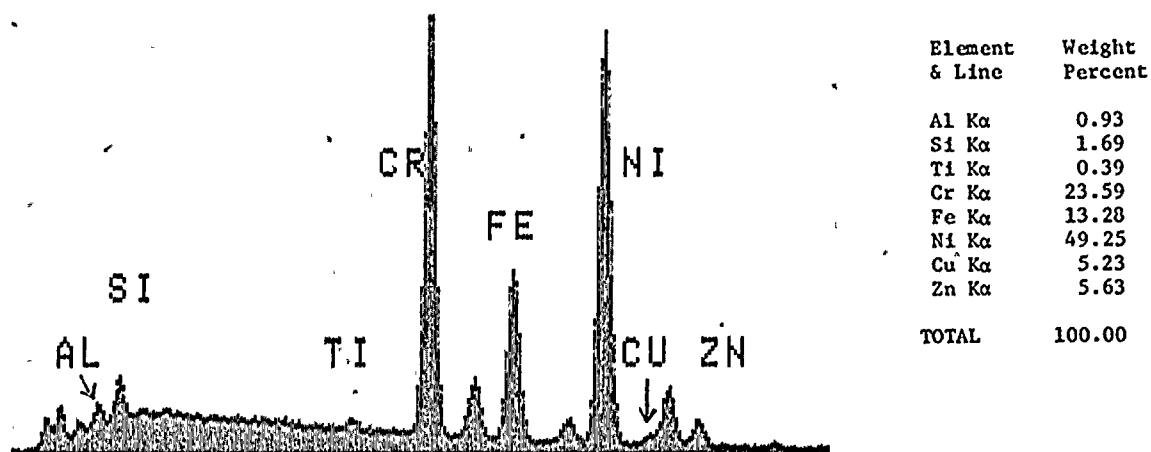
On tube R44-C55, an EDS analysis on a flat was rich in Al, Si, Cr, Fe, Cu and Zn as compared to Inconel 600, Figure 4-5. The fracture surfaces near the bottom of the tube were not well defined and contained deposits, Figures 4-6 to 4-9.

Fig. 4-5. EDS analysis on lower left area of 270° flat that was 1" down from the top of top portion of Tube R44-C55 (Section 7A).

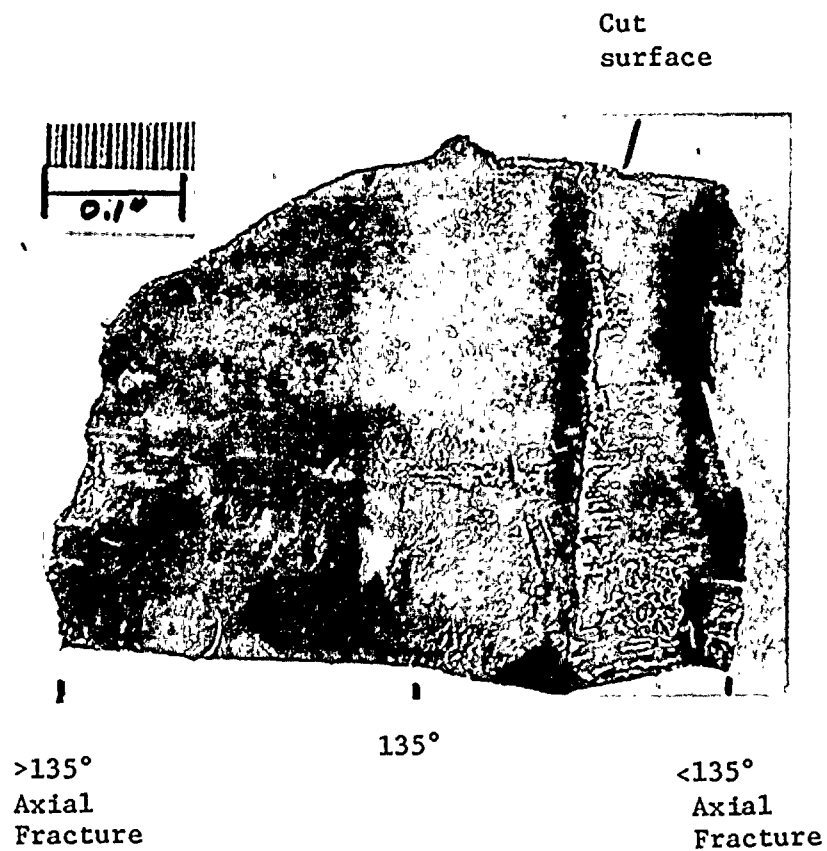
Fig. 4-6. Fractography was performed on two axial fracture surfaces 1-1/2" from the bottom of the top portion of Tube R44-C55

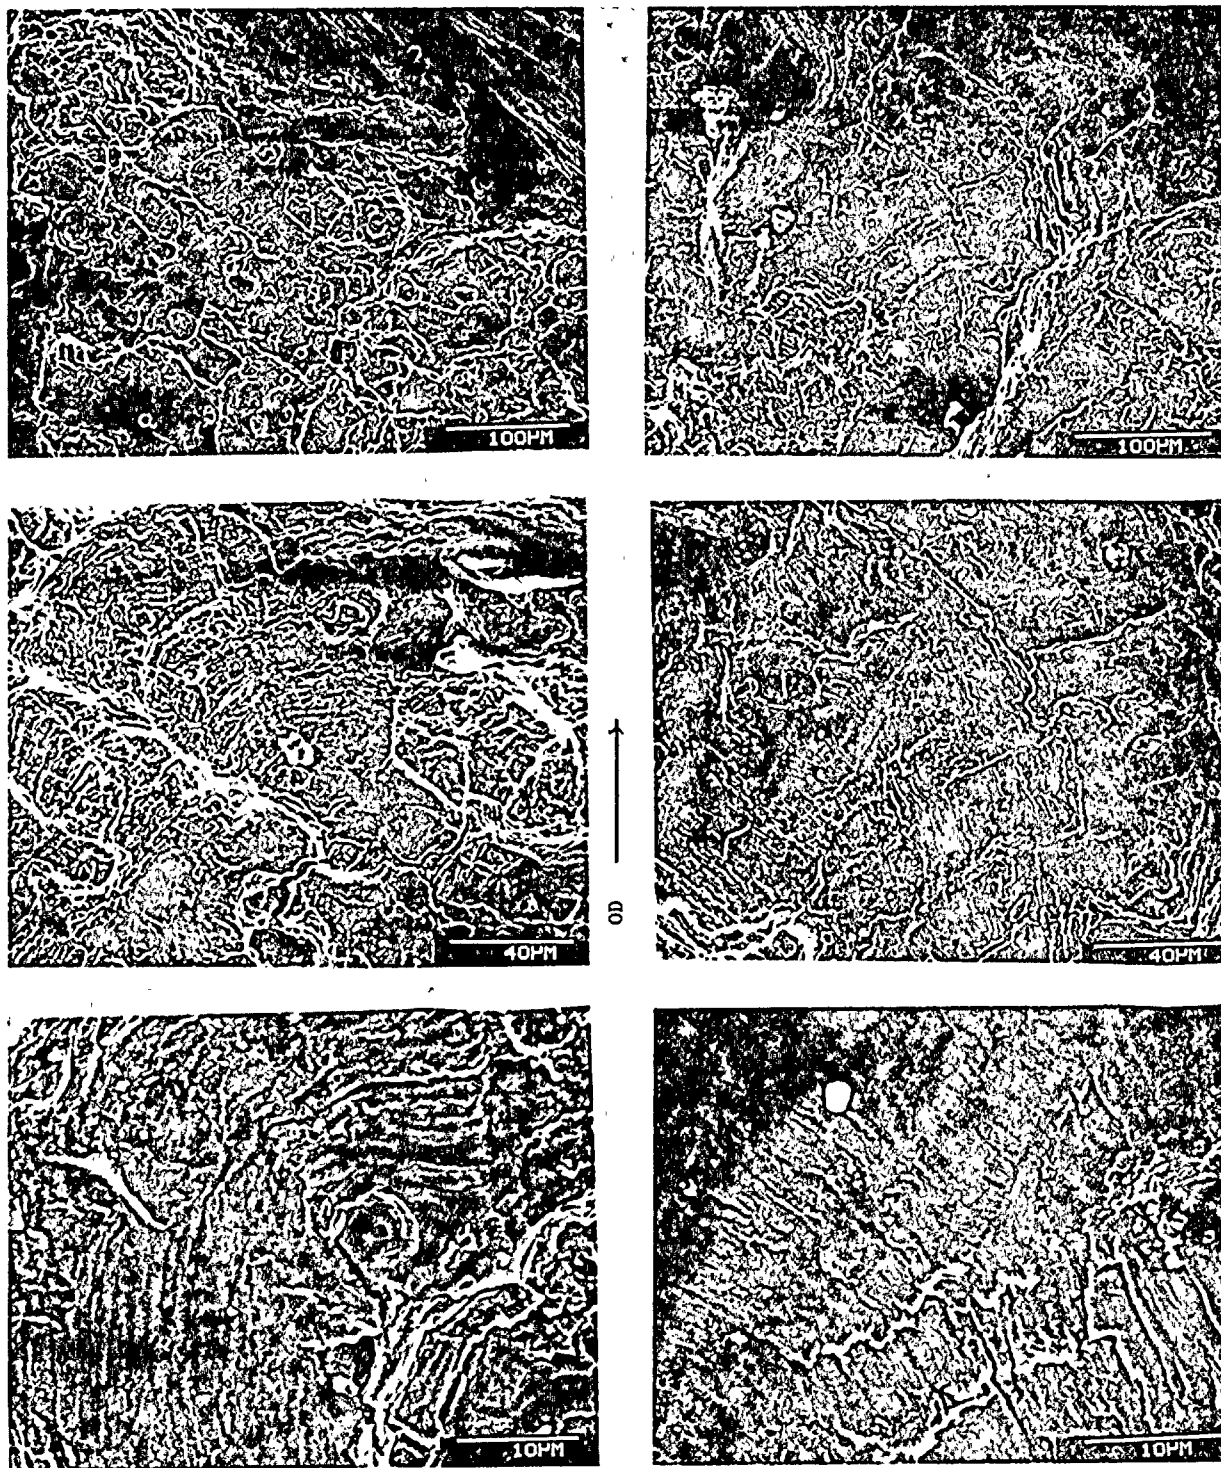
Other fractographs on R44-C54 indicated that fatigue contributed to the fracture, Figures 4-10 and 4-11.

Fig. 4-11. Fractography on bottom fracture surface of Tube R44-C54;
Area 1 (left) and Area 2(right)

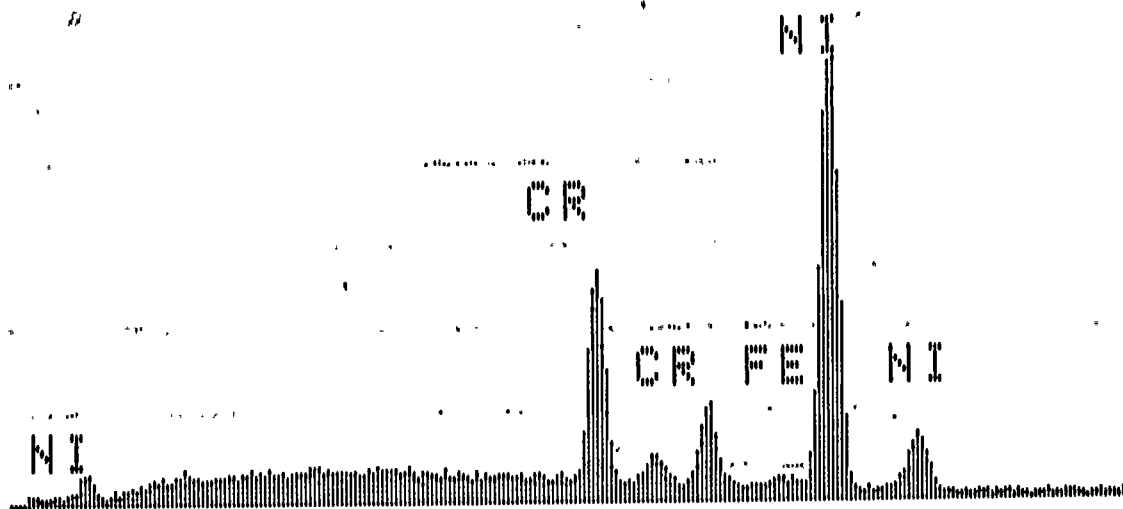
An EDS analysis of Section 1A of tube R44-C55 indicated that the principal elements were within specification. The mechanical properties of the Inconel 600 tubing were estimated and tabulated in Table 5-1. Knoop (500 g) hardness readings were made mid-wall on the metallographic mounts 4 inches down on Tubes R42-C55 and R44-C55. These were converted to Rockwell "B", R_B , readings which were then used to estimate yield strength by two methods. One was a correlation established previously on Inconel 600 tubing, Figure 5-2, and the other was an International Nickel Company correlation on Inconel 600 sheet and strip. Reasonable agreement existed between the two conversions: all estimates of yield strength were between 45,000 and 62,000 psi. An estimate of ductility of the Inconel tubing was obtained with bends. Rings 7A, 7B and 7C from Tube R44-C55 and 7A and 7B from tube R42-C55 were used. Each ring was positioned such that a location free of flats between 1450 and 2250 would be at the apex of a U-bend. The bend was made by placing the ring over a 3/32 in. diameter mandrel with a line of contact at the designated position and deforming the ring at this location around the bar. This strained the O.D. circumference in tension. No fissures were observed on the O.D. surface at the apex and the calculated outer fiber strain was twenty-eight percent.

Fig. 5-1. EDS spectrum and analysis for principal elements on Section 1A from Tube R44-C55
(Included are ASTM specifications).
