Steam Generator Evaluation  
Ginna Steam Generator Tube Failure Incident  
January 25, 1982  
R. E. Ginna Nuclear Power Plant  
Docket No. 50-244

Addendum 2  
Laboratory Fatigue Testing

Revision 0  
May 18, 1982

FATIGUE TESTING OF STRUCTURALLY DEGRADED  
MODEL 44 STEAM GENERATOR TUBING  
(7/8" O.D. x 0.050" WALL)

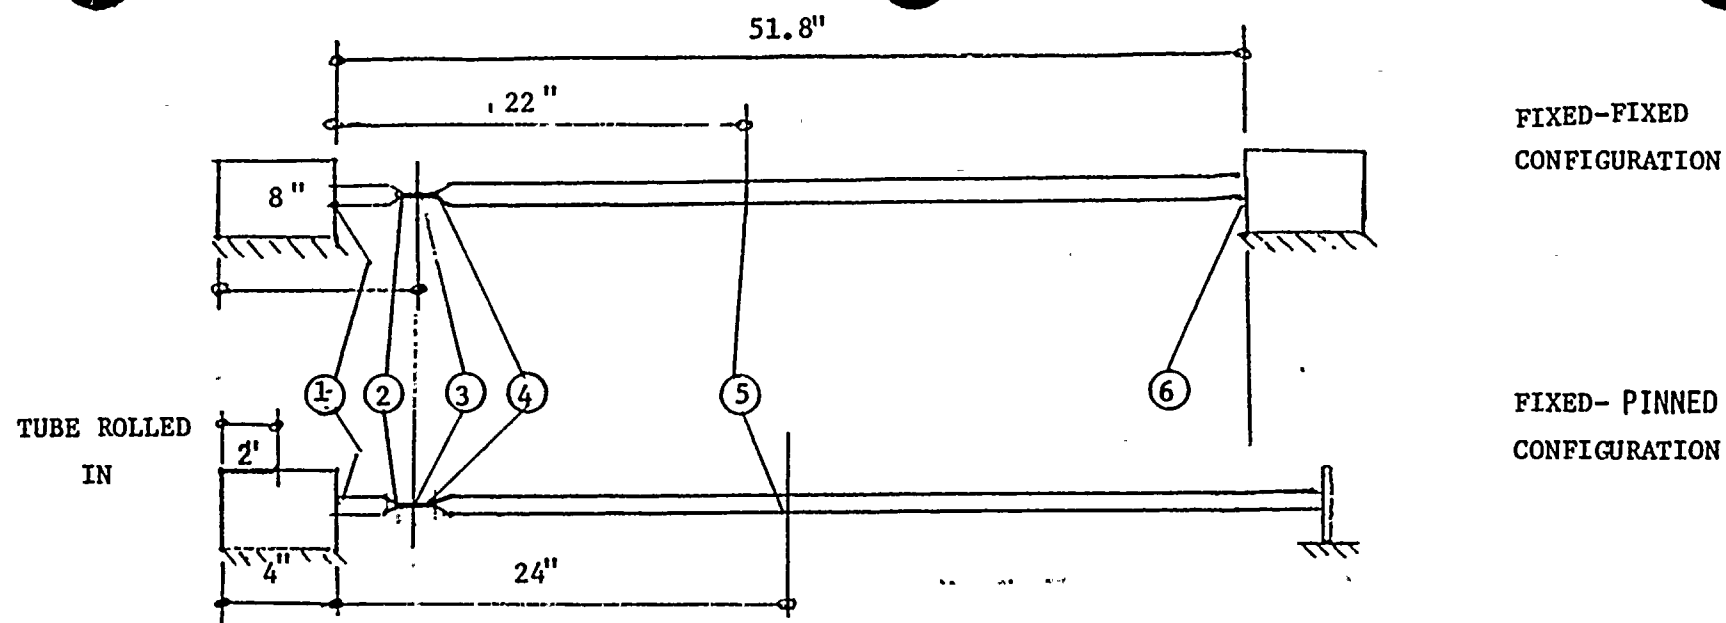
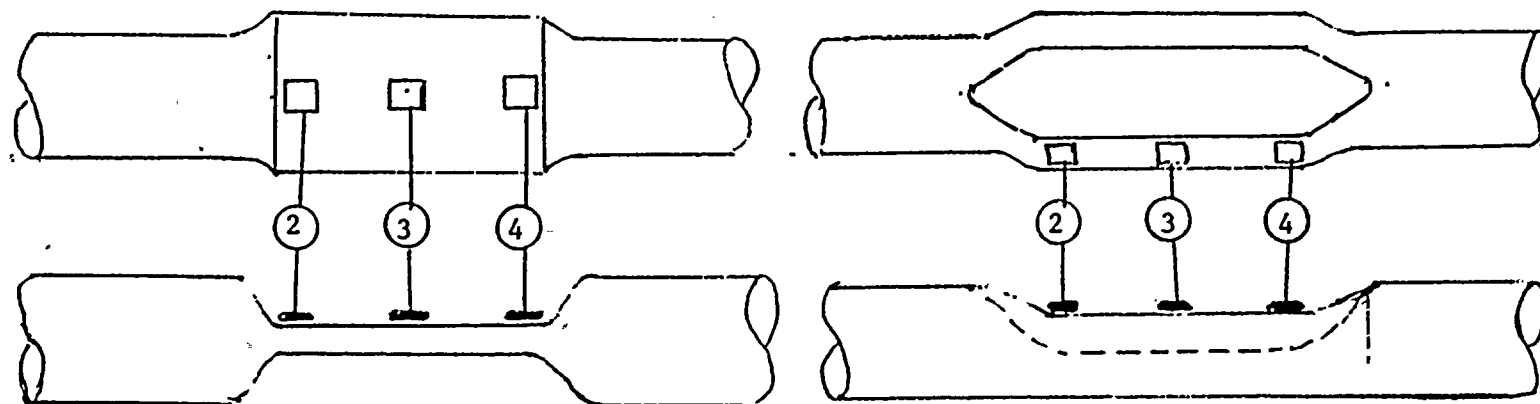
FIGURE 6 - STRAIN SURVEY-TEST CONFIGURATION

In the strain survey tests strain gages were mounted at the locations shown in Figure 6. The strain survey results for a .3 inch peak to peak deflection are found in Table 1. As can be seen from these results the maximum recorded stress was 31,200 psi tension and the maximum stress difference range was 46,800 psi (fixed-fixed flat degradation with 1000 lb. axial tension). Also the fixed-fixed configuration results in substantially higher stresses than the fixed-pinned configuration for a given vibration amplitude.

\* Refer to Figure 6 for gage locations.
