Steam Generator Evaluation
Ginna Steam Generator Tube Failure Incident
January 25, 1982
R. E. Ginna Nuclear Power Plant
Docket No. 50-244

Addendum 3
Phase II Metallurgical Examinations

Revision 0
May 18, 1982

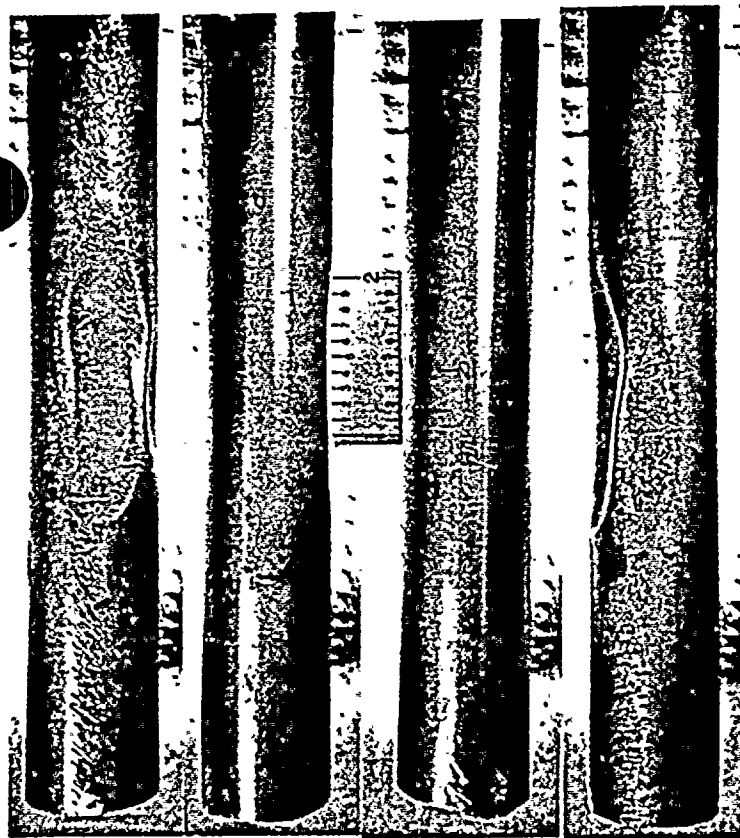
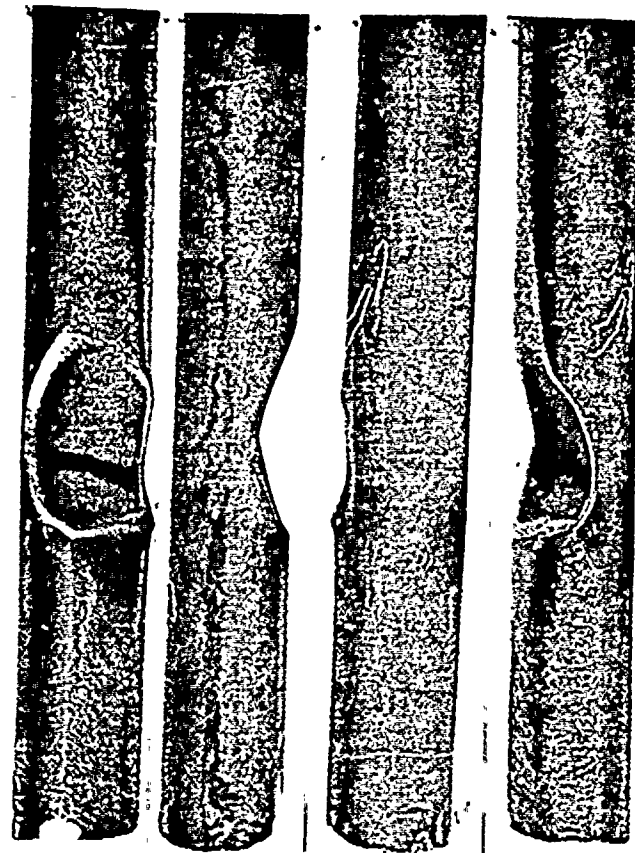
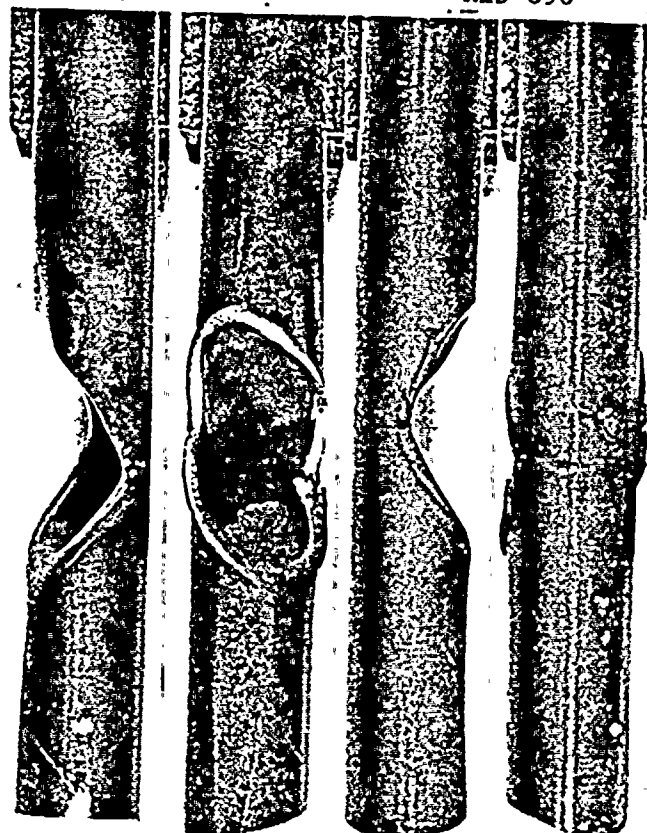
FIGURE 1. Photographs at various angular positions of the bottom 6" of tube sections from Tubes R14-C90, R15-C90, and R12-C91, hot leg, SG "B", Ginna

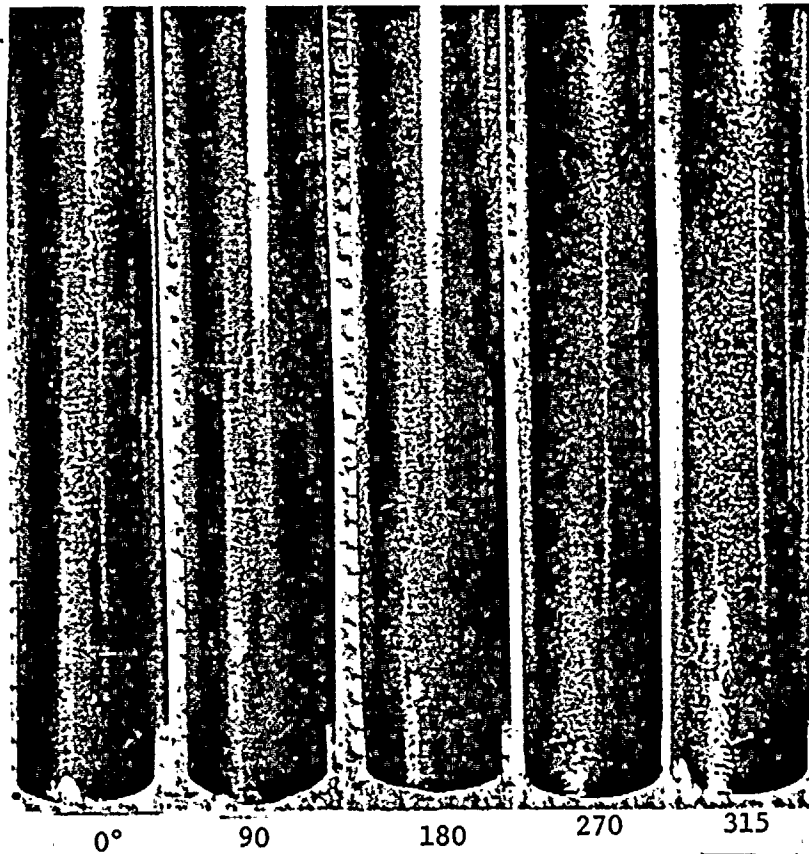
No mechanical degradation of this type was seen on Tubes R43C60 and R43C61 as shown in Figures 2 and 3. However, two unusual O.D. features are evident: 1) electrical discharge cutting strikes at the top at 270° on R43C60 and at the bottom at 0° on R43C61, and 2) surface undulation at predominately 0°, 270°, 315° on R43C60 and at 0°, 30°, and 90° on R43C61. Eddy current testing in the laboratory gave no indications in Tube R43C61 and found the electrical discharge cutting strikes 3 inches from the top of R43C60.

FIGURE 2. Photographs of 10-1/8" section of Tube R43-C60

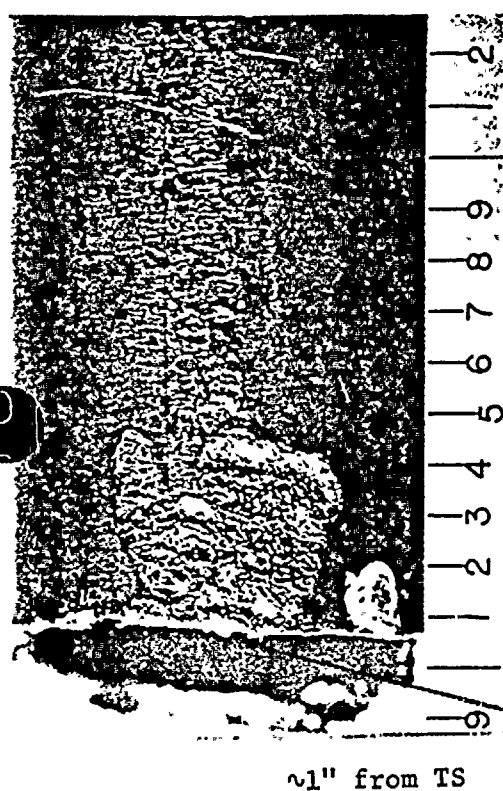
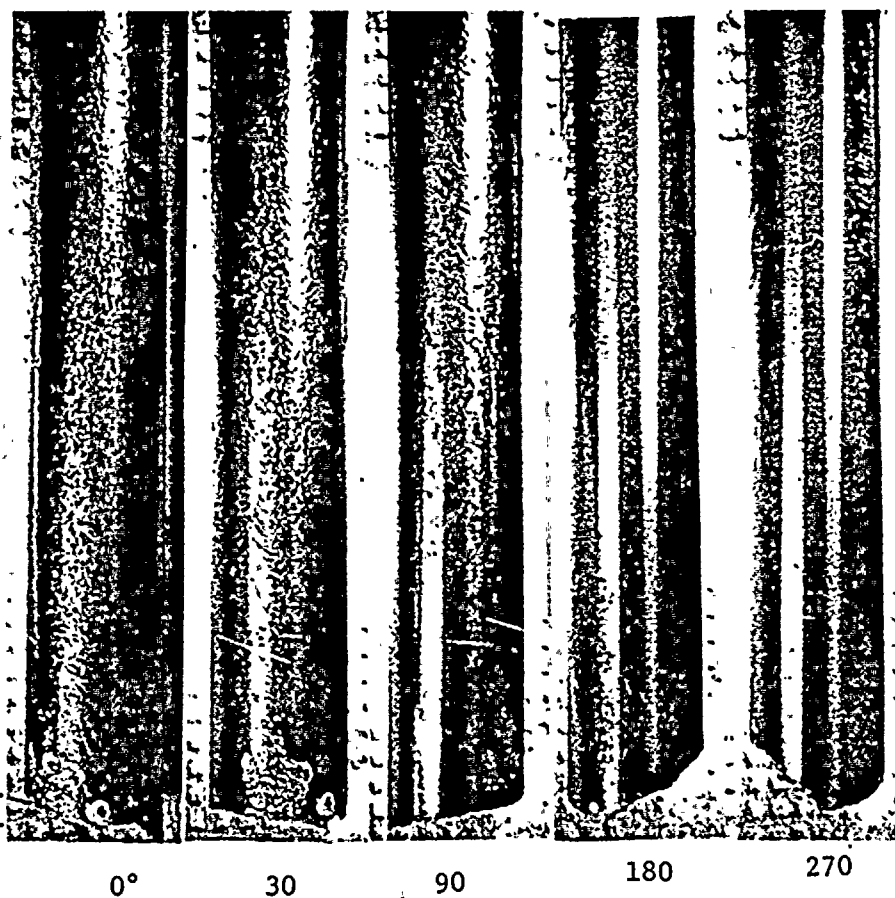
FIGURE 3. Photographs of bottom portion of Tube R43-C61

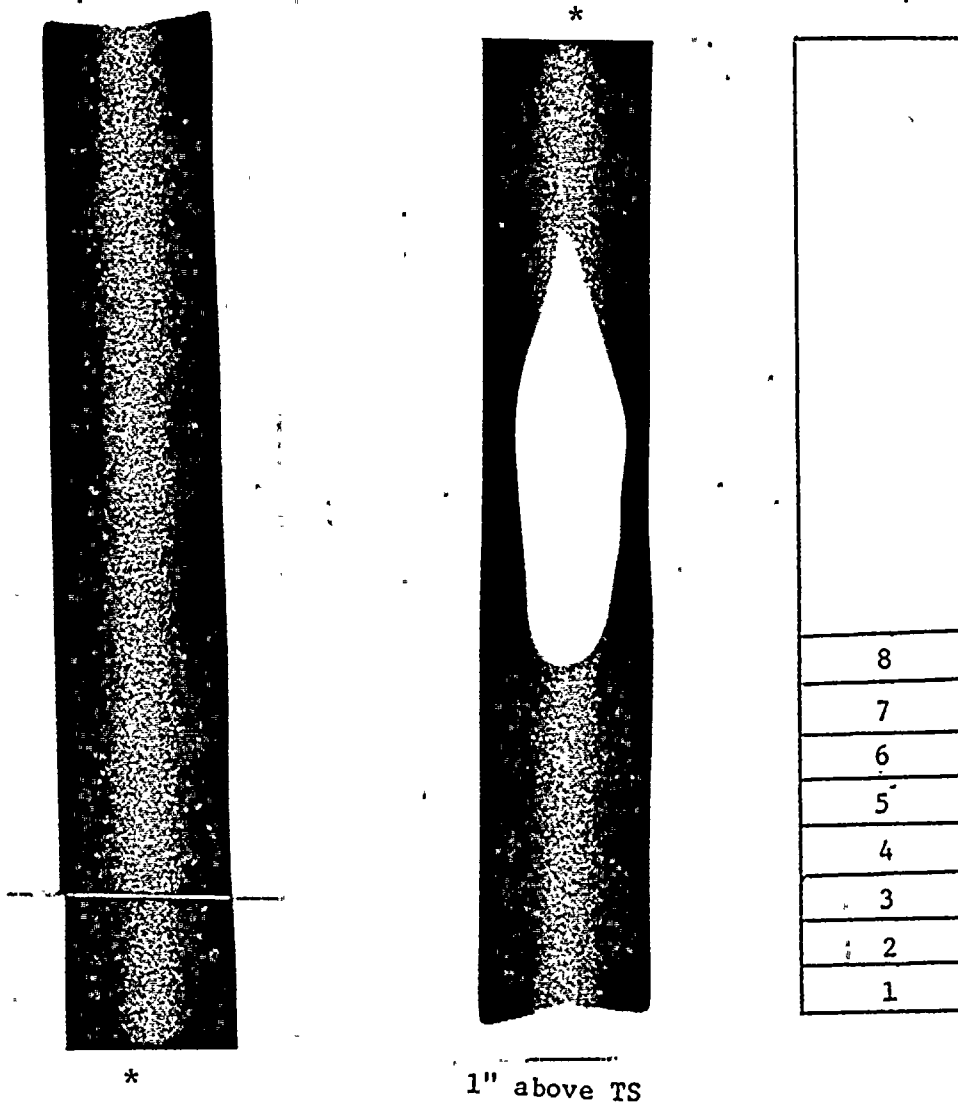
Rings were cut at 270°, flattened to strain ID in tension, and IDs examined

FIGURE 4. Print of 0° double wall X-ray radiograph and cutting diagram from Tube (R14-C90)

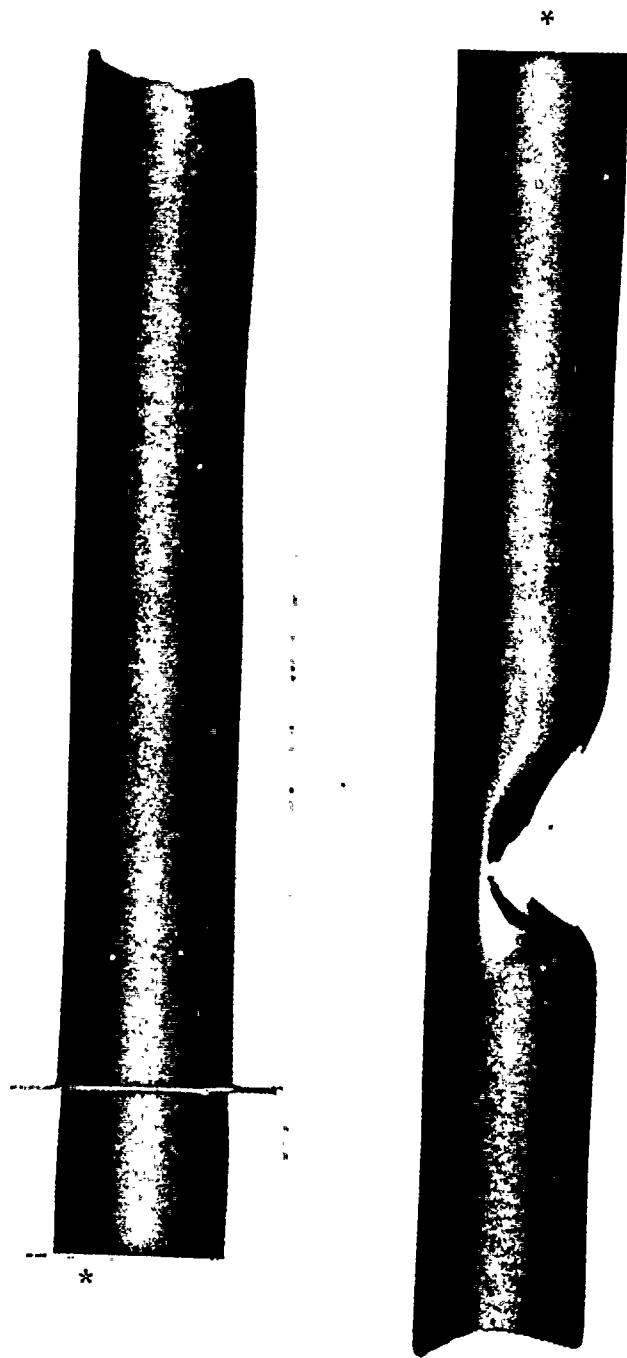
All ring cut at 0°, flattened to strain ID in tension, and then ID's were examined

FIGURE 5. Print of 45° double wall X-ray radiograph and cutting diagram for Tube (R15-C90).

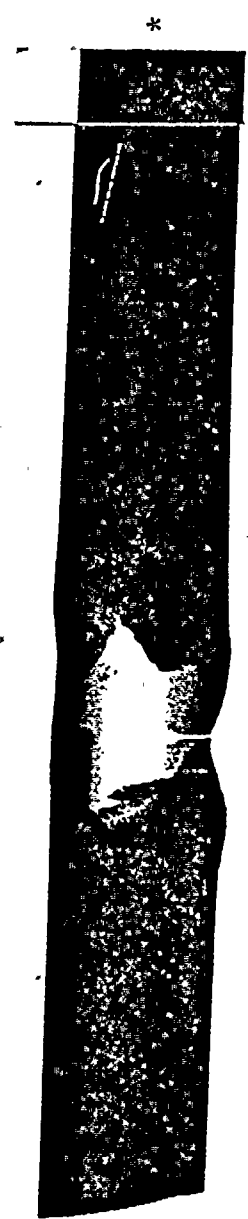
Rings were cut at 270°, flattened to strain ID in tension, and IDs examined

FIGURE 6. Print 90° double wall X-ray radiograph and cutting diagram for Tube (R12-C91)

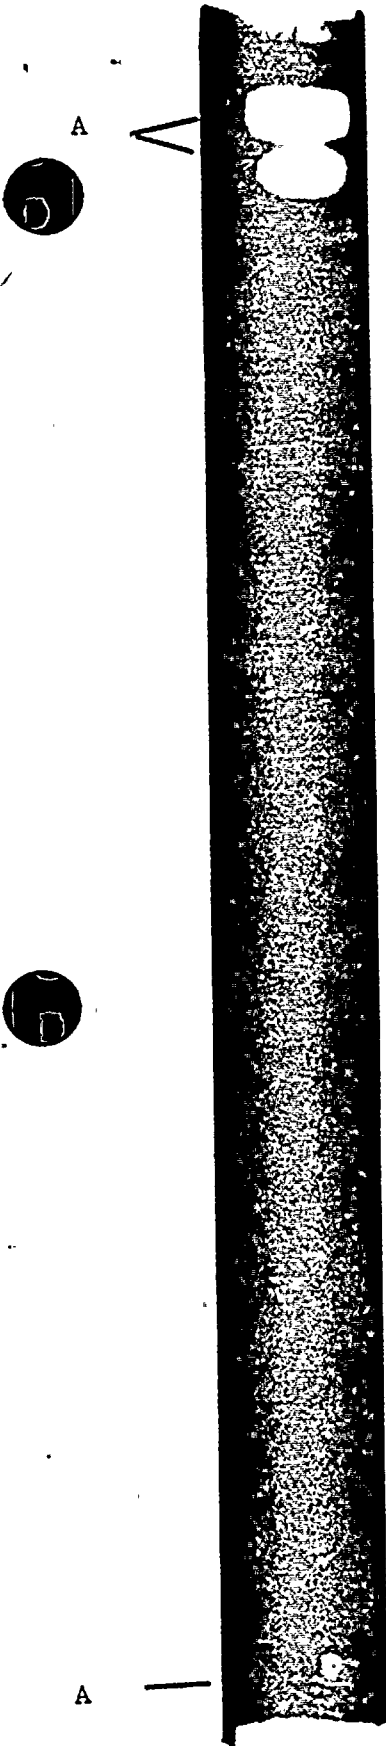
FIGURE 8. Print of 45° double wall X-ray radiograph for Tube R43-C61 from the hot leg of "B" steam generator and Cutting diagram. Topography of Spots A was like that of cut tube and indicating they resulted from cutting tool strikes. Rings examined as for Tube R43-C60.

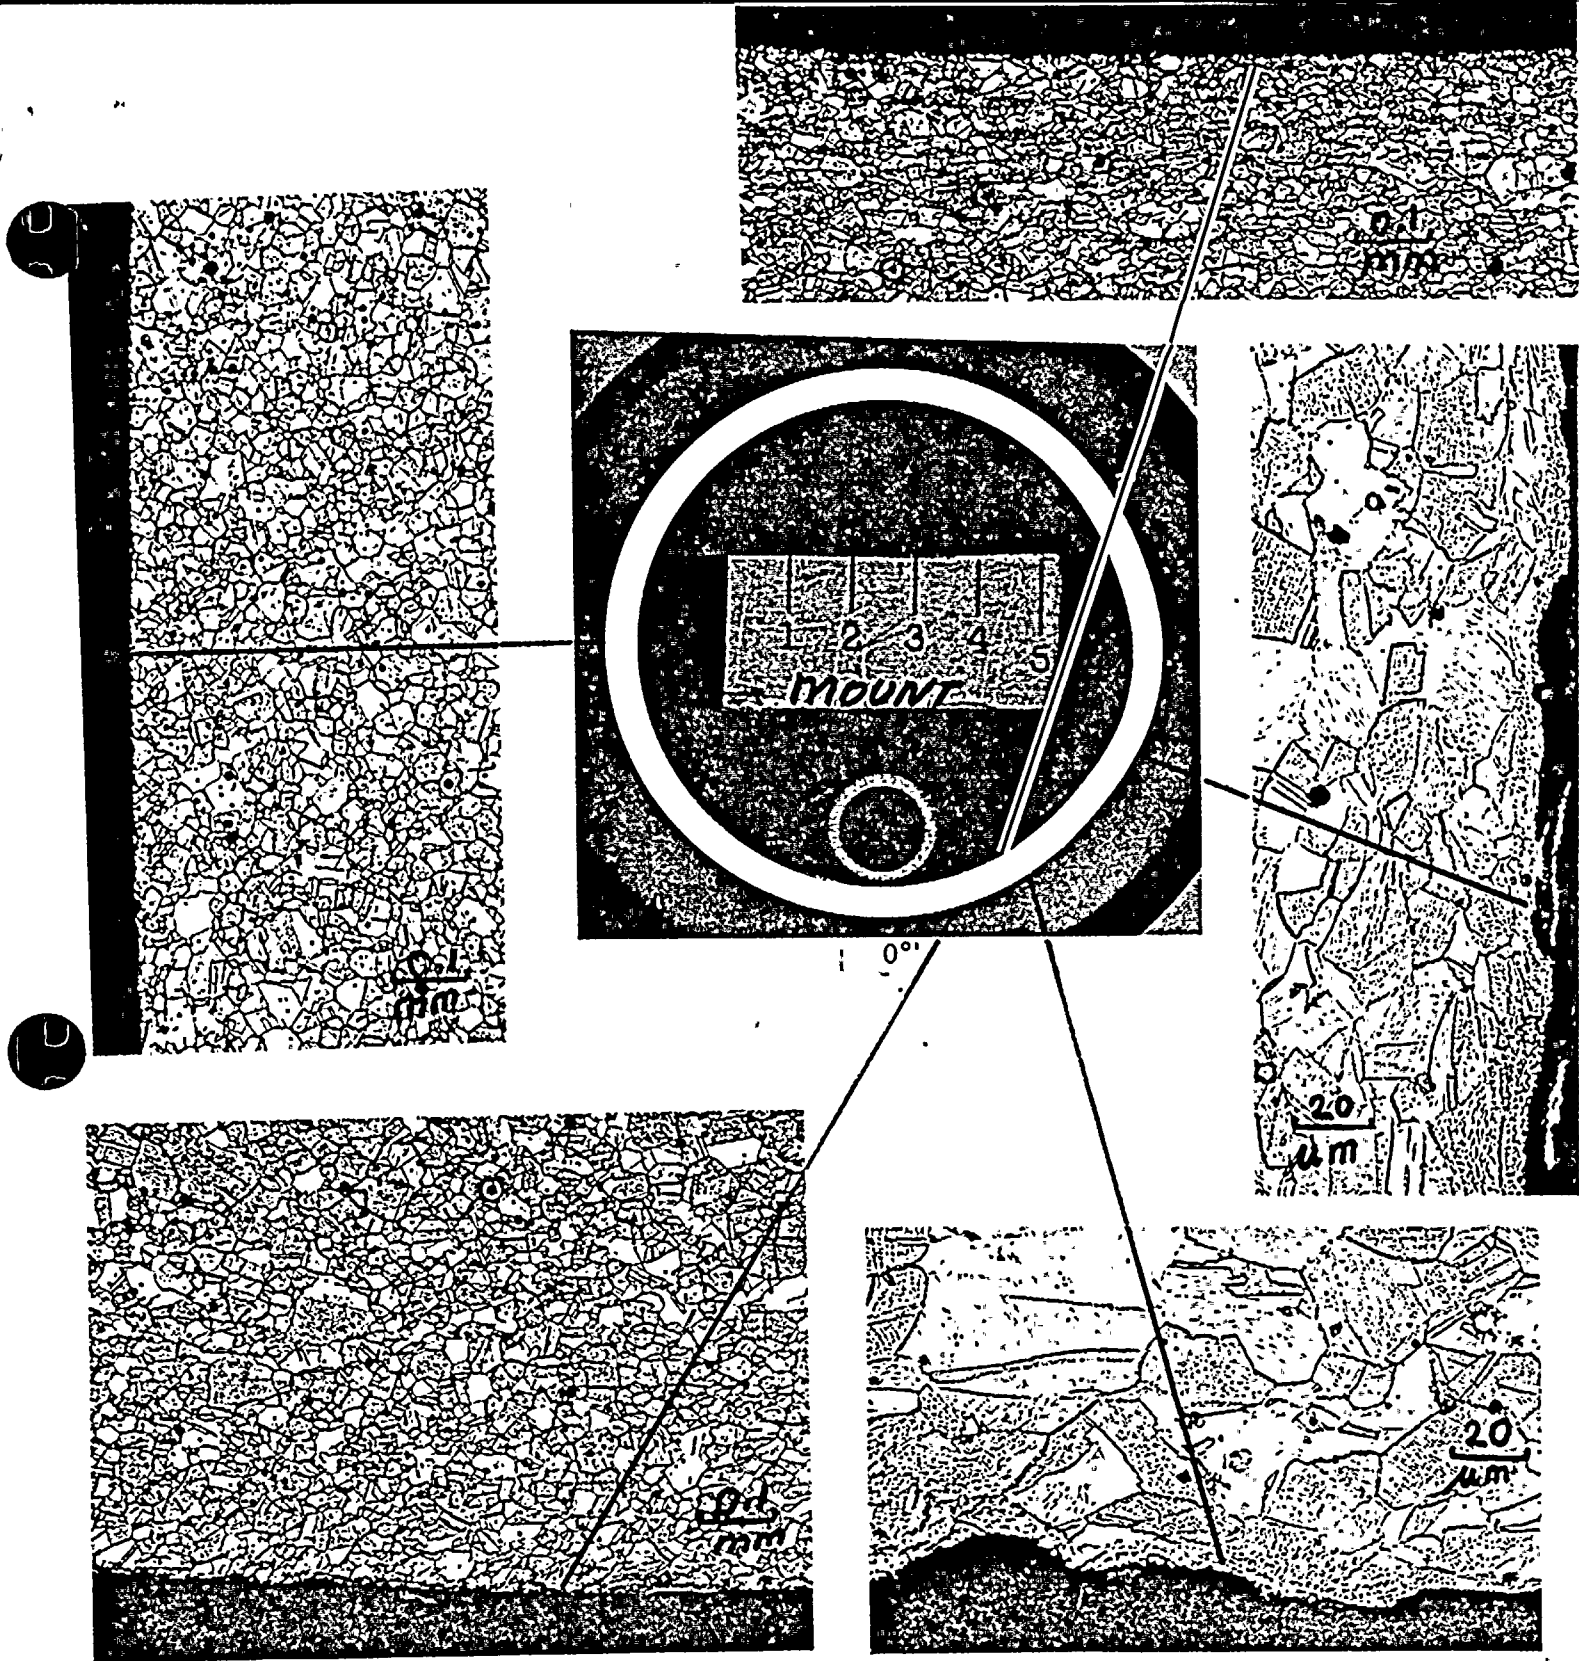
1 Metallography showed no evidence of stress corrosion cracking or intergranular attack in Tubes R43C60 and R43C61, Figures 9 and 10. Surface roughening was most pronounced at approximately 315° on Tube R43C60 and the small amount of cold work present was roughly equivalent to the cold work associated with the final polishing operation in the manufacture of the tubes.

FIGURE 9. Metallography on Ring No. 4,
Tube No. R43-C60.

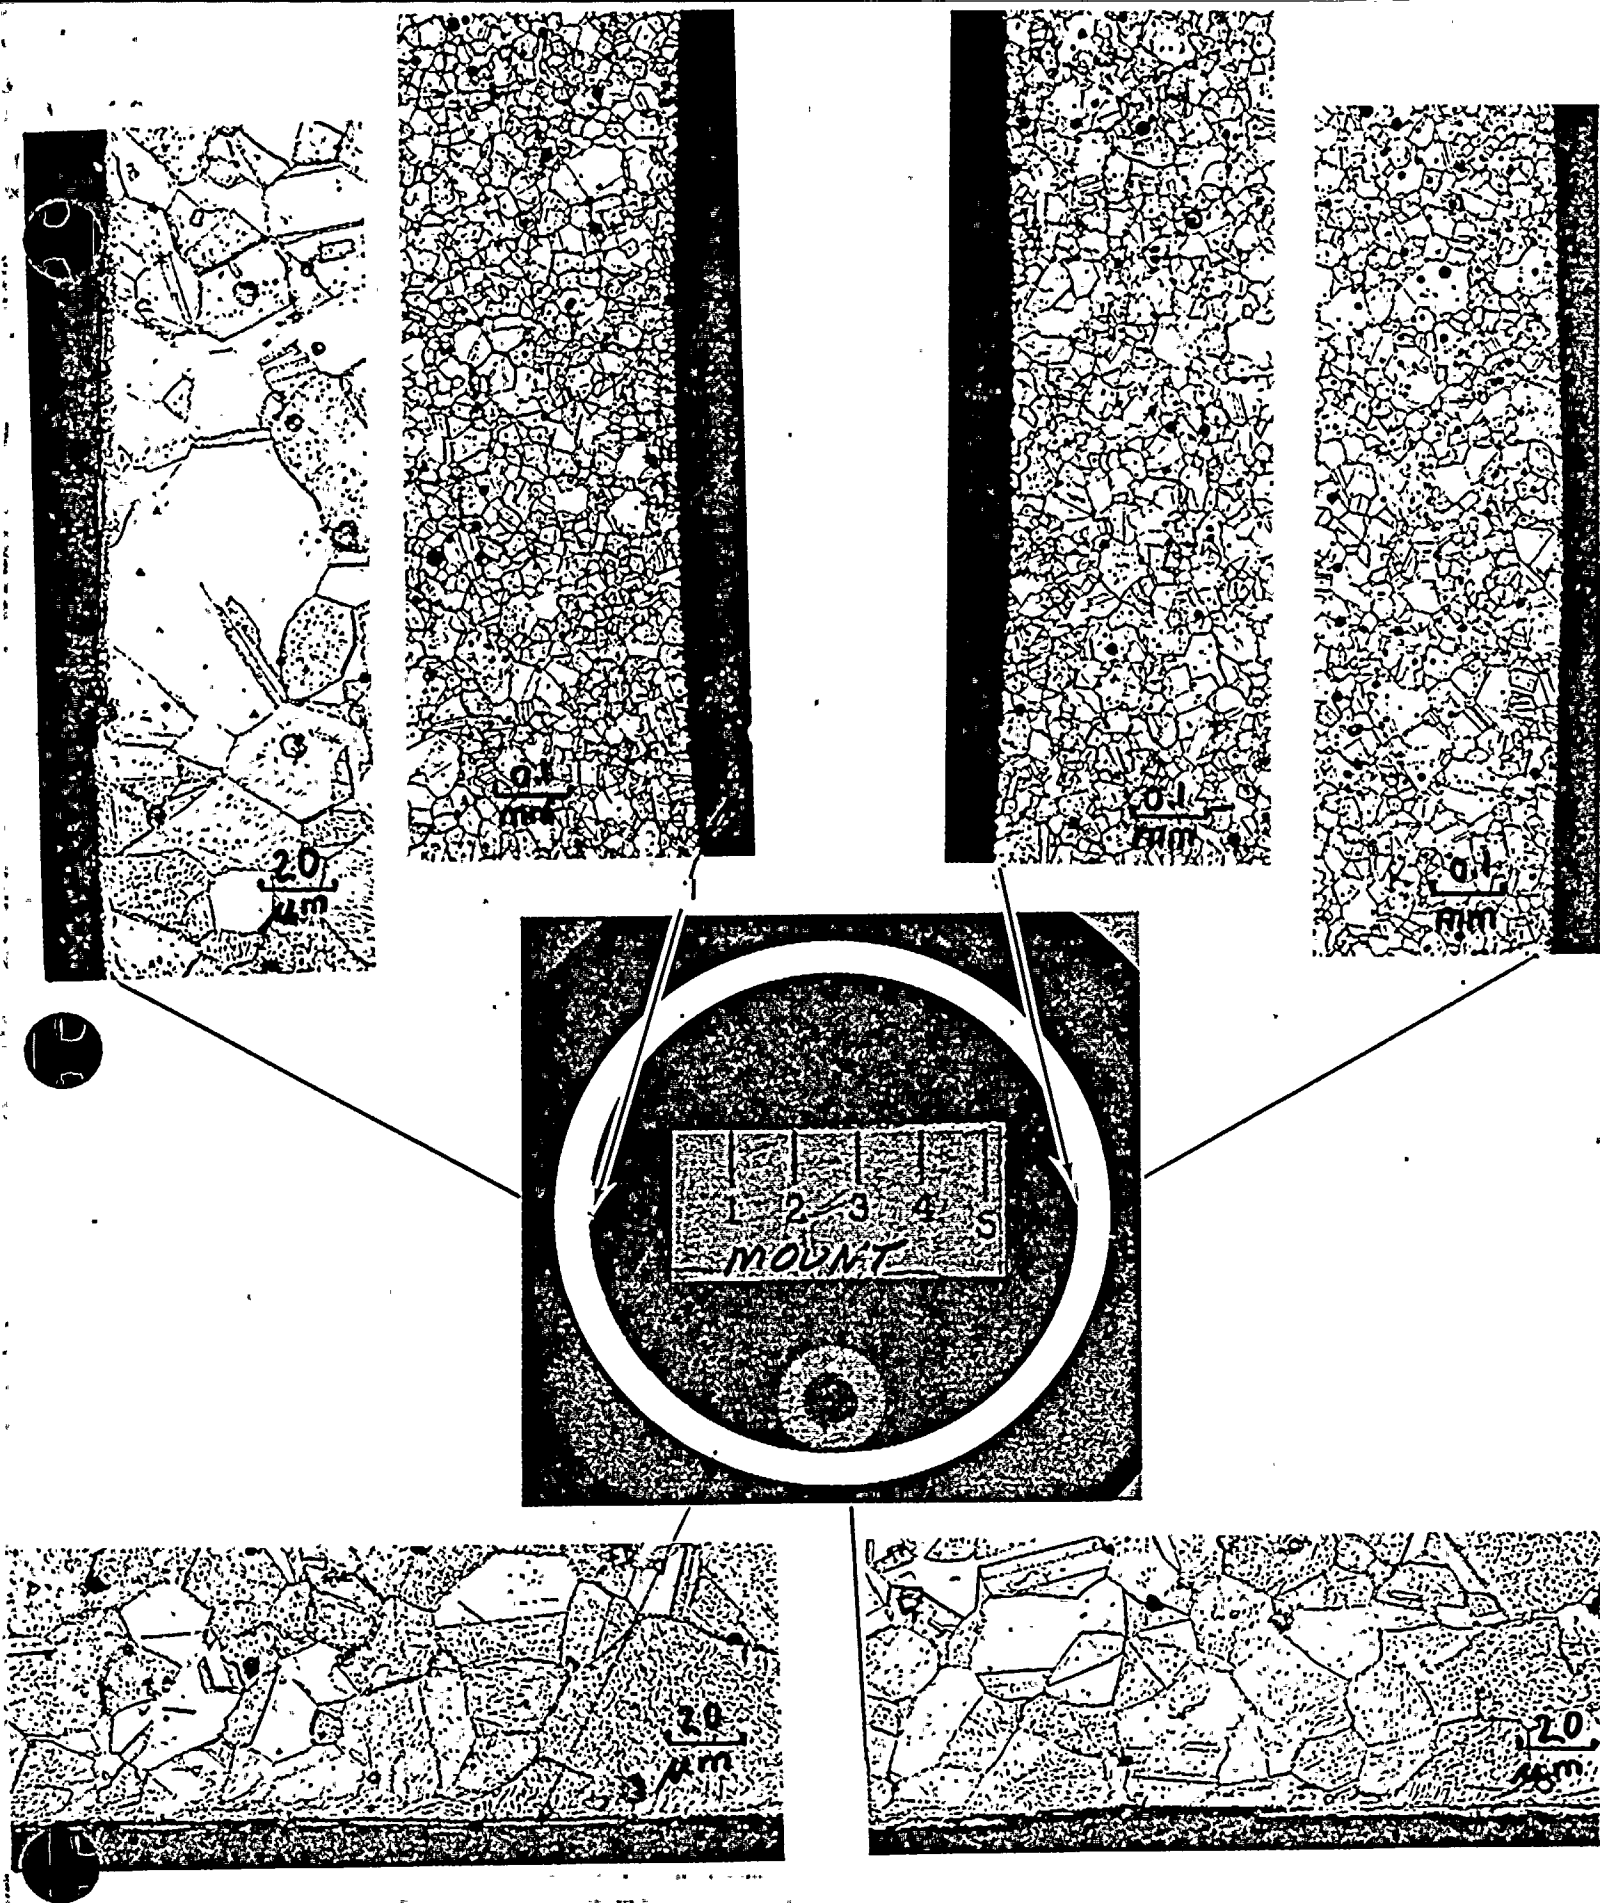
FIGURE 10. Metallography on Ring No. 4,
Tube R43-C61
