Steam Generator Evaluation  
Ginna Steam Generator Tube Failure Incident  
January 25, 1982  
R. E. Ginna Nuclear Power Plant  
Docket No. 50-244

Addendum 4  
External Tube Loading Test

Revision 1  
May 18, 1982

GINNA STEAM GENERATOR  
EXTERNAL TUBE LOADING TEST

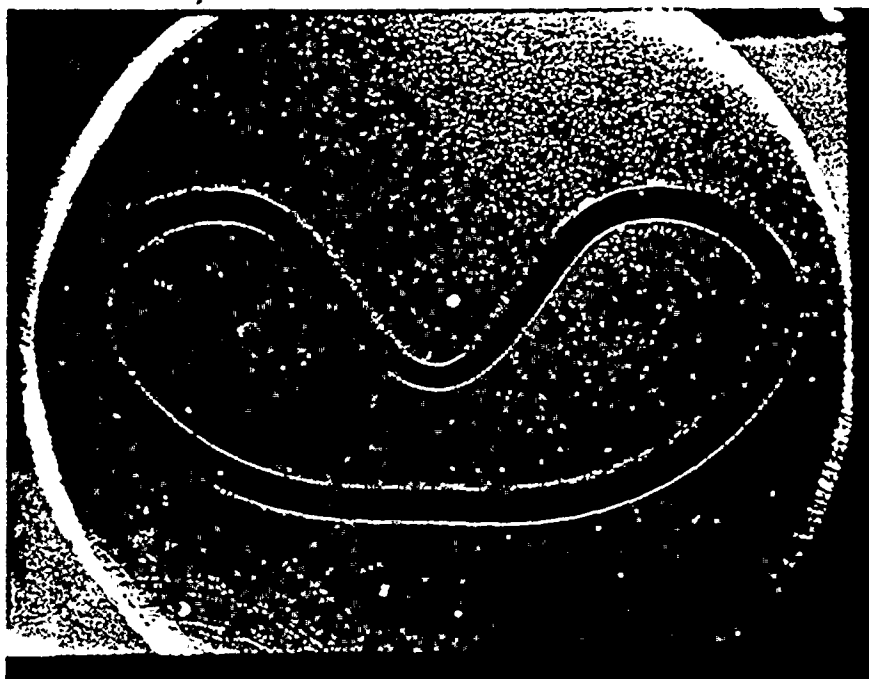
PHOTOGRAPH OF TUBE CROSS SECTION AFTER  
COLLAPSE UNDER EXTERNAL PRESSURE

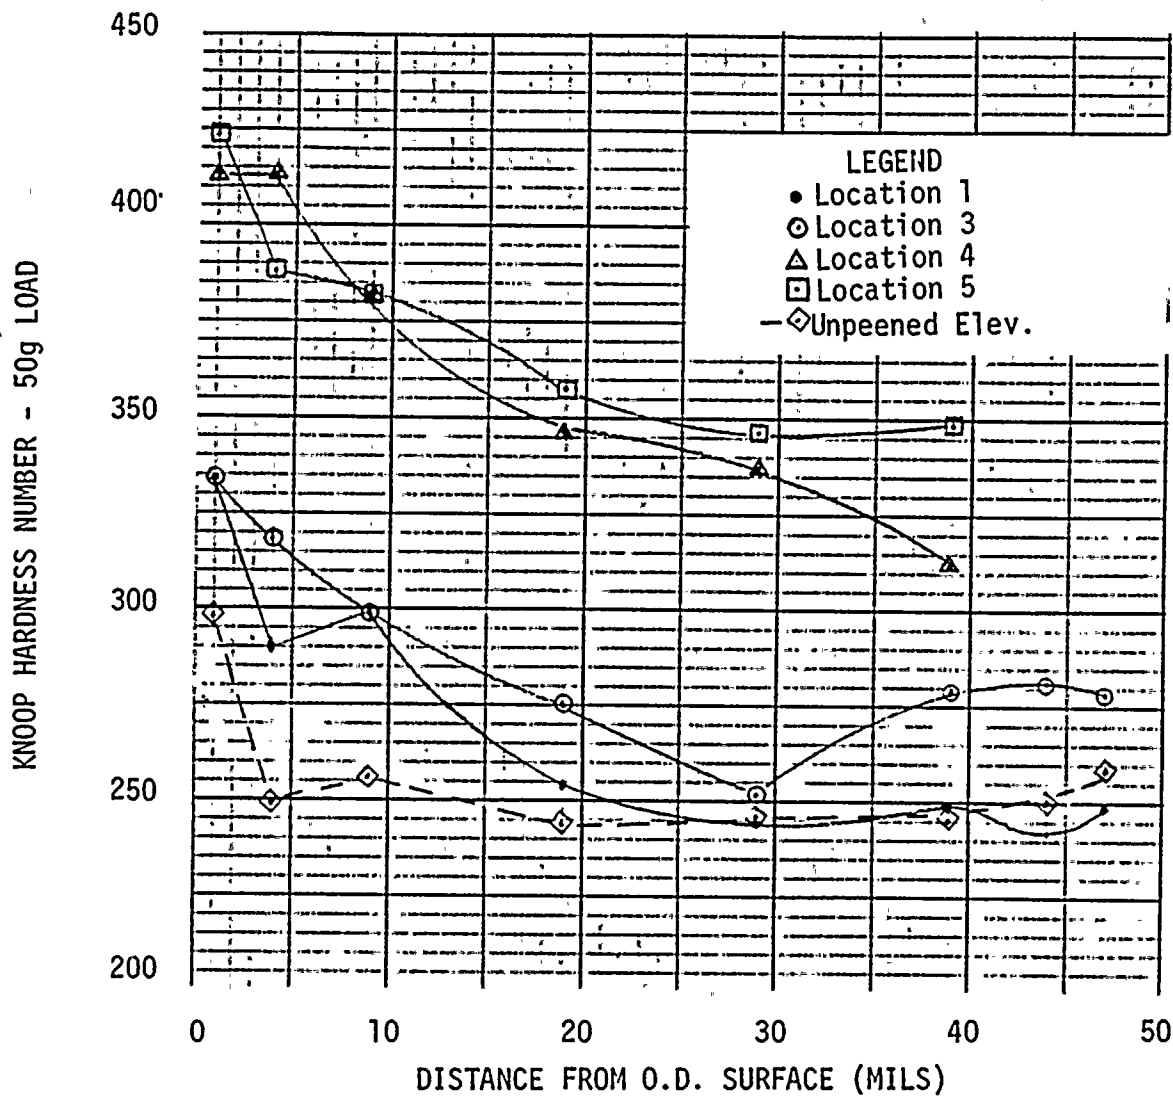
Figure C.6-5

Photographs of the collapsed tube at the end of the test are provided in Figures C.6-1, C.6-2, and C.6-3. The tube was subsequently sectioned and micro-hardness survey performed at various locations through the wall thickness. Figure C.6-4 provides a view of the cross-section. Figures C.6-5 and C.6-6 provide plots of micro-hardness through the wall thickness at various locations around the tube. It is interesting to note that the hardness across the wall thickness is of the same approximate magnitude as values determine during development of the peening procedure. The range of hardness for 1 minute of peening was comparable to 27 minutes of peening with the 3/16" diameter steel balls. Although the hardness does not appreciably increase as a function of time of peening, the physical distortion of the tube (ovality) does increase. The ovality must be primarily a function of plastic flow during the peening operation.

# HARDNESS VS. DISTANCE THROUGH TUBE WALL (COLLAPSED TUBE)

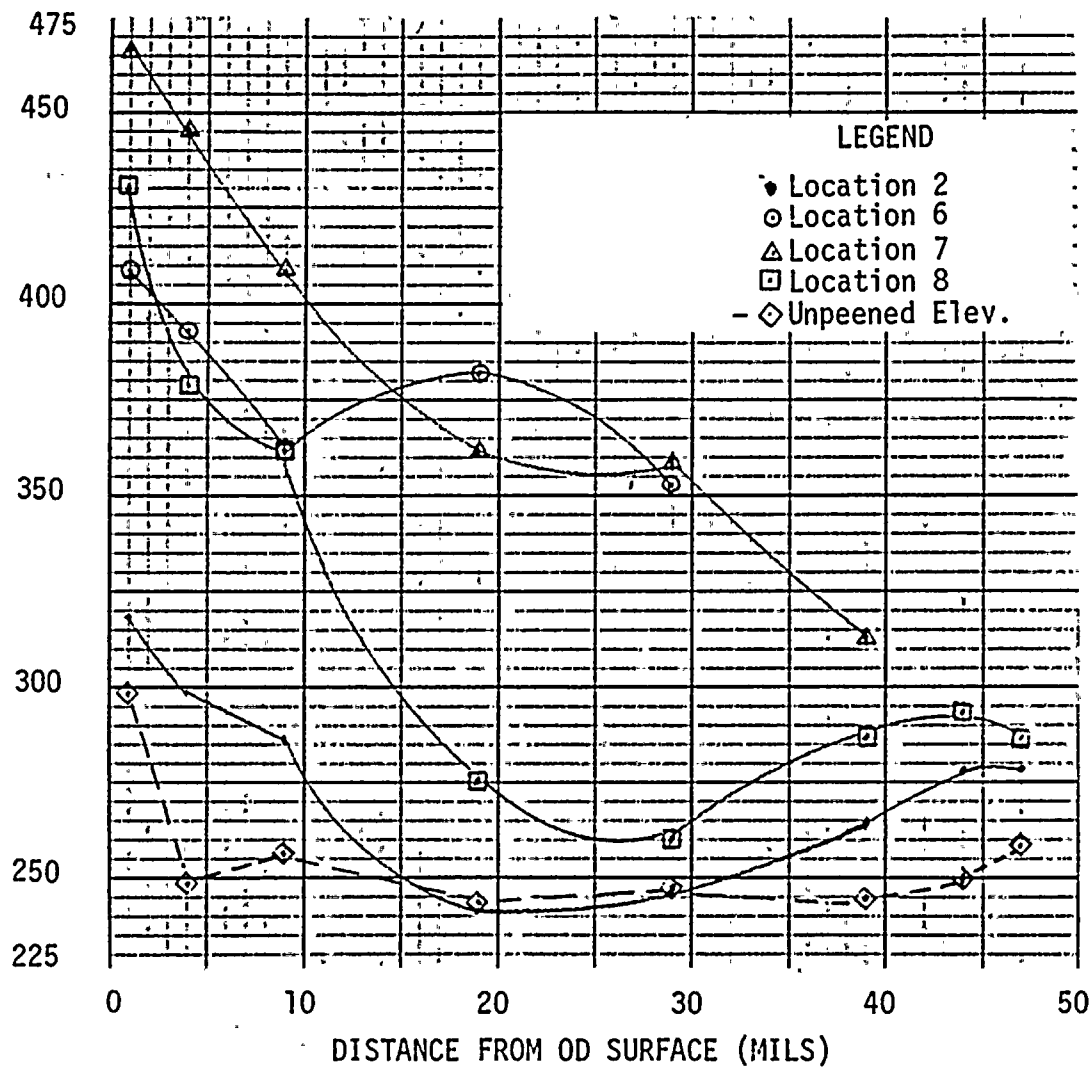
Figure C.6-6

# HARDNESS VS DISTANCE THROUGH TUBE WALL (COLLAPSED TUBE)

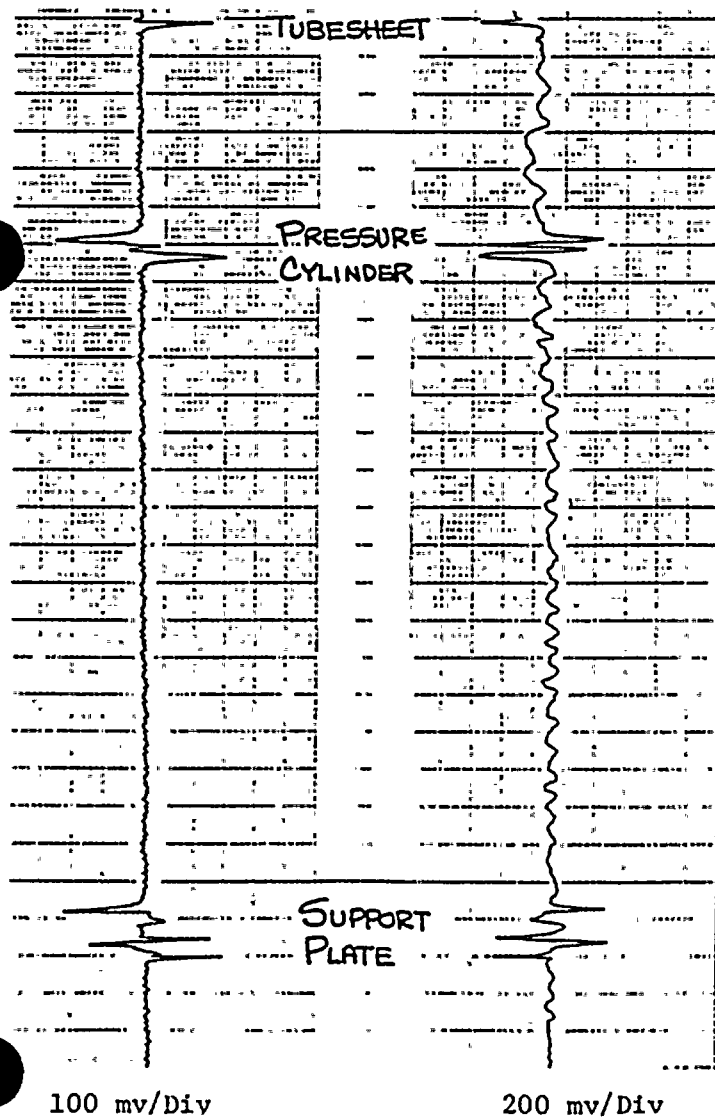
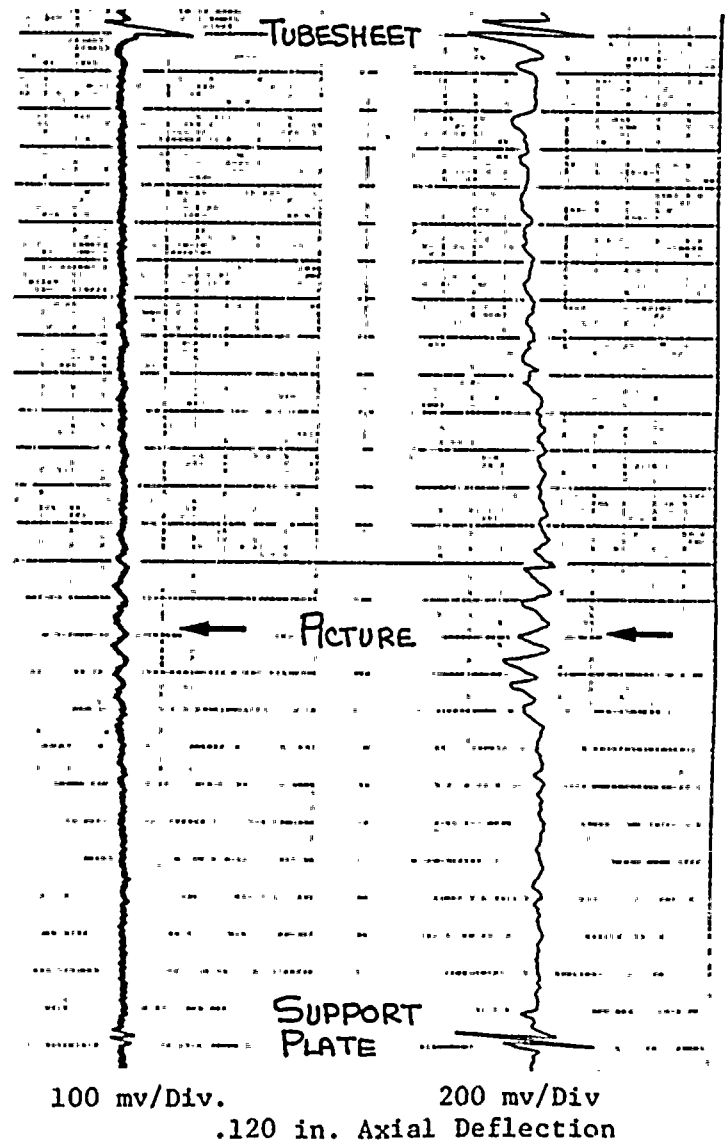
Figure C.7-2

# INDICATION IN TUBE NO. 1 @ .120 in. AXIAL DEFLECTION

Area of max.  
Lateral Deflec-  
tion.

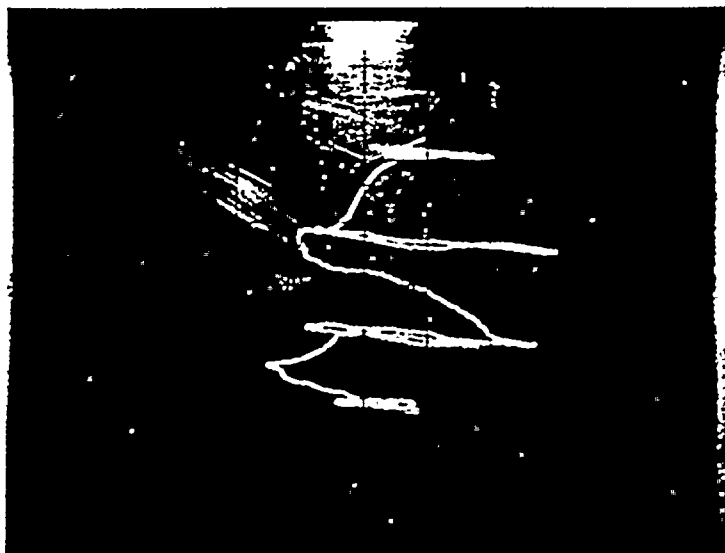
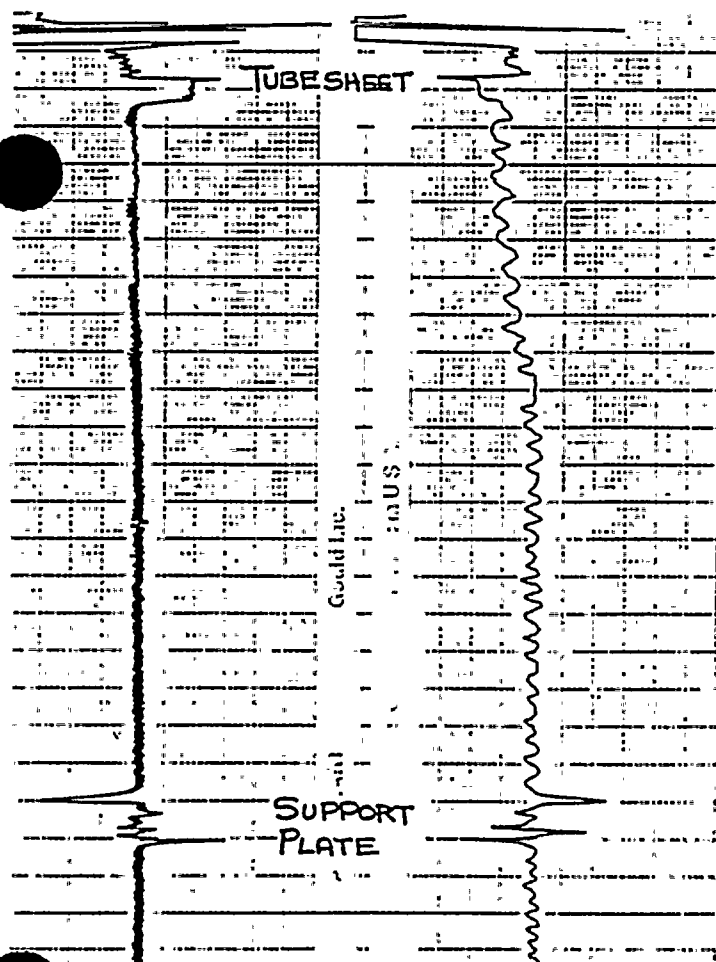
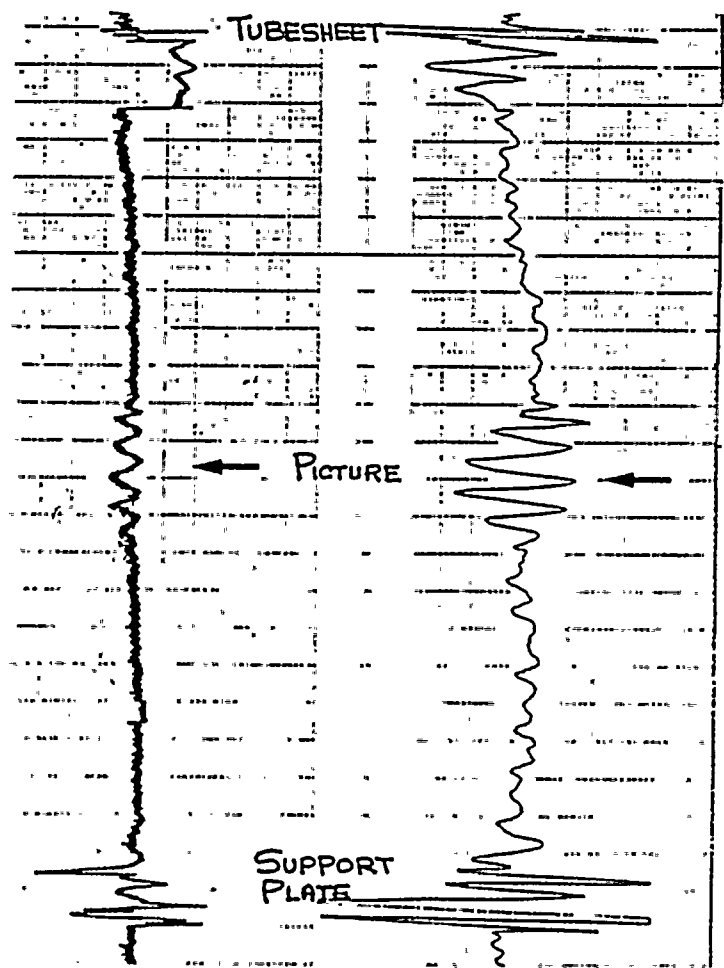
Figure C.7-3

The eddy current examination data for tube no. 3, at an axial deformation of .630", indicated a phase angle rotation of 11°. This same condition exists in the presence of I.D. defects. However, after consultation with various technical personnel at CE it was recognized that it was probably due to the effect of microscopic "wrinkling" of the tube that was occurring in the region of high plastic deformation (bowing) of the tube. It was then decided that tube No. 4 should be loaded in the same manner as tube No. 3 and more frequent eddy current examinations performed.

Eddy current testing showed some differences between baseline examinations and examinations conducted at the various axial loading, peening, and pressurization stages. The signals from tube number 3, for example, could possibly be interpreted as ID indications because of their phase, especially in view of tubes leaking in surrounding areas.

# INDICATIONS IN TUBE NO. 3. @ .630 IN. AXIAL DEFLECTION

Area of Max.  
Lateral  
Deflection

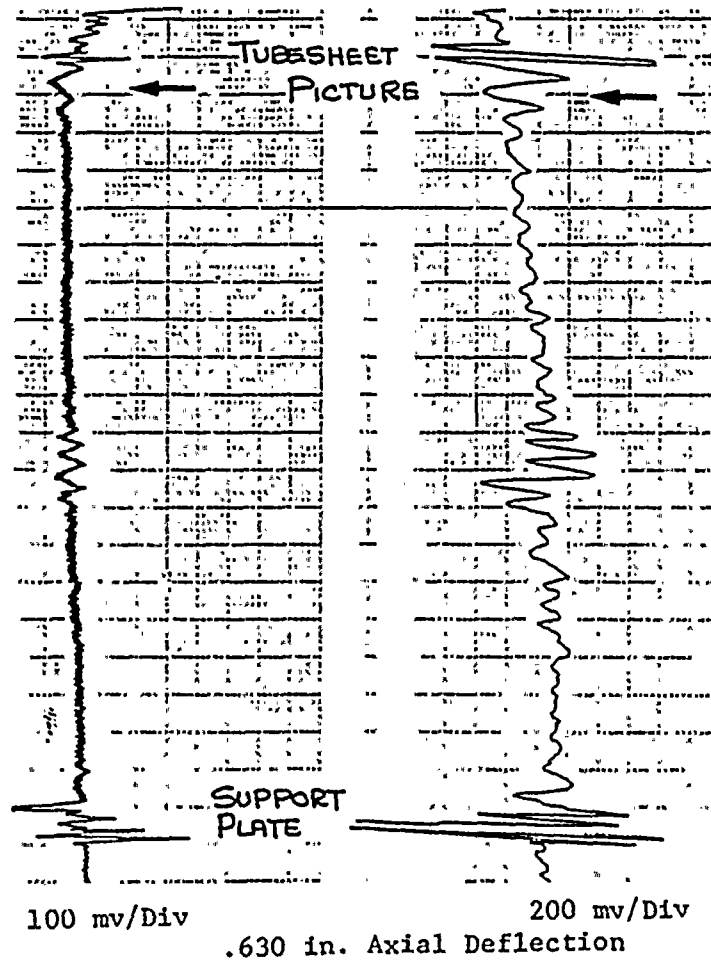
Figure C.7-4

INDICATION IN TUBE NO. 3 @ .630 IN. AXIAL DEFLECTION

Located Approx.  
1/2 in. Above  
Tubesheet.

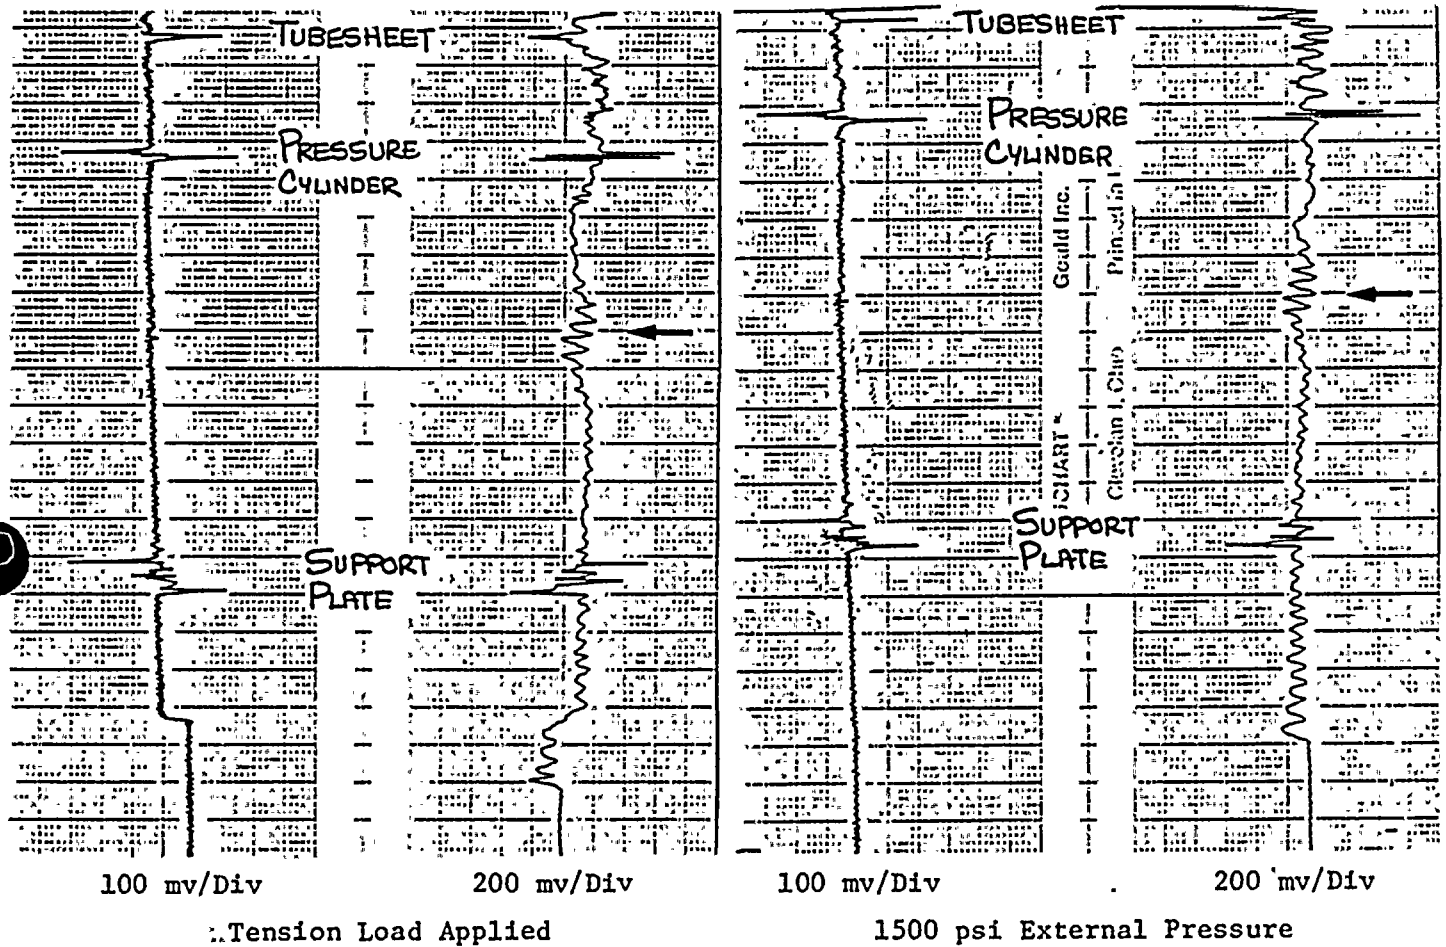
Figure C.7-8

5	.120" deflection	1.4 volt increase in tube noise over baseline in region of greatest lateral deflection. This tube noise did not rotate up into the ID phase plane
5	Tension load applied	Noise level in area of greatest lateral deflection reduced to 800 mv over background noise. (Figure C.7-8)
5	1500 psi external pressurization	No change (Figure C.7-8)

TUBE NO. 5 AFTER TENSION LOAD AND STRAIGHTENING
