REVIEW OF THE OPERATING EXPERIENCE HISTORY
OF THE GINNA NUCLEAR POWER PLANT FOR THE
NUCLEAR REGULATORY COMMISSION'S
SYSTEMATIC EVALUATION PROGRAM

Performed by the Staff of the
Nuclear Safety Information Center (NSIC)
Oak Ridge National Laboratory (ORNL)

October 1981

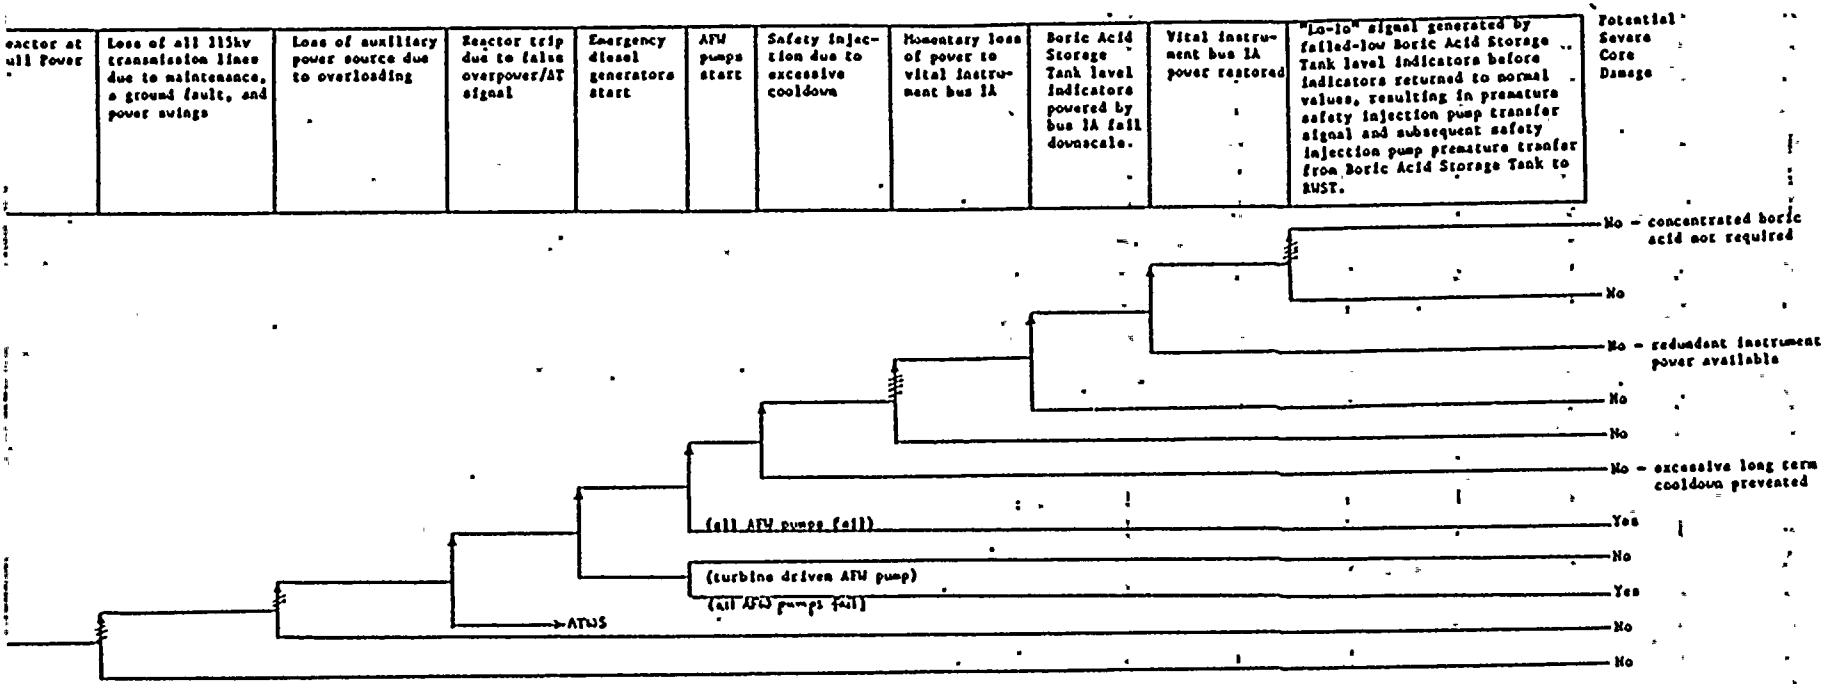
Figure 4.2 ACCIDENT SEQUENCE PRECURSOR STUDY LOSS OF OFF-SITE POWER EVENT TREE FOR EVENT 10/21/73

4.5.1.1 Loss of offsite power leads to excessive cooldown rate. On October 21, 1973, the reactor was at 91% power, with one of four 115-kV transmission circuits out of service because of construction. Auxiliary power was provided from the station switchyard and an external 34.5 kV line. A second 115-kV line, sagging from the increased load, flashed over to an underbuilt 34.5 kV line, and its circuit opened. The consequent 230-MWe power swing on the remaining two 115-kV lines caused them both to trip, resulting in complete loss of generator output ability. The loss of all 115-kV transmission lines overloaded a supply circuit for the remaining auxiliary power source, causing it to trip and resulting in a total loss of offsite power plus a turbine trip and a reactor trip (Fig. 4.2).

According to an RGE letter on October 23, 1973, to the AEC Directorate of Regulatory Operations, Region 1 (NSIC 87031), disturbances on the instrument buses generated a double low level in both steam generators which started the steam driven auxiliary feedwater pump. This injected cold water into the steam generators and caused a rapid cooldown of the reactor coolant system (RCS) (an 85°F drop in the cold leg in 10 min, see NSIC 85369) which exceeded the Technical Specification limit. (TS 3.1.2.1.b states "for temperature above an indicated temperature of 290°F the [cooldown] rate shall not exceed 100°F/hr.") The rapid cooldown lowered the RCS pressure, and SI was automatically initiated on low pressure/low level in the pressurizer.

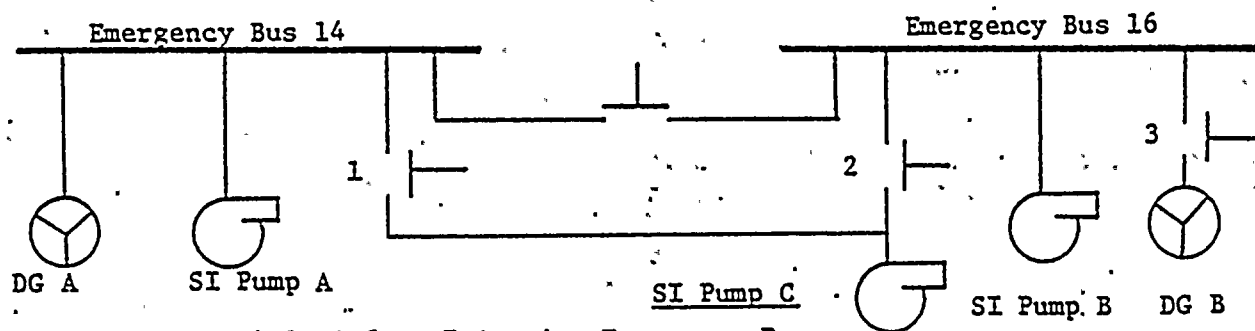
Figure 4.3 Safety Injection Emergency Power Supply

Table 4.12 lists the 14 breaker failures between the diesel generator "B", buses 14 and 16, and HPSI pump "C".

From this series of failures, apparently the conservative design of three 50% HPSI pumps is partially nullified by the unreliability of the circuit breakers. From 1973 through 1979, the three breakers failed an average of two tests per year. The HPSI pumps are tested monthly (TS 4.5.2.1) — this is the relevant test for breaker position numbers 1 and 2. The diesel generators are started in a monthly test (TS 4.6.1.a) — this is the relevant test for breaker position 3 only. The diesel generators are also tested with a simulated
