SUBJECT: Forwards memo for record re stone shore revetment. Revetments considered structurally sound & stable. W/photos.

NCBED-DC Re: R.E. GINNA Nuclear Generating Plant

SUBJECT: Trip Report Concerning Stone Revetment at R.E. GINNA Nuclear
Generating Plant

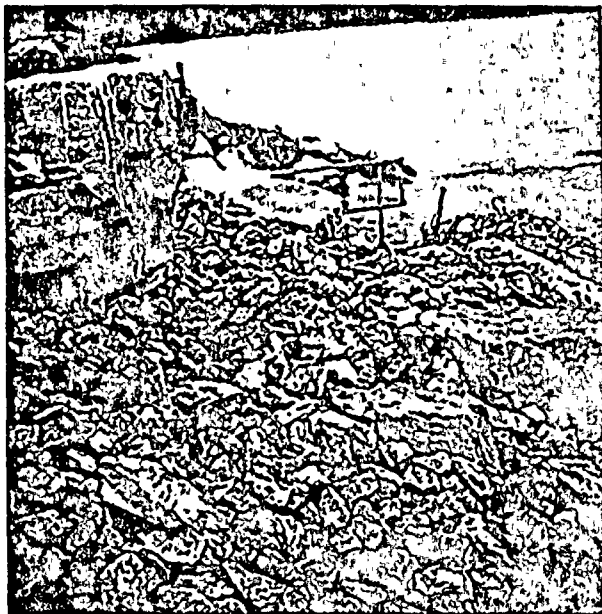
EAST REVETMENT @ WEST END. NOTE SMALL STONE FILL OBSCURING ARMOR STONES. CAP STONE @ LEFT. DISCHARGE CANAL VISIBLE IN REAR, LOOKING WEST.

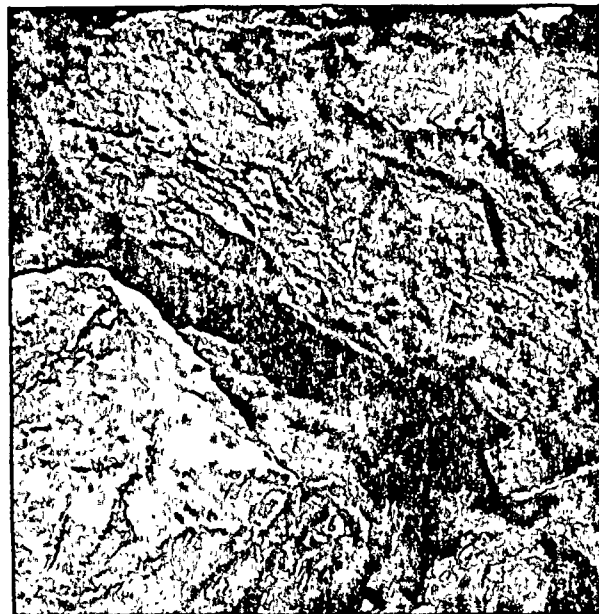
and, except for possibly the area in the east revetment reach where the large void exists, there is no evidence of any structure stability problem. A determination could not be made at the time of the inspection as to whether two layers of armor stones exist in the areas where the smaller stones had been placed. According to Mr. Gary Goetz, this small stone had been placed to form a roadway in the lee of the structure during the early 1970's for equipment used to place the cap stone. Upon completion of the cap stone placement, the roadway stone was dumped over the face of the revetment to fill the voids between armor stones, thereby making a more aesthetically looking revetment.

EAST REVETMENT APPROX. 100 L.F. EAST OF WEST END. NOTE LARGE VOID UNDER CAP STONE (THIS VOID EXTENDS A TOTAL LENGTH OF ABOUT 25 L.F. TO RIGHT & LEFT OF PHOTO).

10. The area in the vicinity of the large void in the east revetment reach will be reexamined during the 13 November 1981 inspection. Our assessment of structural adequacy and any recommendations will be presented in the future letter report.

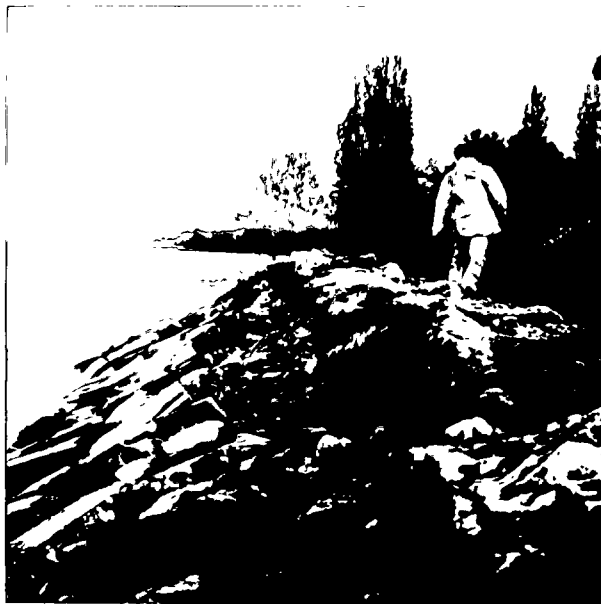
EAST REVETMENT NEAR EAST END - LOOKING EAST. NOTE SMALL STONE FILL OBSCURING TOP ARMOR STONES, LAID UP REVETMENT @ LEFT, CAP STONES @ RT.

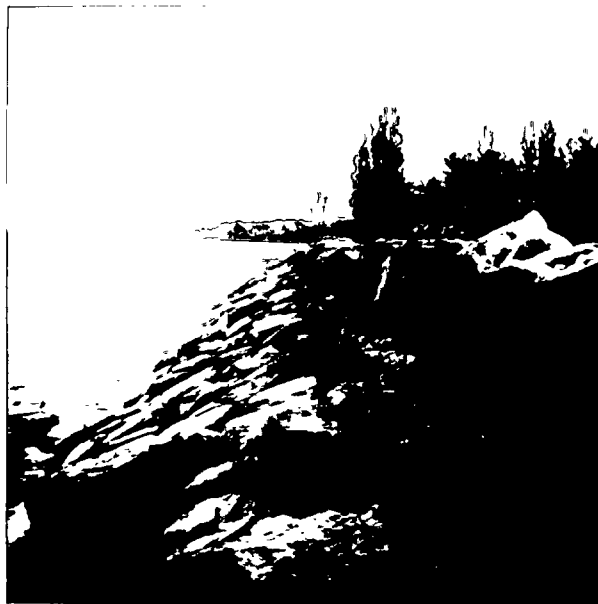
INCLOSURE F
EAST REVETMENT - LOOKING EAST, NEAR EAST END. NOTE LAID - UP REVETMENT, ROW OF CAP STONES.
