ROCHESTER GAS AND ELECTRIC CORPORATION  
89 EAST AVENUE, ROCHESTER, NY 14649

SUMMARY EXAMINATION REPORT

1987 STEAM GENERATOR EDDY CURRENT INSPECTION

R.E. GINNA NUCLEAR POWER STATION

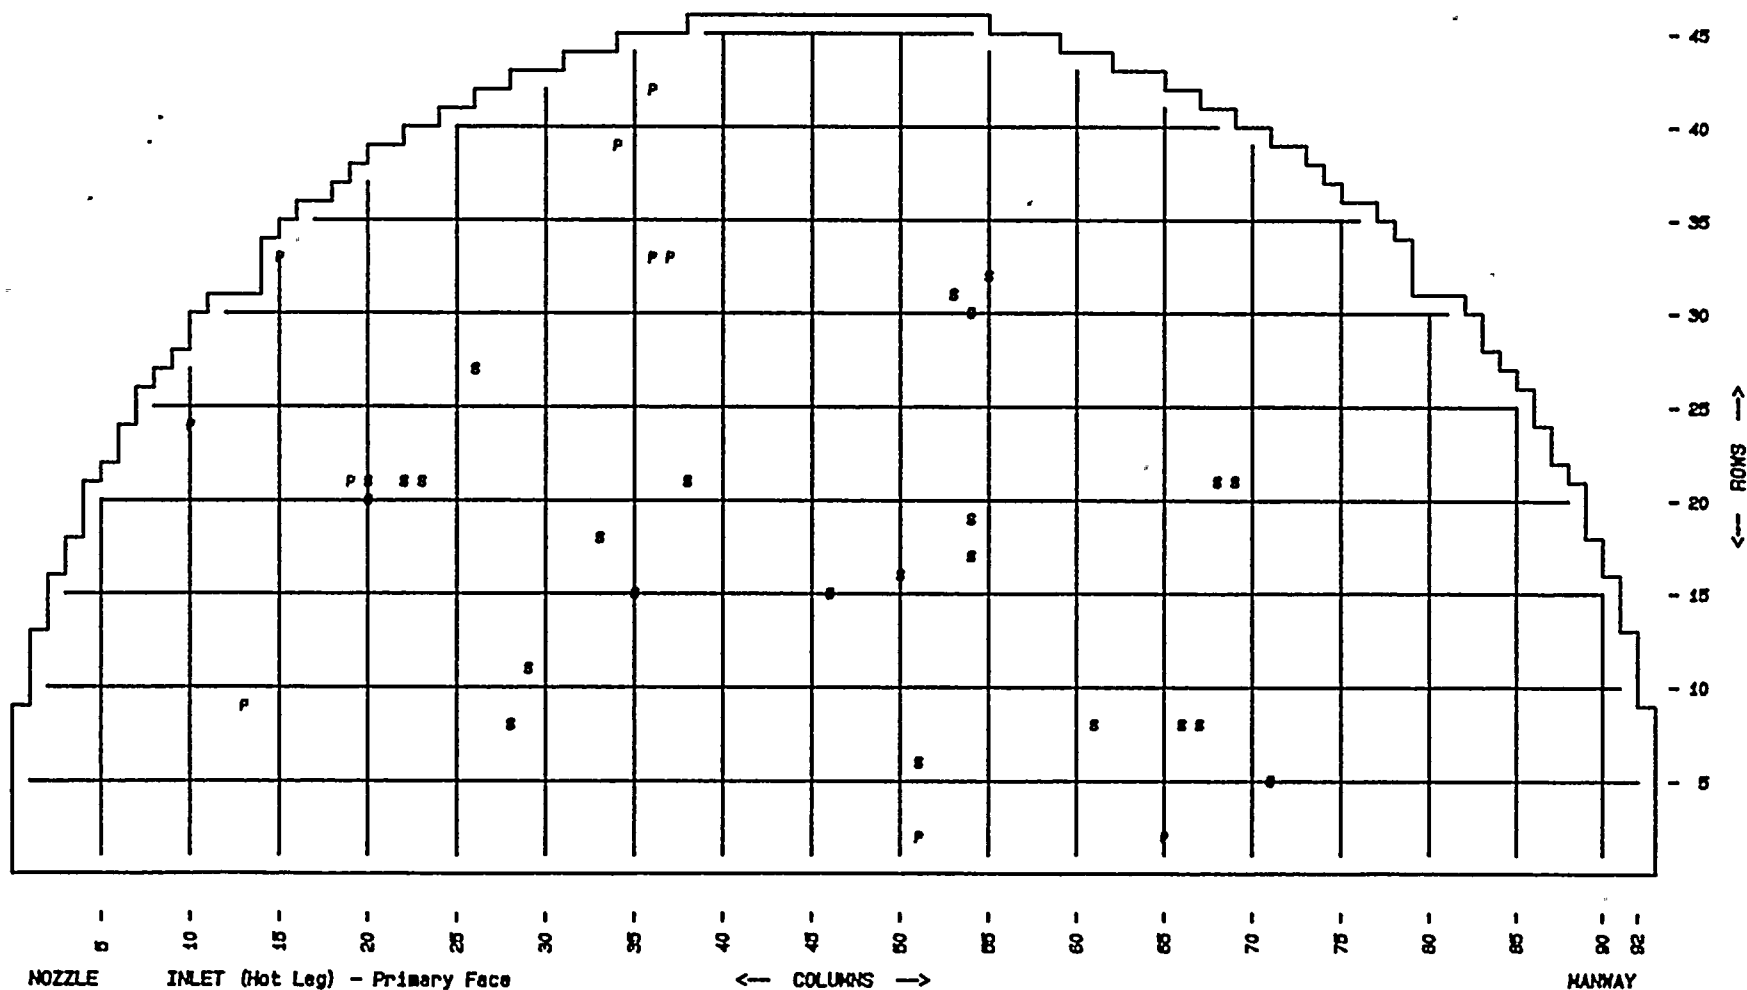
# STEAM GENERATOR "A" TUBES RECEIVING CORRECTIVE ACTION - FEBRUARY 1987

Table 5 has been generated to identify the tubes with crevice indications or with indications which exceed the repair criteria. This table also shows the location and axial extent of the indication and what corrective action was taken on these tubes. All tubes requiring repair had hot leg tubesheet crevice indications which were identified by an absolute drift signal of the Mix-2 Channel and/or quantifiable intergranular stress corrosion cracking (IGSCC) indications by the 400 kHz data. Several squirrel type (SQR) indications, multiple IGSCC, were also identified and have been placed on the list of tubes requiring corrective action. A total of 24 sleeves and 10 plugs were installed into the "A" steam generator. The "B" steam generator required a total of 80 sleeves and 73 plugs to be installed. One plug is attributed to a sleeve installed this outage which had to be removed from service due to unacceptable ultrasonic examination results of the upper weld.

- (8) The 34 tubes identified with crevice indications in the "A" steam generator inlet were repaired as follows:
