Re: Submission of Root Cause Analysis under Conditions 1 and 2 of the Confirmatory
Order of March 28, 2017 modifying License No. SUA-1471, EA-16-114

Root Cause Analysis Report

Homestake Mining Company of California - Confirmatory Order

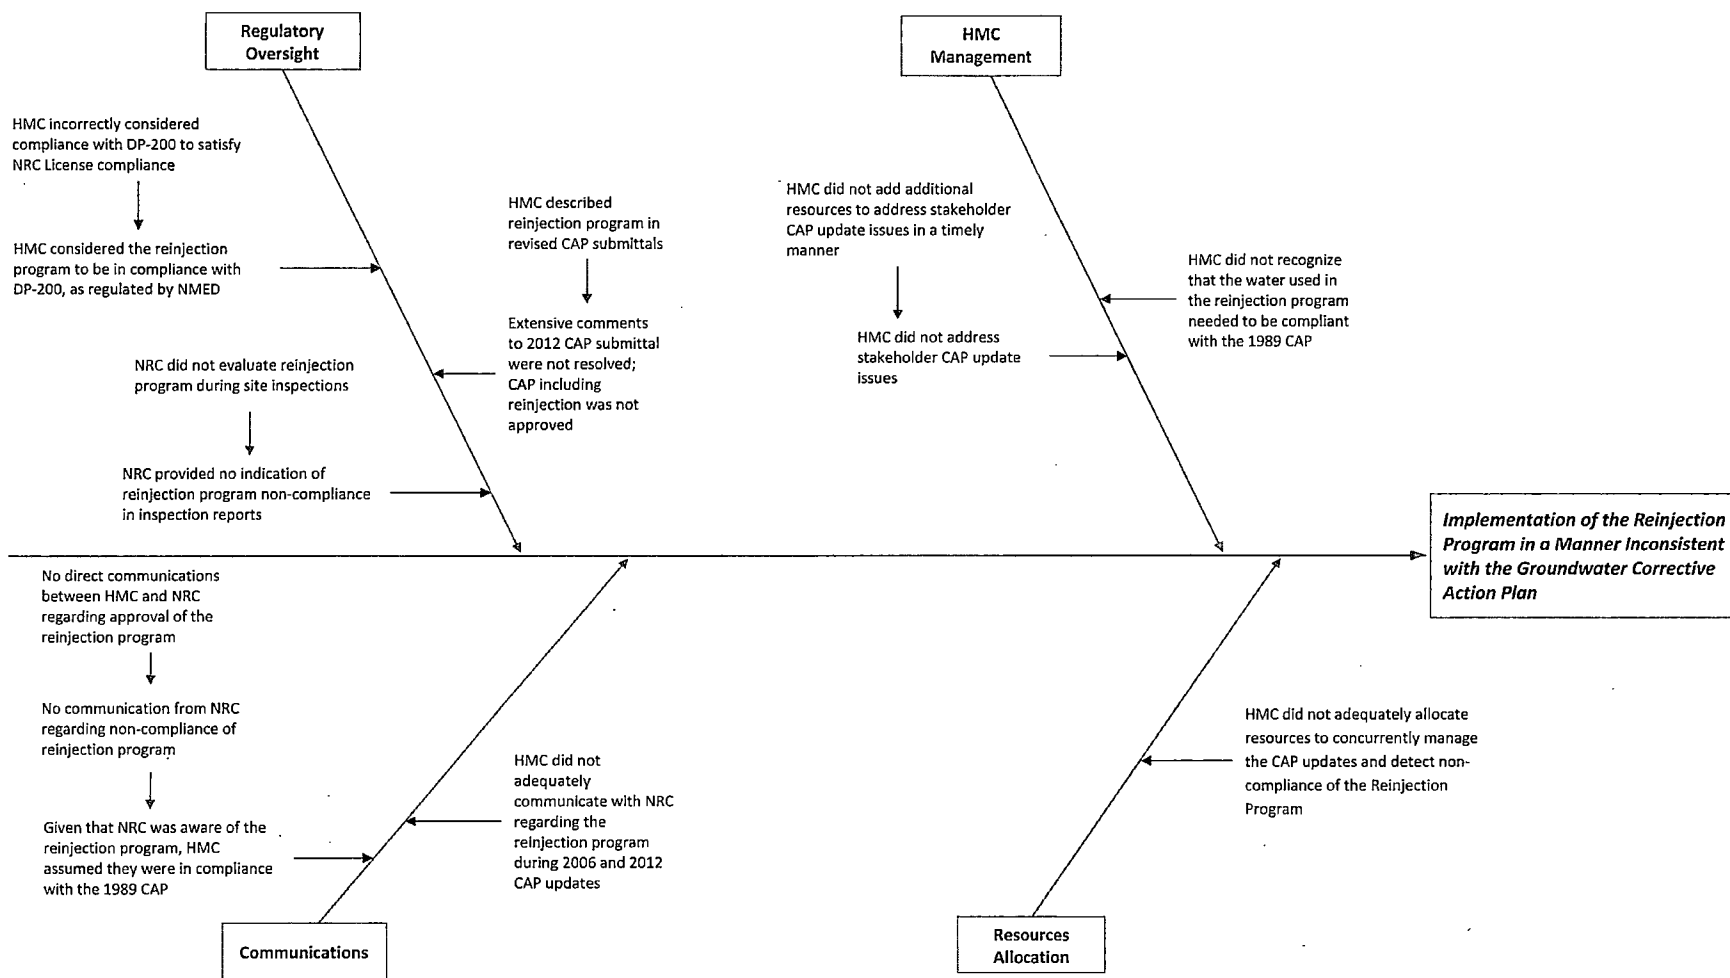
Problem Statement No. 1 – Fishbone Diagram

The attached fishbone diagram for Problem Statement No. 1 includes four categories encompassing the root causes and contributory factors that include Communications, Regulatory Oversight, HMC Management and Inadequate Resources, which were identified in the Specific, Detection and Systemic analyses. Common factors throughout the root cause structure are poor communications between HMC and NRC as well as HMC's failure to establish protocols for ensuring full compliance in the complex regulatory environment, which resulted in HMC devoting inadequate resources at the Site for compliance-related matters. Communications between the Site Manager and corporate management may not have addressed sufficiently the ability of Site staff to simultaneously and adequately focus on compliance, closure progression and routine Site activities.

The inability of HMC and NRC to update the 1989 CAP over a nominal 20-year period also points to other contributory factors that include: 1) the regulatory overlap of NMED with authority over the Reinjection Program, which HMC appears to have relied upon to assume compliance with relevant LCs; and 2) HMC's assumption that an absence of NRC complaints would justify not ensuring that all water used in the Reinjection Program was compliant with all applicable LCs (and documents referenced therein) as well as with NMED groundwater protection standards.

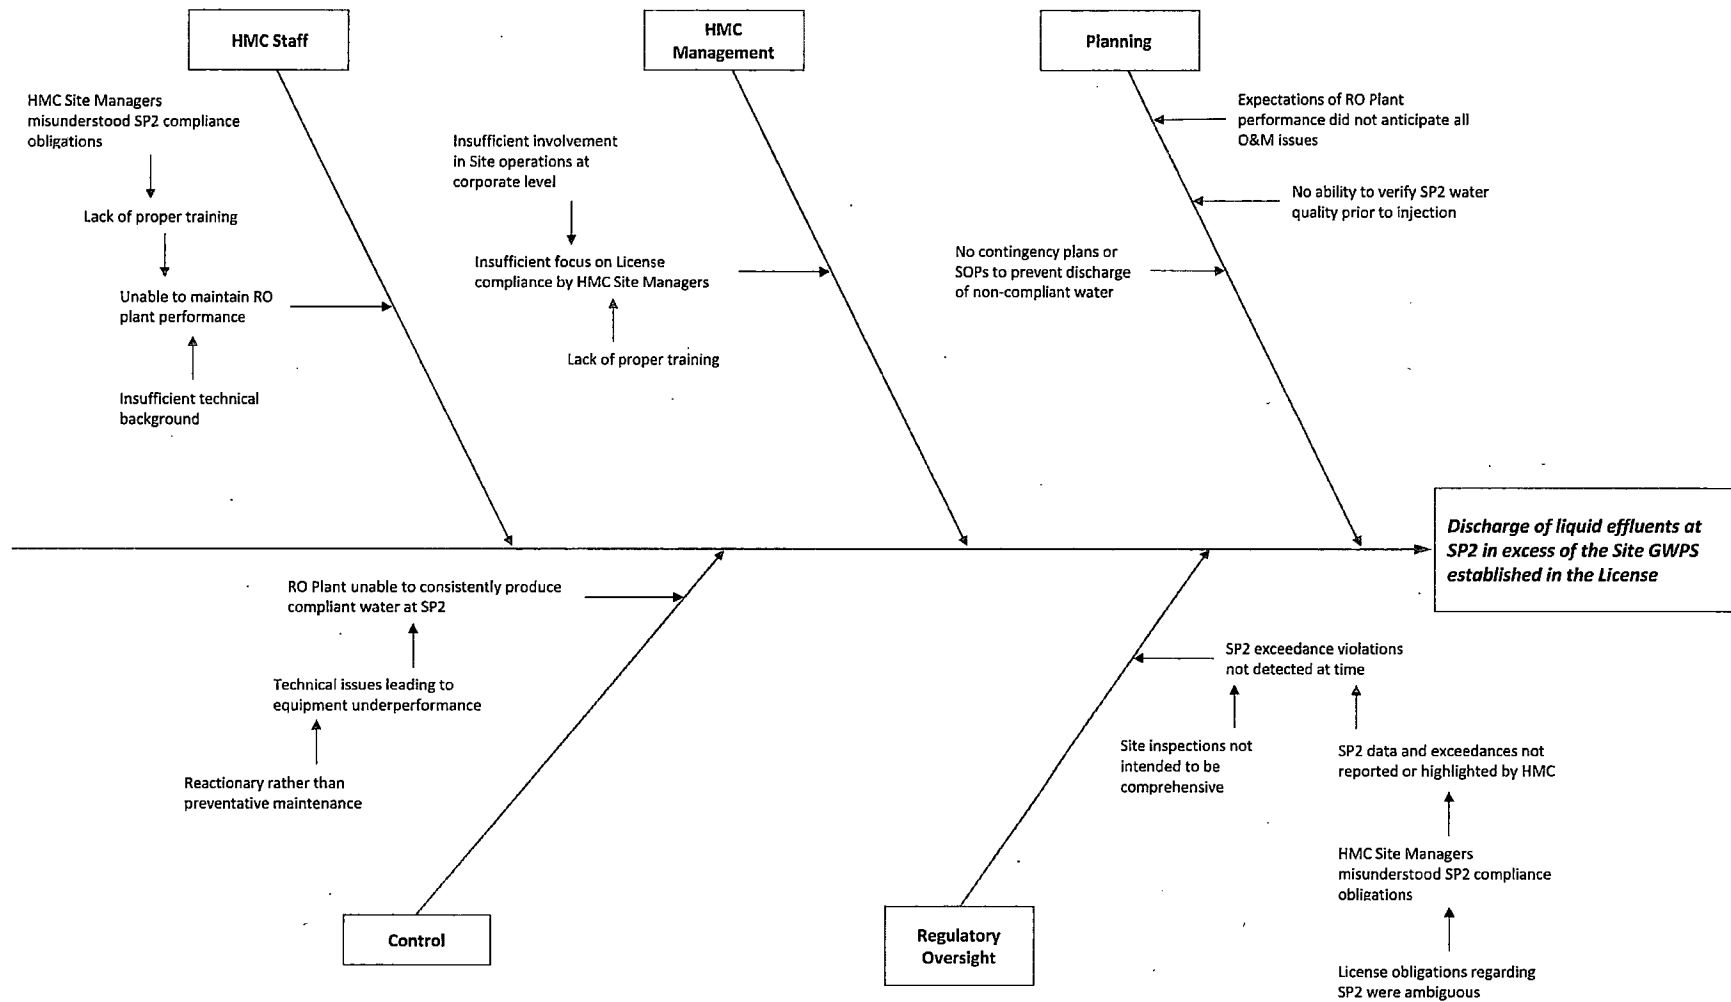
Problem Statement No. 2 – Fishbone Diagram

The attached fishbone diagram for Problem Statement No. 2 includes five categories encompassing the root causes and contributory factors that include Regulatory Oversight, HMC Management, HMC Staff, Planning and Control, which were identified in the Specific, Detection and Systemic analyses. The three analyses form a primary root cause structure that includes technical and maintenance issues, and detection and reporting failures.

The fishbone diagram indicates that an insufficient focus on compliance by HMC Site Managers was a pervasive element of this apparent violation. HMC Site Managers did not believe the License required compliance and reporting at SP2, and thus did not dedicate sufficient resources to resolving RO Plant performance issues. Unclear and ambiguous language in the License was a contributory factor that led to HMC's misunderstanding of SP2 compliance obligations.

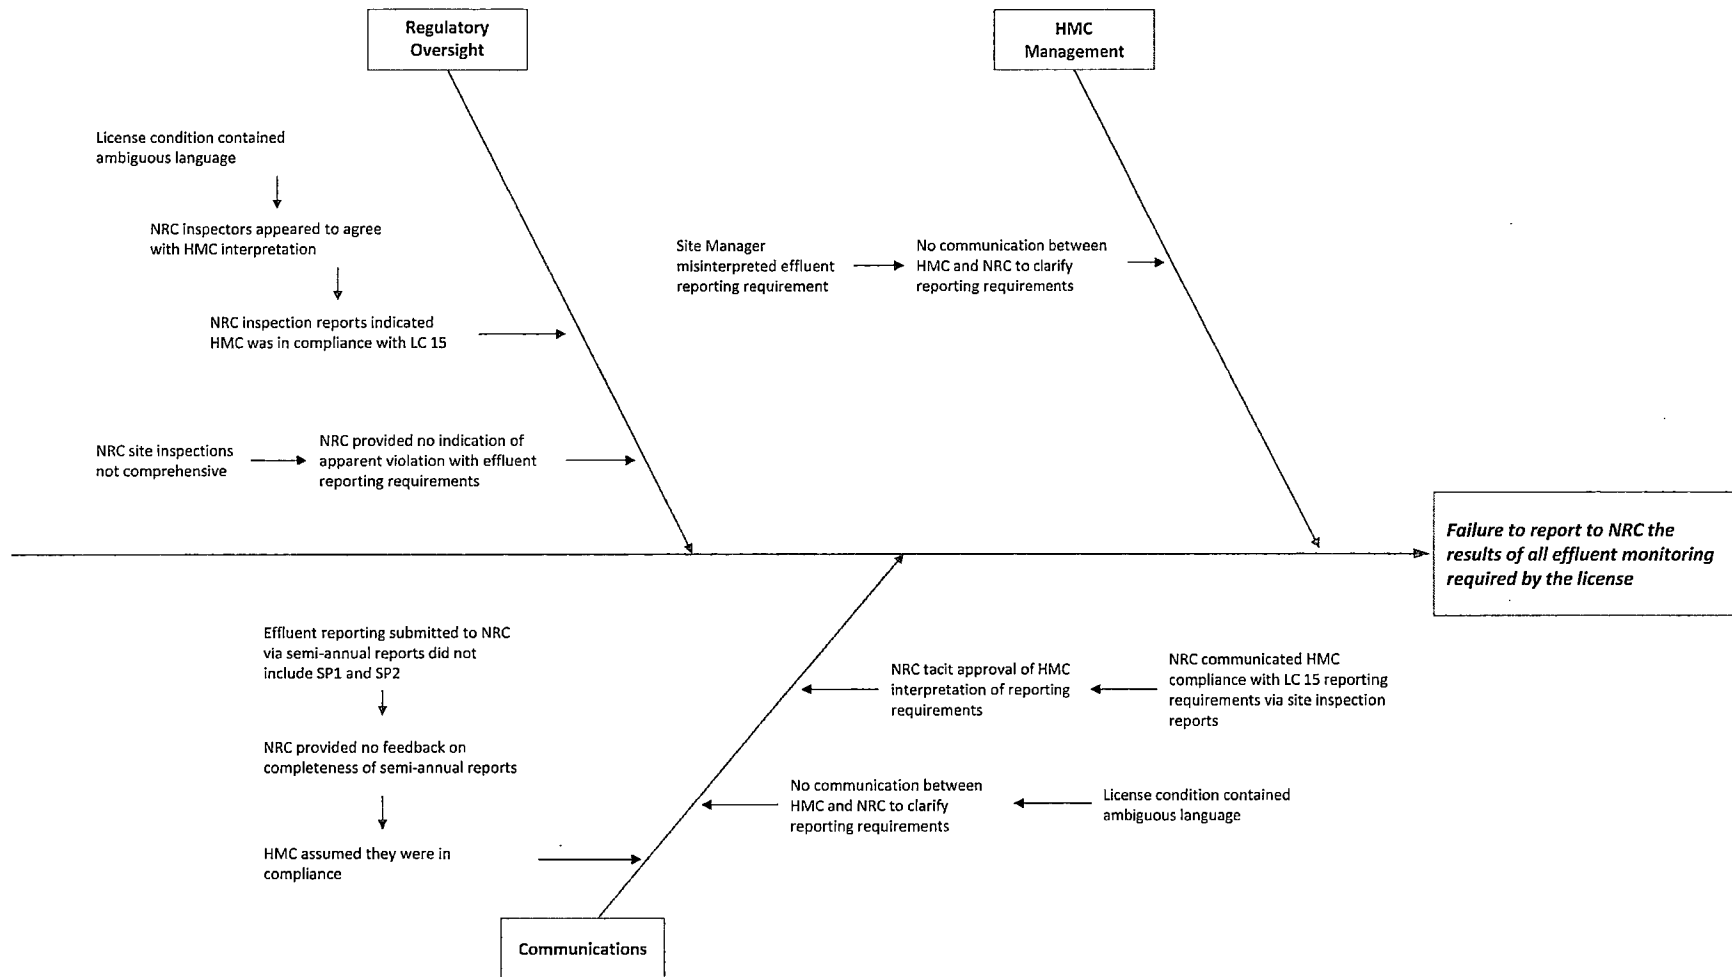
Problem Statement No. 3 – Fishbone Diagram

The attached fishbone diagram for Problem Statement No. 3 includes three categories that encompass the root causes and contributory factors that include Communications, HMC Management and Regulatory Oversight. HMC did not completely understand the requirements of the LC due to unclear or ambiguous language. In addition, HMC did not clarify the LC requirements with NRC, nor did the reporting issues come up during the many years of NRC compliance audits, which reinforced HMC's belief that it was reporting correctly. Communications between HMC and NRC were insufficient to proactively address this problem during Site inspections and, subsequently, within annual inspection reports.

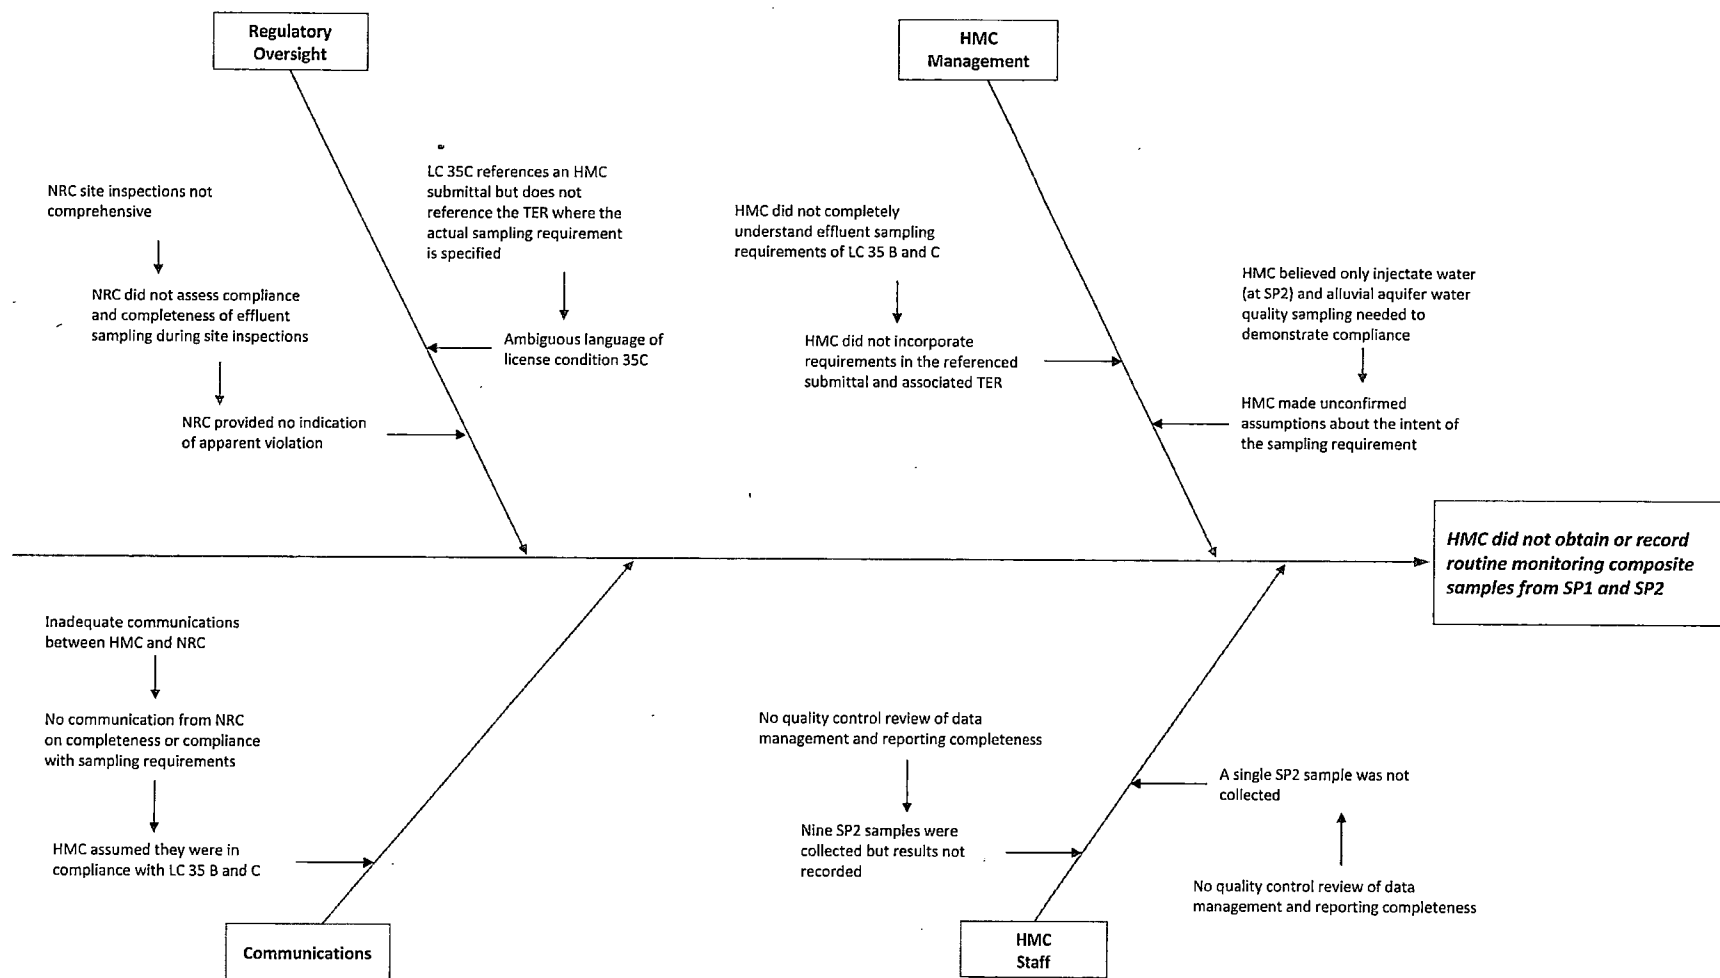
Problem Statement No. 4 – Fishbone Diagram

The attached fishbone diagram for Problem Statement No. 4 identifies four categories that encompass the root causes and contributory factors that include Communications, HMC Management, HMC Staff and Regulatory Oversight. HMC failed to: 1) understand License requirements; 2) provide or enforce QC and data management procedures; and 3) provide or allocate adequate resources to perform compliance-related tasks. Communications between HMC and NRC were insufficient to address this problem during Site inspections and inspection reports. HMC did not completely understand the LC requirements due to: 1) to HMC's failure to proactively incorporate the TER information provided by NRC; and 2) the absence of a specific reference in the LC to the TER.

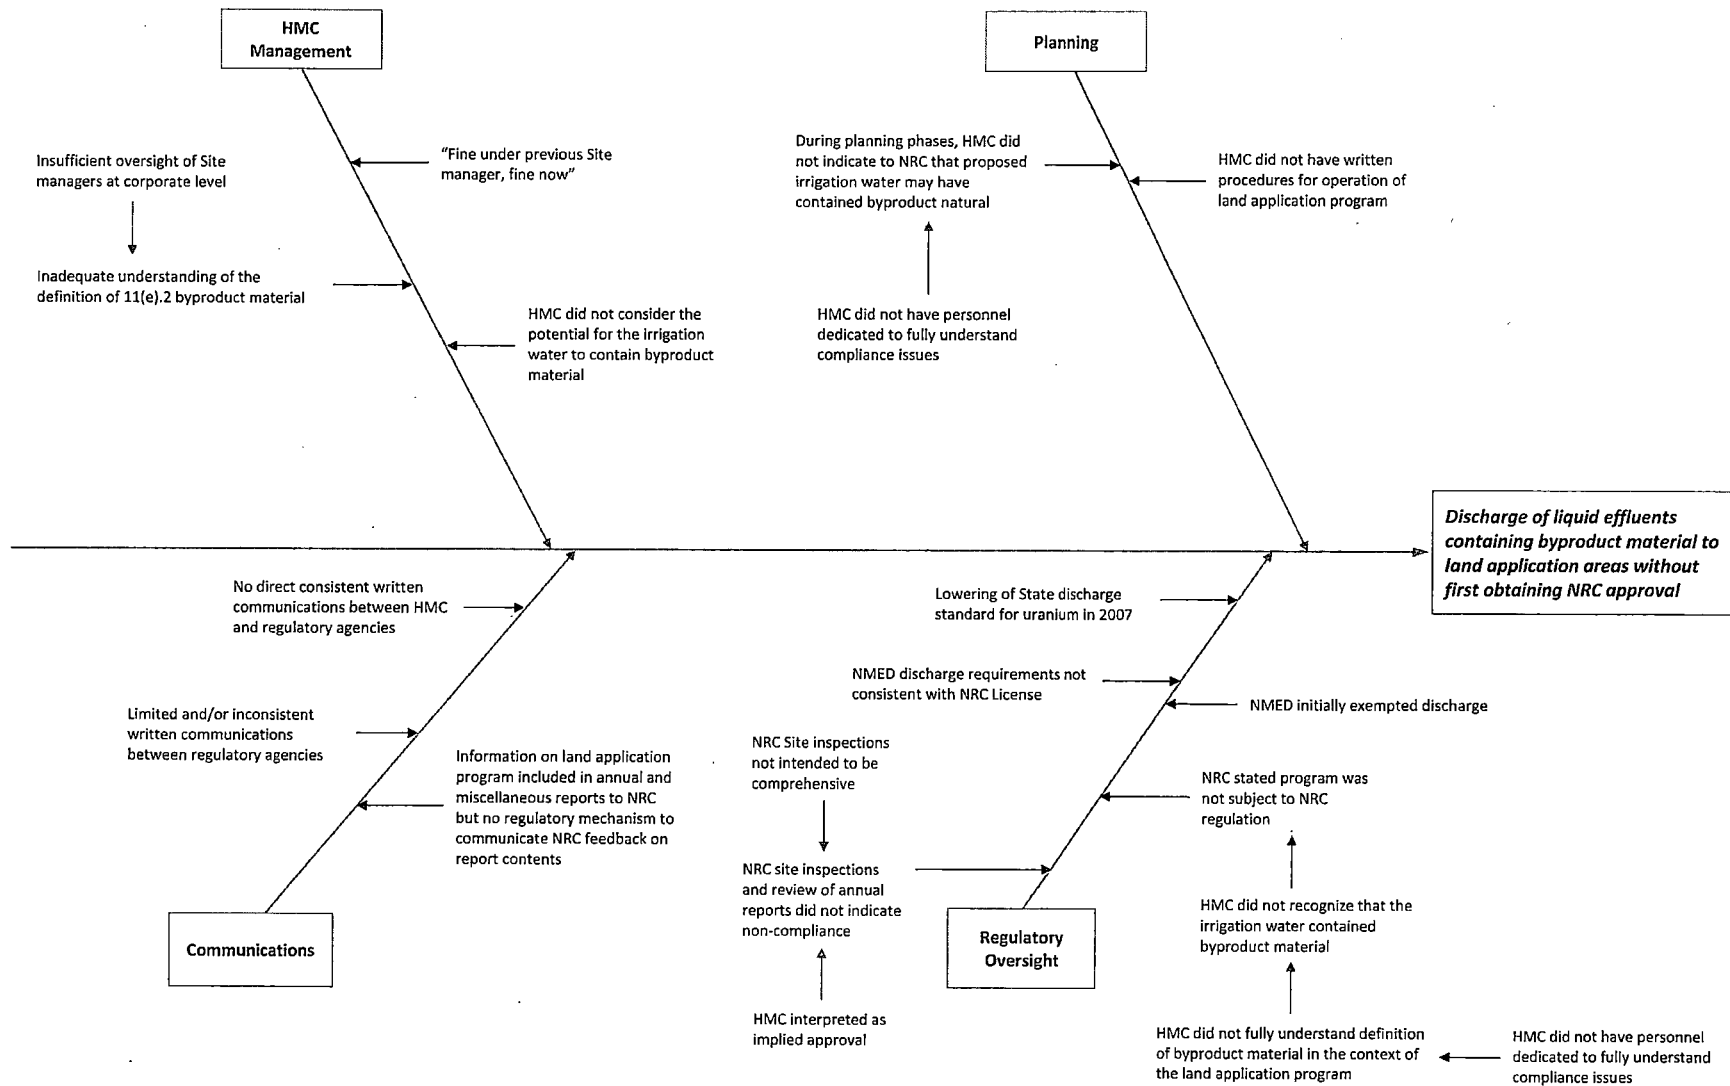
Problem Statement No. 5 – Fishbone Diagram

The attached fishbone diagram for Problem Statement No. 5 includes four categories encompassing the root causes and contributory factors that include Communications with NRC, Regulatory Oversight, HMC Management and Planning. In addition to the general HMC management issues shown on the diagram, HMC failed to recognize that the source water from the alluvial aquifer may have contained byproduct material, and did not proactively plan for this potential occurrence. It was not until community action groups raised concerns about environmental effects of the land application program to NMED that HMC and NMED considered such effects in their planning. However, up until its termination in 2012, the land application program was conducted in compliance with NMED requirements. The three root cause analyses form a root cause structure that indicates inadequate recognition by HMC of the potential issues created by the program; infrequent and/or inconsistent communications between HMC, NRC and NMED; and the failure by HMC to detect potential byproduct material in the land application water.
