SUMMARY EXAMINATION REPORT

1995 STEAM GENERATOR EDDY CURRENT INSPECTION

R.E. GINNA NUCLEAR POWER STATION

April 18, 1995

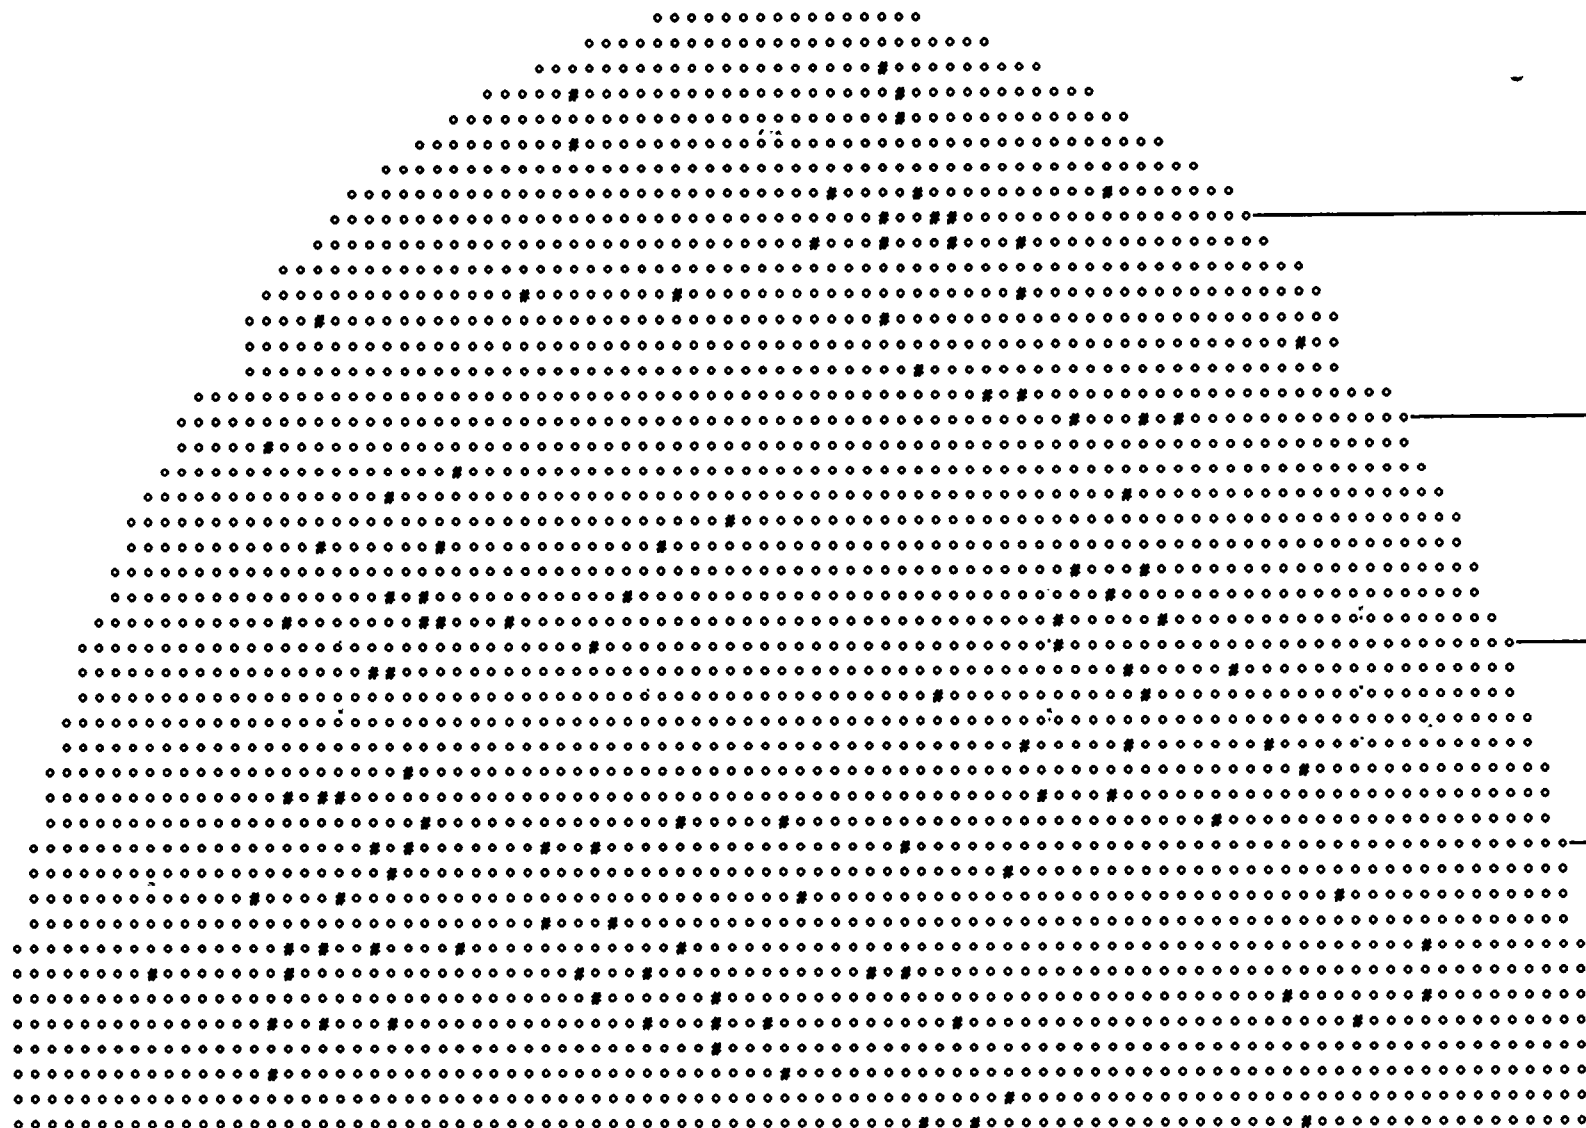
Rochester Gas & Electric Corp.
Ginna Nuclear Power Station
S/G - B 04/07/95 Inlet

#: 113: TUBES TO BE REPAIRED - 95MAR OUTAGE
