SUBJECT: Forwards LER 96-014 re pressure relieving capability.LER withheld.

Subject: LER 96-014, Pressure Relieving Capability Could be Degraded Due to Single Failure of DC Power, Which Could Prevent Mitigating the Consequences of an Accident
R.E. Ginna Nuclear Power Plant
Docket No. 50-244

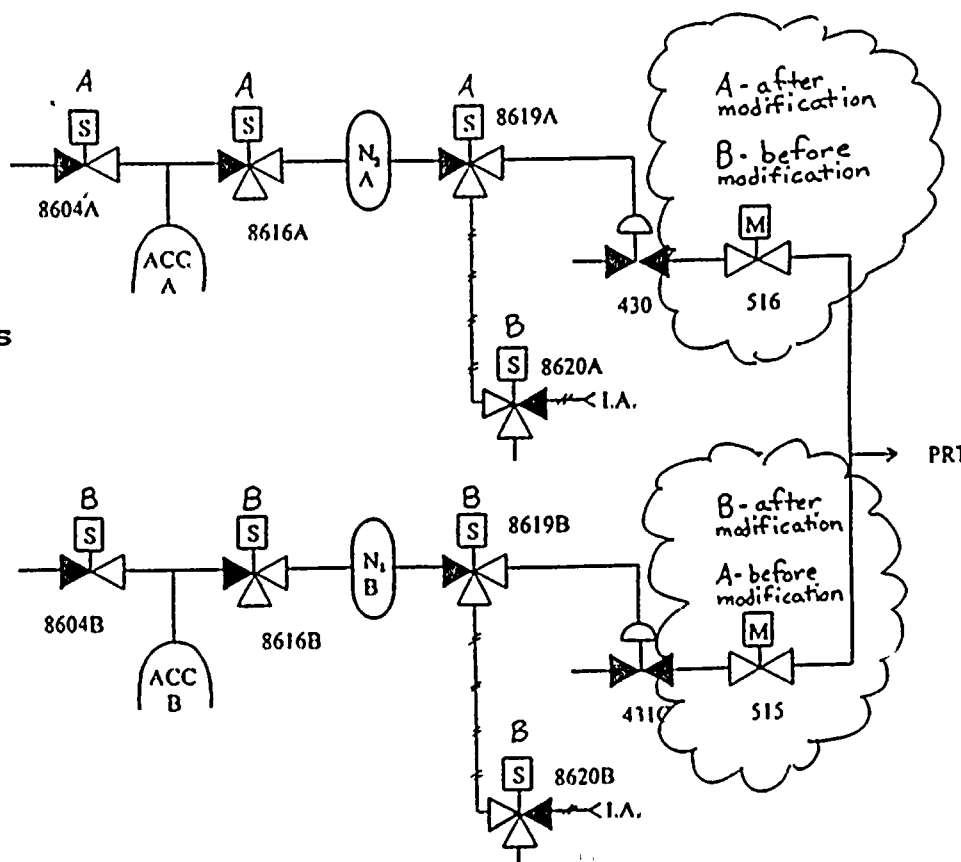
PORV DC Power Trains

When the plant was originally constructed in the 1960's, the "A" electrical train of DC power was configured to supply DC control power to MOV-515, the motor-operated block valve for PORV-431C. After the Low Temperature Overpressure Protection (LTOP) system modification in 1978, which installed nitrogen tanks to provide a safety-related pneumatic source for operation of the PORVs, the "A" train also supplied DC power to the safety-related nitrogen admission solenoid valve (SOV-8619A) for the opposite train PORV, PORV-430. Similarly, the "B" train of DC power was configured to supply DC control power to MOV-516 (the block valve for PORV-430) and to supply DC power to SOV-8619B for the opposite train PORV-431C. See the attached sketch of the PORV configuration for clarification.

If block valve MOV-515 were to be closed as allowed by Ginna Station Improved Technical Specifications (ITS) Limiting Condition for Operation (LCO) 3.4.11, and a subsequent postulated failure of the "A" train of DC power were to occur, a condition could exist where there is no available flow path for either PORV. That is, failure of the "A" train of DC power would cause SOV-8619A to fail in the vented position, preventing PORV-430 from opening with nitrogen pressure. With MOV-515 closed, no control power is available to re-open MOV-515, such that use of PORV-431C for pressure relief would be blocked. Similarly, if MOV-516 were initially closed, a postulated failure of the "B" train of DC power would prevent the ability to re-open MOV-516, thus blocking flow through PORV-430, while SOV-8619B would remain vented, preventing PORV-431C from opening with nitrogen pressure.

Thus, a single failure of either DC electrical train could prevent the ability to relieve pressure through both trains of PORVs with one or both PORV block valves initially closed.

1. The plant was restricted to operation below Mode 3 until this condition was resolved.
2. The DC electrical power and control cabling for MOV-515 and MOV-516 were modified (swapped). The train "A" DC power is now associated with MOV-516, and train "B" DC power is now associated with MOV-515. This modification ensures that the PORV LTOP nitrogen control trains are powered consistent with their associated PORV and PORV block valve to ensure DC power train redundancy in all required accident scenarios. This modification was completed on November 9, 1996.
