SUBJECT: LER 97-002-00: on 970720, 34.5 KV offsite power circuit 751 was lost. Caused by automatic actuation of "B" emergency DG due to undervoltage on safeguards buses 16 & 17. Offsite power restored to safeguards buses 16 & 17. W/970819 ltr.

Subject: LER 97-002, Loss of 34.5 KV Offsite Power Circuit 751, Due to External Cause,
Results in Automatic Start of "B" Emergency Diesel Generator
R.E. Ginna Nuclear Power Plant
Docket No. 50-244

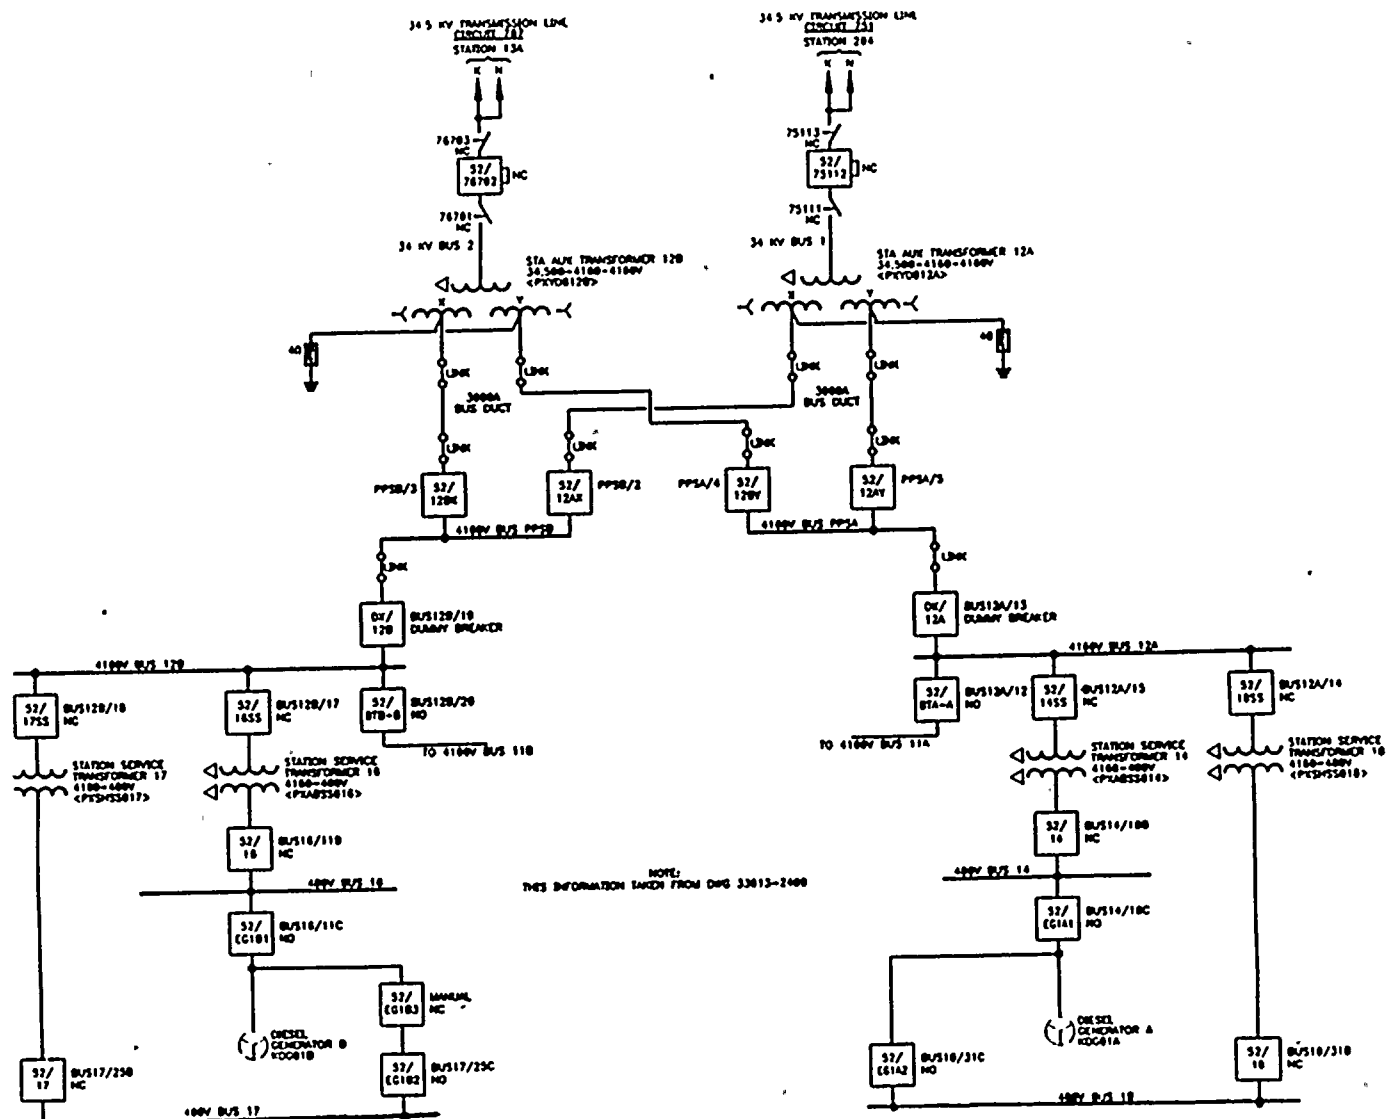
- Circuit 751 (34.5 KV offsite power source) was supplying power to the "B" train 480 Volt safeguards buses 16 and 17 through 34.5 KV to 4160 Volt transformer 12A (12A transformer), via circuit breaker 52/12AX, to 4160 Volt bus 12B, and through the safeguards bus 4160 Volt to 480 Volt transformers 16 and 17.
- Circuit 767 (34.5 KV offsite power source) was supplying power to the "A" train 480 Volt safeguards buses 14 and 18 through 34.5 KV to 4160 Volt transformer 12B (12B transformer), via circuit breaker 52/12BY, to 4160 Volt bus 12A, and through the safeguards bus 4160 Volt to 480 Volt transformers 14 and 18.

See the attached sketch of the offsite power distribution system.
