Subject: LER 1998-005, Loss of 34.5 KV Offsite Power Circuit
751, Due to Faulted Cable Splice, Results in Automatic
Start of "B" Emergency Diesel Generator
R.E. Ginna Nuclear Power Plant
Docket No. 50-244

LICENSEE EVENT REPORT (LER)

Loss of 34.5 KV Offsite Power Circuit 751, Due to Faulted Cable Splice, Results in Automatic Start of "B" Emergency Diesel Generator

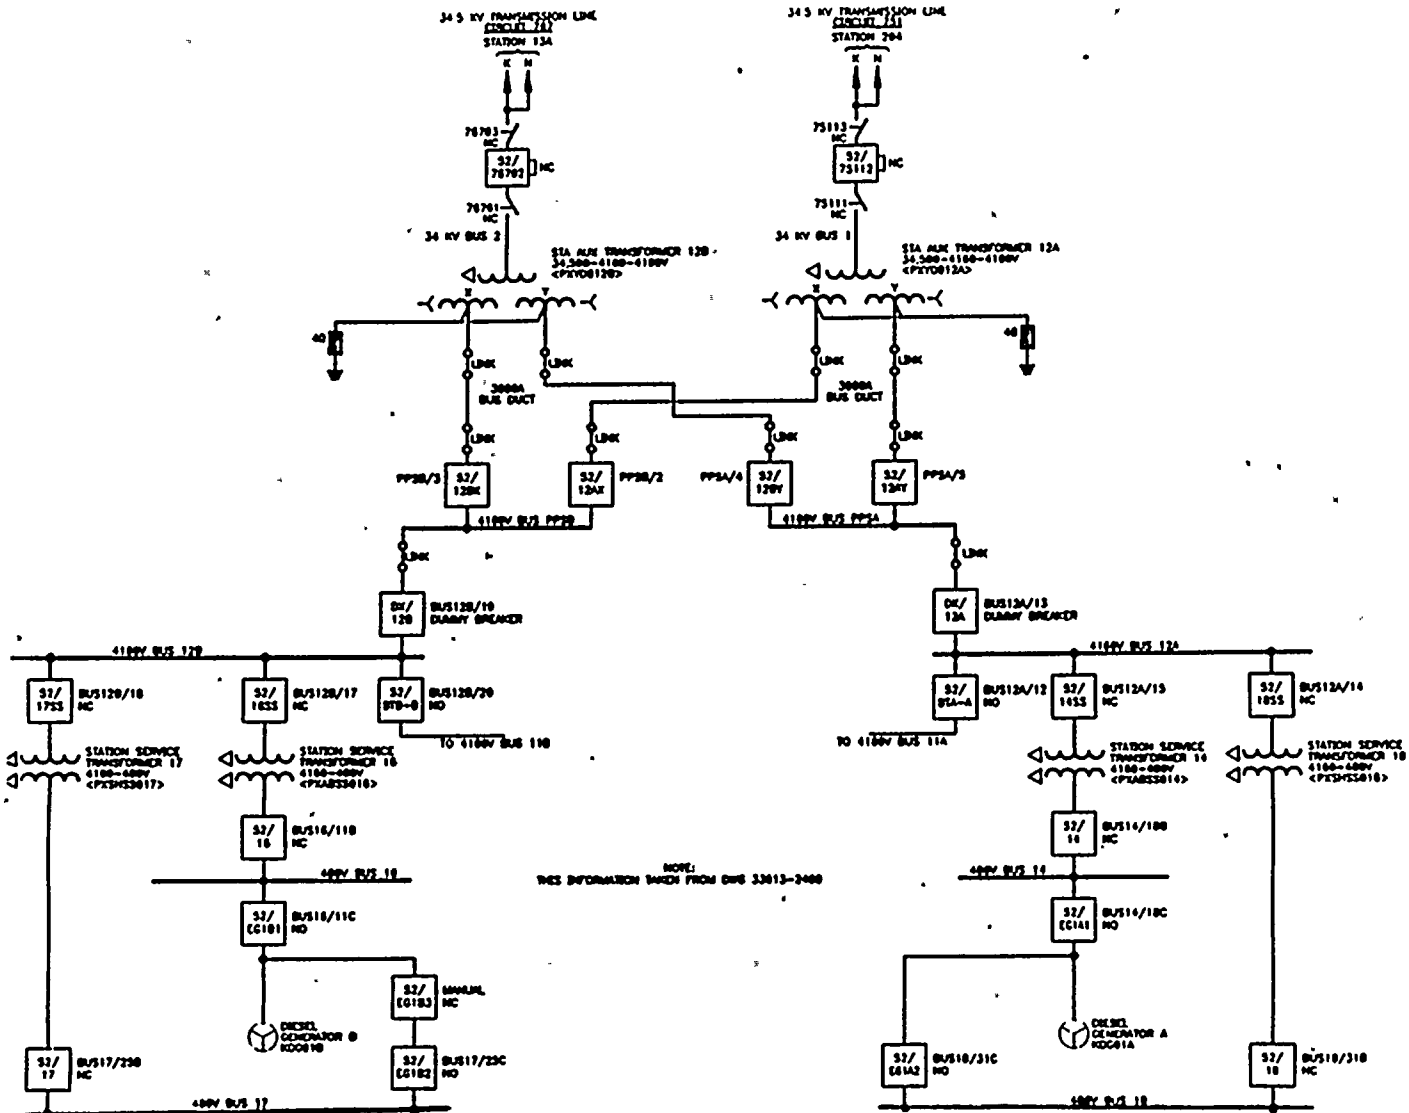
- o Circuit 751 (34.5 KV offsite power source) was supplying power to the "B" train 480 Volt safeguards buses 16 and 17 through 34.5 KV to 4160 Volt transformer 12A (12A transformer), via circuit breaker 52/12AX, to 4160 Volt bus 12B, and through the safeguards bus 4160 Volt to 480 Volt transformers 16 and 17.
- o Circuit 767 (34.5 KV offsite power source) was supplying power to the "A" train 480 Volt safeguards buses 14 and 18 through 34.5 KV to 4160 Volt transformer 12B (12B transformer), via circuit breaker 52/12BY, to 4160 Volt bus 12A, and through the safeguards bus 4160 Volt to 480 Volt transformers 14 and 18.

See the attached sketch of the offsite power distribution system.
