SACRIFICIAL SHIELD WALL

- ANALYSIS, DESIGN, CONSTRUCTION OF SSW

- o BWR MARK II
- o 1100 MW PLANT

Docket # 50-397
Control # 8007310013
Date 7-11-80 of Document:
REGULATORY DOCKET FILE

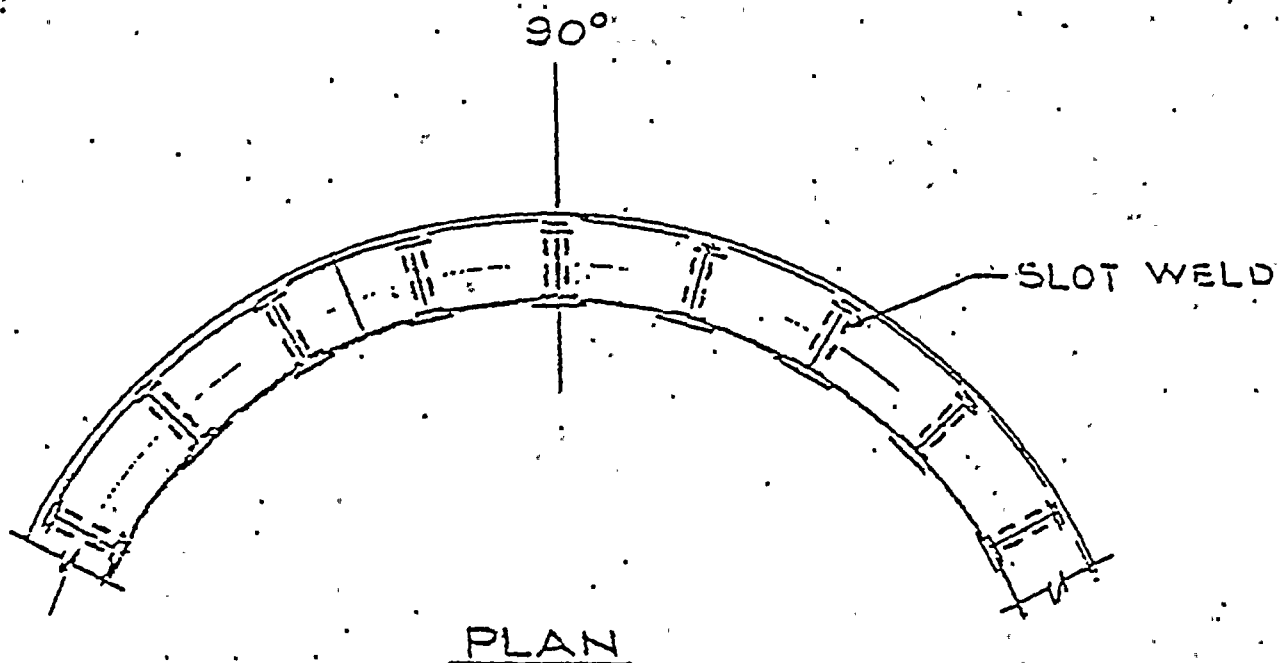
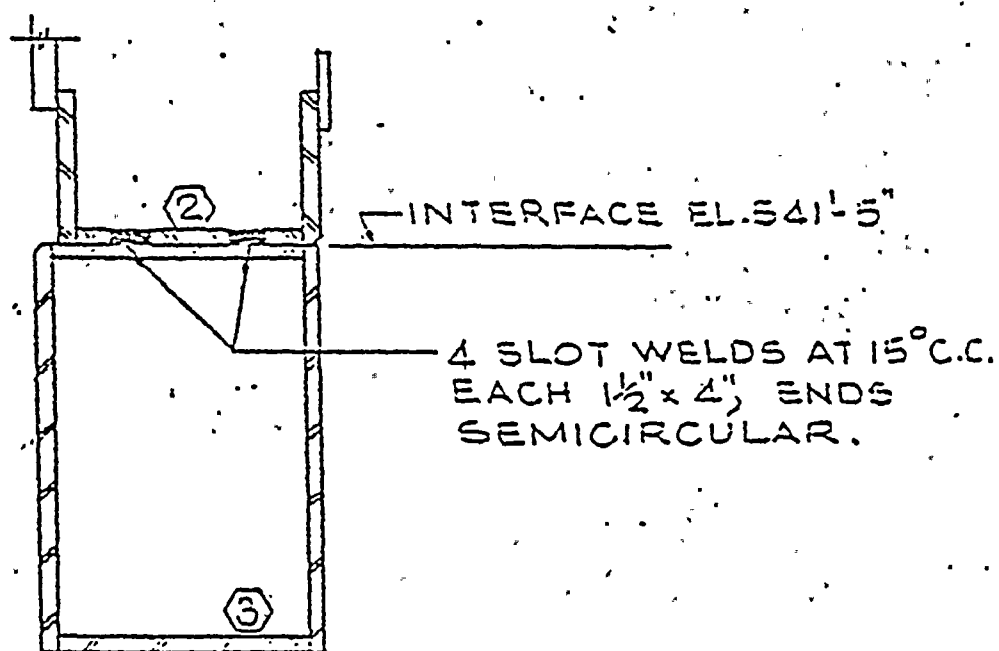
CROSS SECTION OF SAC. SHIELD WALL
AT INTERFACE

- o AS SEEN IN THE CROSS SECTION, THE INTERFACE LIES BETWEEN UPPER CHANNEL 2 AND THE LOWER BOX BEAM 3.
- o THE CONTRACT PROVIDED FOR TRANSMISSION OF HORIZONTAL SHEAR BY SLOT WELDS IN CHANNEL WEB JOINING THE BOX BEAM.
- o AS INDICATED IN THE PLAN, 4 SLOT WELDS WERE PROVIDED IN THE VICINITY OF EACH OF THE 24 WF COLUMNS WHICH JOIN THE CHANNEL FROM ABOVE.
- o IN ORDER TO PLUMB THE UPPER PORTION OF THE WALL ABOVE EL. 541'5", SHIMS WERE PLACED BETWEEN MEMBERS 2 AND 3. THEN, IN MANY CASES THE SLOT WELDS THROUGH THE CHANNEL WEB WERE MADE TO THE SHIMS INSTEAD OF TO MEMBER 3. THUS, THE CONTRACT REQUIREMENT WAS VITIATED.

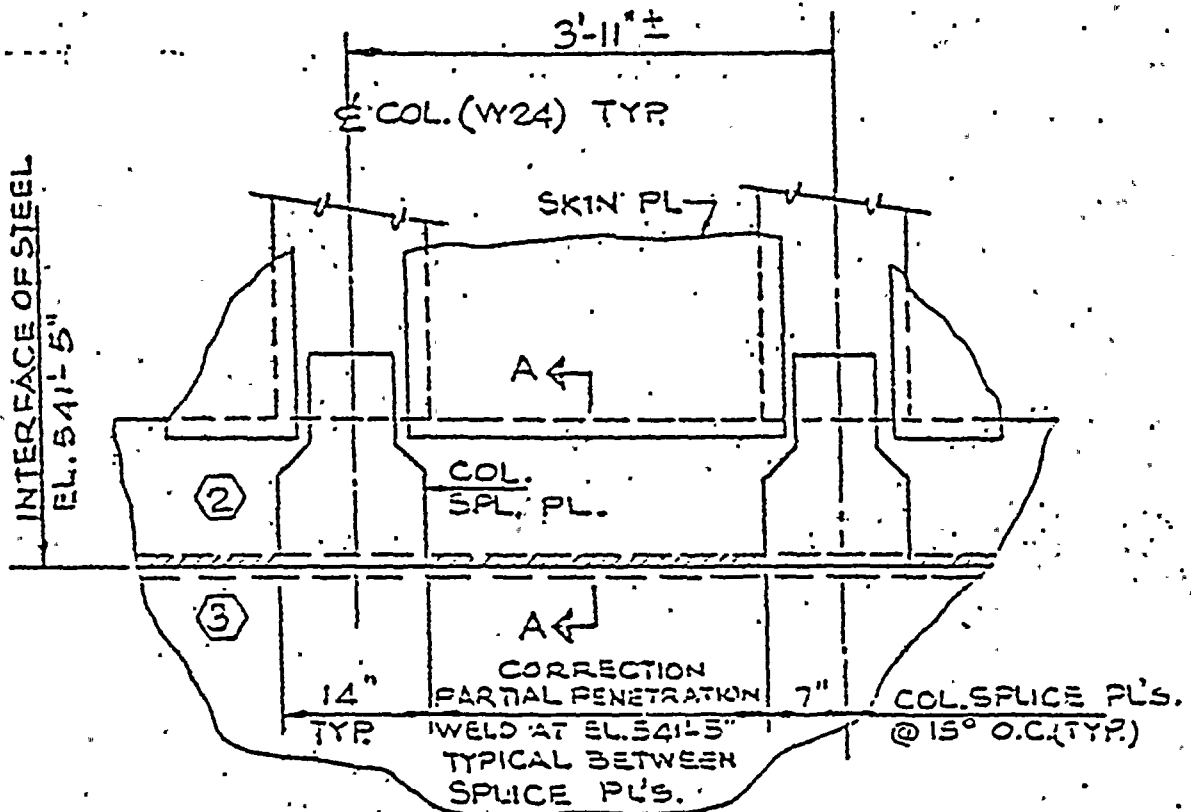
THE UPPER VIEW IS AN EXTERIOR ELEVATION OF THE WALL.
IT SHOWS:

- ° THE INSTALLED COLUMN SPLICE PLATES WHICH JOIN THE UPPER COLUMNS TO THE BOX BEAMS BELOW THE INTERFACE.
- ° THE PROPOSED CORRECTION WELD WHICH WILL EXTEND FOR THE FULL WIDTH BETWEEN SPLICE PLATES IN EACH OF THE 24 PANELS AROUND THE WALL.

THE PROPOSED CORRECTION MEASURE INVOLVES THE INSTALLATION OF A PARTIAL PENETRATION WELD ALONG THE EXTERIOR CIRCUMFERENCE BETWEEN THE TWO RINGS. THIS REPRESENTS A CHANGE FROM THE ORIGINAL DESIGN AND AS SUCH IS OF CONCERN TO USNRC.

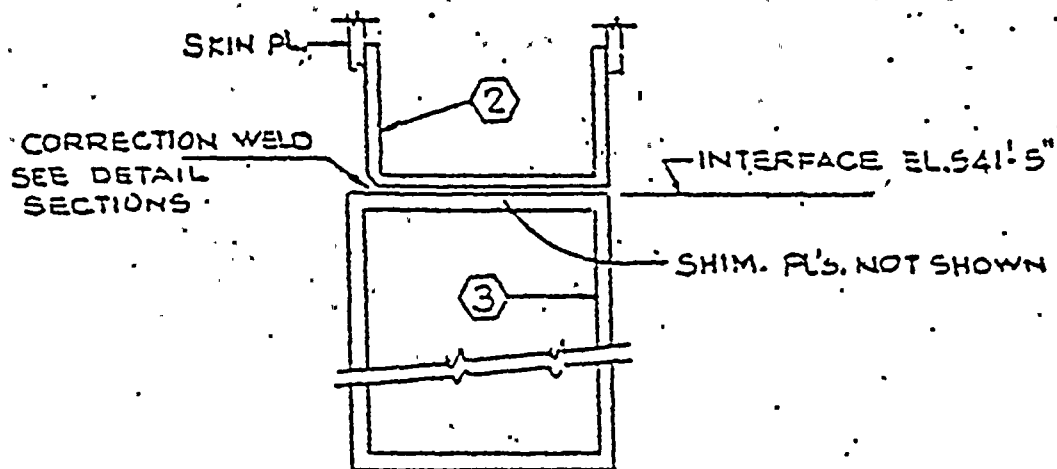
SECTION A-A

SECTION A-A, TAKEN ACROSS THE SHIELD WALL, SHOWS:

- ° CHANNEL MEMBER 2 ABOVE THE INTERFACE AND BOX MEMBER 3 BELOW THE INTERFACE.
- ° SEIM PLATES HAVE BEEN INSTALLED BETWEEN THE TWO MEMBERS UP TO A MAXIMUM THICKNESS OF 1/2 INCH.
- ° THE CORRECTION WELD IS A PARTIAL PENETRATION GROOVE WELD BETWEEN THE TWO MEMBERS.

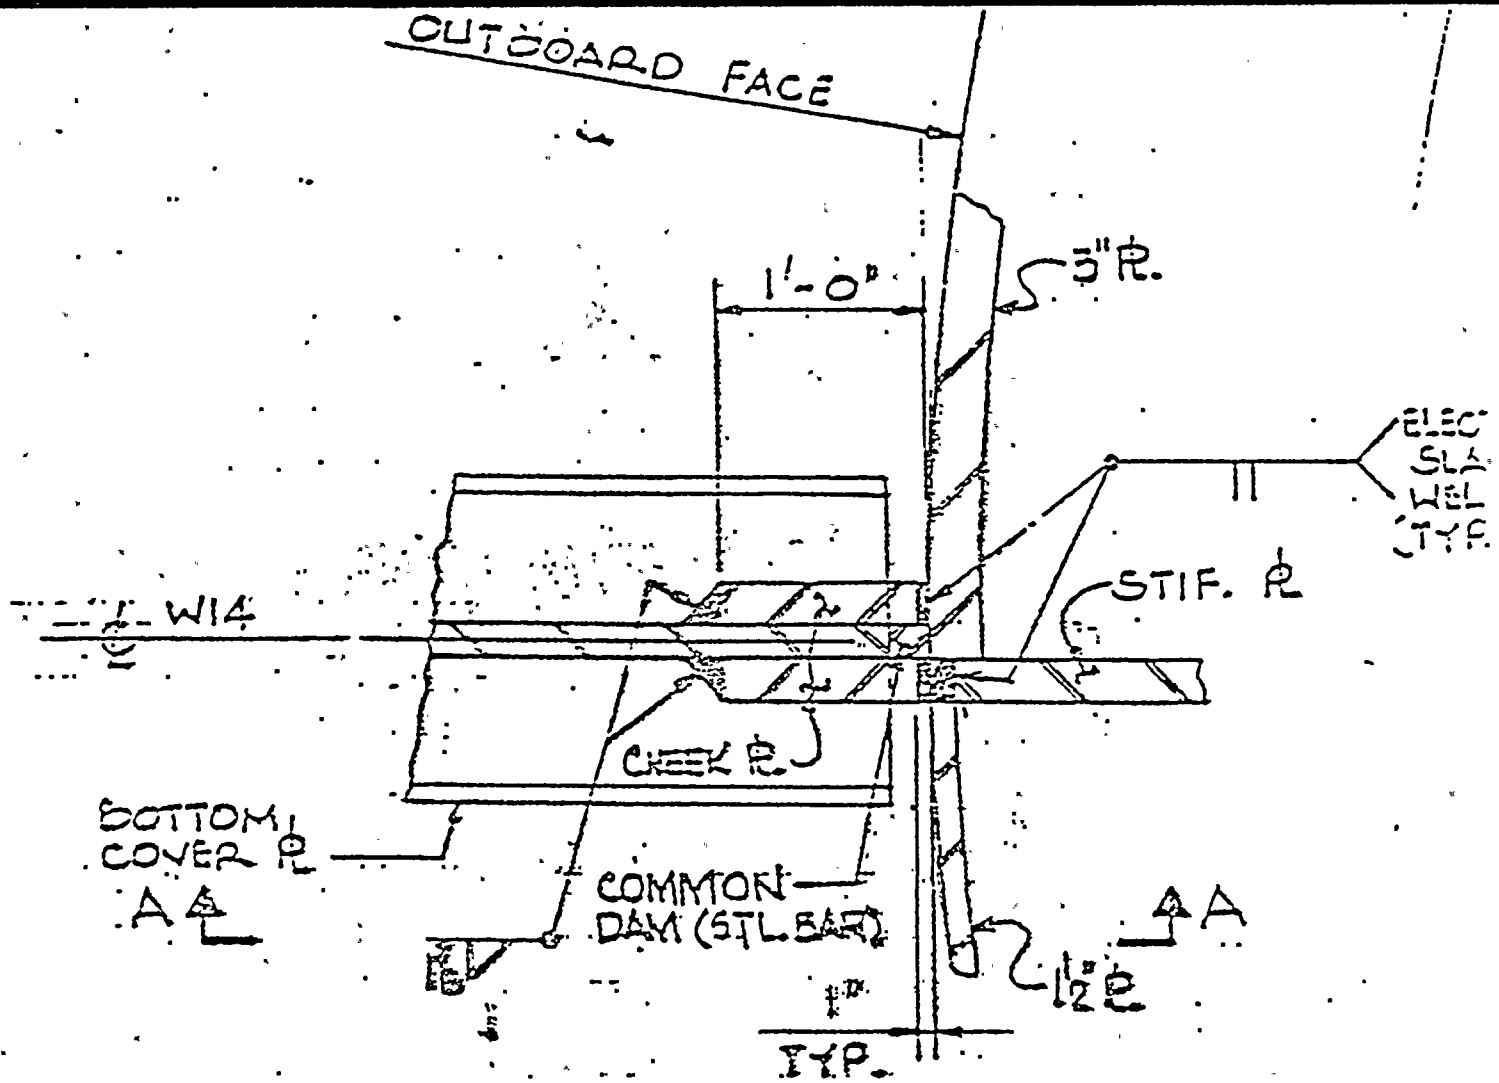
PLAN - TYP. BEAM CONN. @ SAC. SHIELD WALL
FOR W14 x 426 WITH COVER PLATES T. & B.

At the time the subject crack was discovered in the SSW where a radial beam was welded to it, three radial beams had been attached and the installation of the fourth was in progress. Examination of these attachments revealed that two of the three were cracked.

• DESCRIPTION OF CRACK

- CONSULTANTS LETTER HAS BEEN REVIEWED
- THEORIES OF CAUSE OF CRACK DISPUTED
- BEAMS AFFECTED WERE CORRECTED -
SUBSEQUENT BEAMS WERE WELDED
SUCCESSFULLY WITH REVISED WELDING
SEQUENCE & PROCEDURE.
- FURTHER ACTION - NONE REQUIRED

1. The radial beams were all removed from the SSW.
2. The cracks were weld repaired and the repairs were determined to be sound by U-T.
3. The attachment areas for all remaining radial beams were examined by U-T and found to be sound.

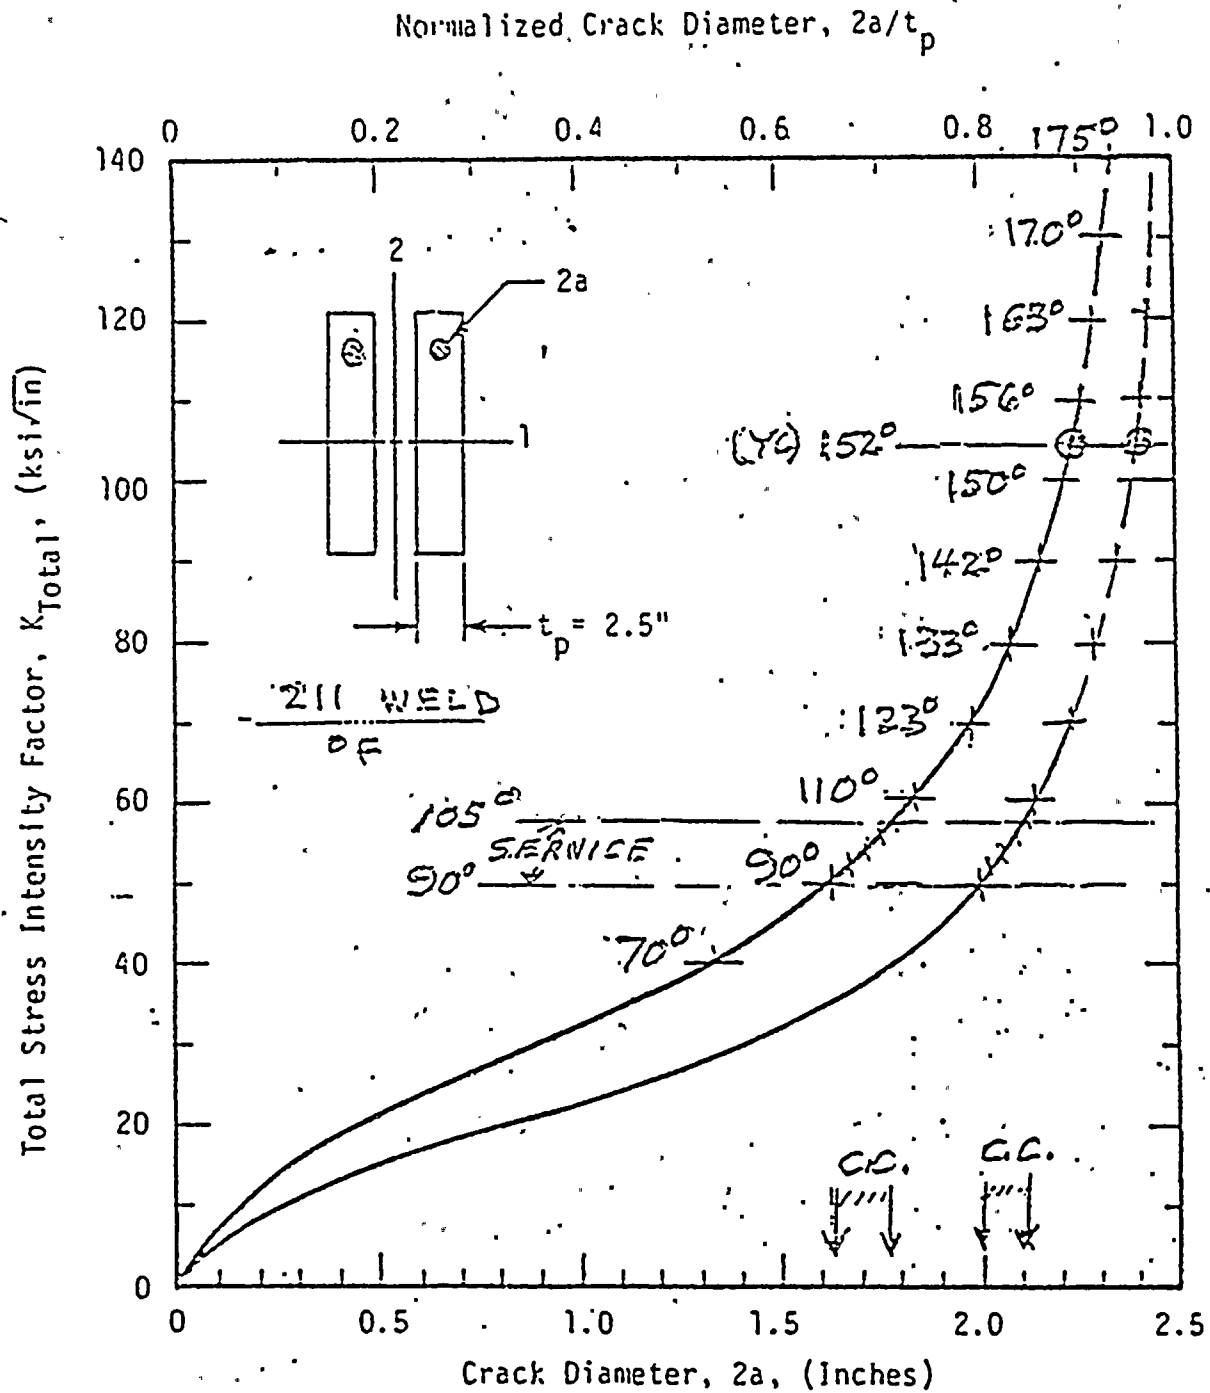
Figure 3.16 - Total Stress Intensity Factor as a Function of Crack Diameter For a Buried Circular Crack in the Cheek Plate-to-Wall Weld Connection (With Residuals).

LARGE G.C. SIZE — TWO DEFECTS NOT REALISTIC
