Subject: WPPSS Nuclear Project No. 2
Docket No. 50-397, CPPR-93
Reportable Deficiency - 10CFR50.55(e)

REPORTABLE DEFICIENCY AND CORRECTIVE ACTION
WPPSS NUCLEAR PROJECT NO. 2
POSSIBLE LOSS IN OPERABILITY OF BORG-WARNER-NDV VALVES
WITH LIMITORQUE SMC SERIES ACTUATORS

WASHINGTON PUBLIC POWER SUPPLY SYSTEM
DOCKET NO. 50-397
LICENSE NO. CPPR-93

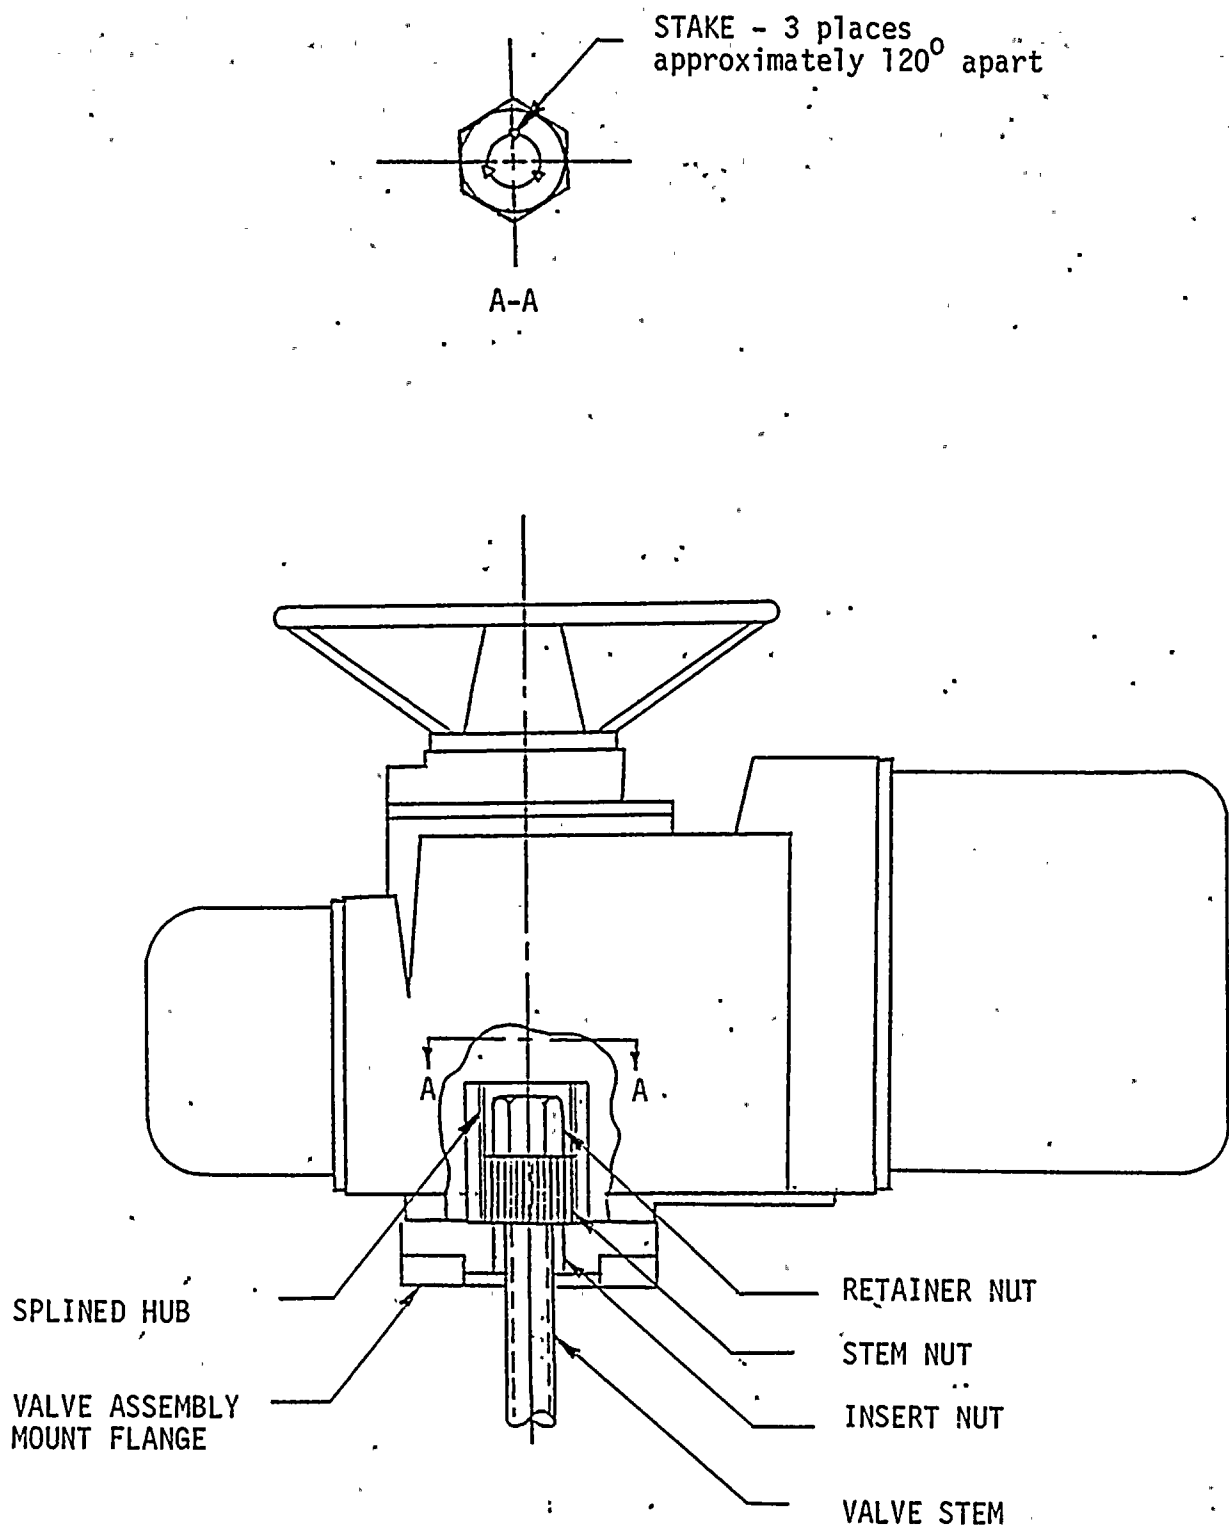
FIGURE 1.

The reported deficiency involves the possible loosening of the stem nut on some Borg-Warner Nuclear Valve Division valves equipped with Limitorque SMC series operators. Loosening of the stem nut could result in disengagement of the connection between the valve and operator, rendering the valve inoperable.

The deficiency is similar to that reported by NRC IE Circular 79-04, however, the design of the connection between the valve and operator is not the same as described by the Circular and involves components provided by the valve manufacturer. The design, for which the deficiency is reported, applies to valves with threaded rising stems that rotate. The required axial movement of valve stem is provided by the interaction between the valve stem threads and a fixed insert nut installed in a flange fitting between the valve assembly mount flange and the operator. Rotation of the valve stem is provided by a splined stem nut which mates with splines in the hub of the operator drive gear. The stem nut, which has a square socket to mate with a squared section of the valve stem, is retained by a nut on the end of the valve stem. The stem nut moves axially with the valve stem as the valve opens or closes. Loosening or loss of the retainer nut could result in movement of the stem nut to a point that the connection between the valve and operator disengages.

The Borg-Warner Nuclear Valve Division has developed a method of correcting the reported deficiency which involves staking the threads of the valve stem and retainer nut as indicated on Figure 1. This staking procedure has been tested with very satisfactory results.

All of the valves, which have been identified, will be reworked in accordance with Borg-Warner's recommendations. The rework will be supervised and checked by Borg-Warner personnel.
