Subject: WPPSS NUCLEAR PROJECT NO. 2
HARDSHIP EXEMPTION REQUEST
WNP-2 SACRIFICIAL SHIELD WALL

SUBJECT: WNP-2 HARDSHIP EXEMPTION REQUEST
WNP-2 SACRIFICIAL SHIELD WALL

Hardship Exemption Request
For Acceptance As-Is of
Certain Identified Weld Defects
In The WNP-2 Sacrificial Shield Wall in
Violation of AWS D1.1 (Rev. 1-73)

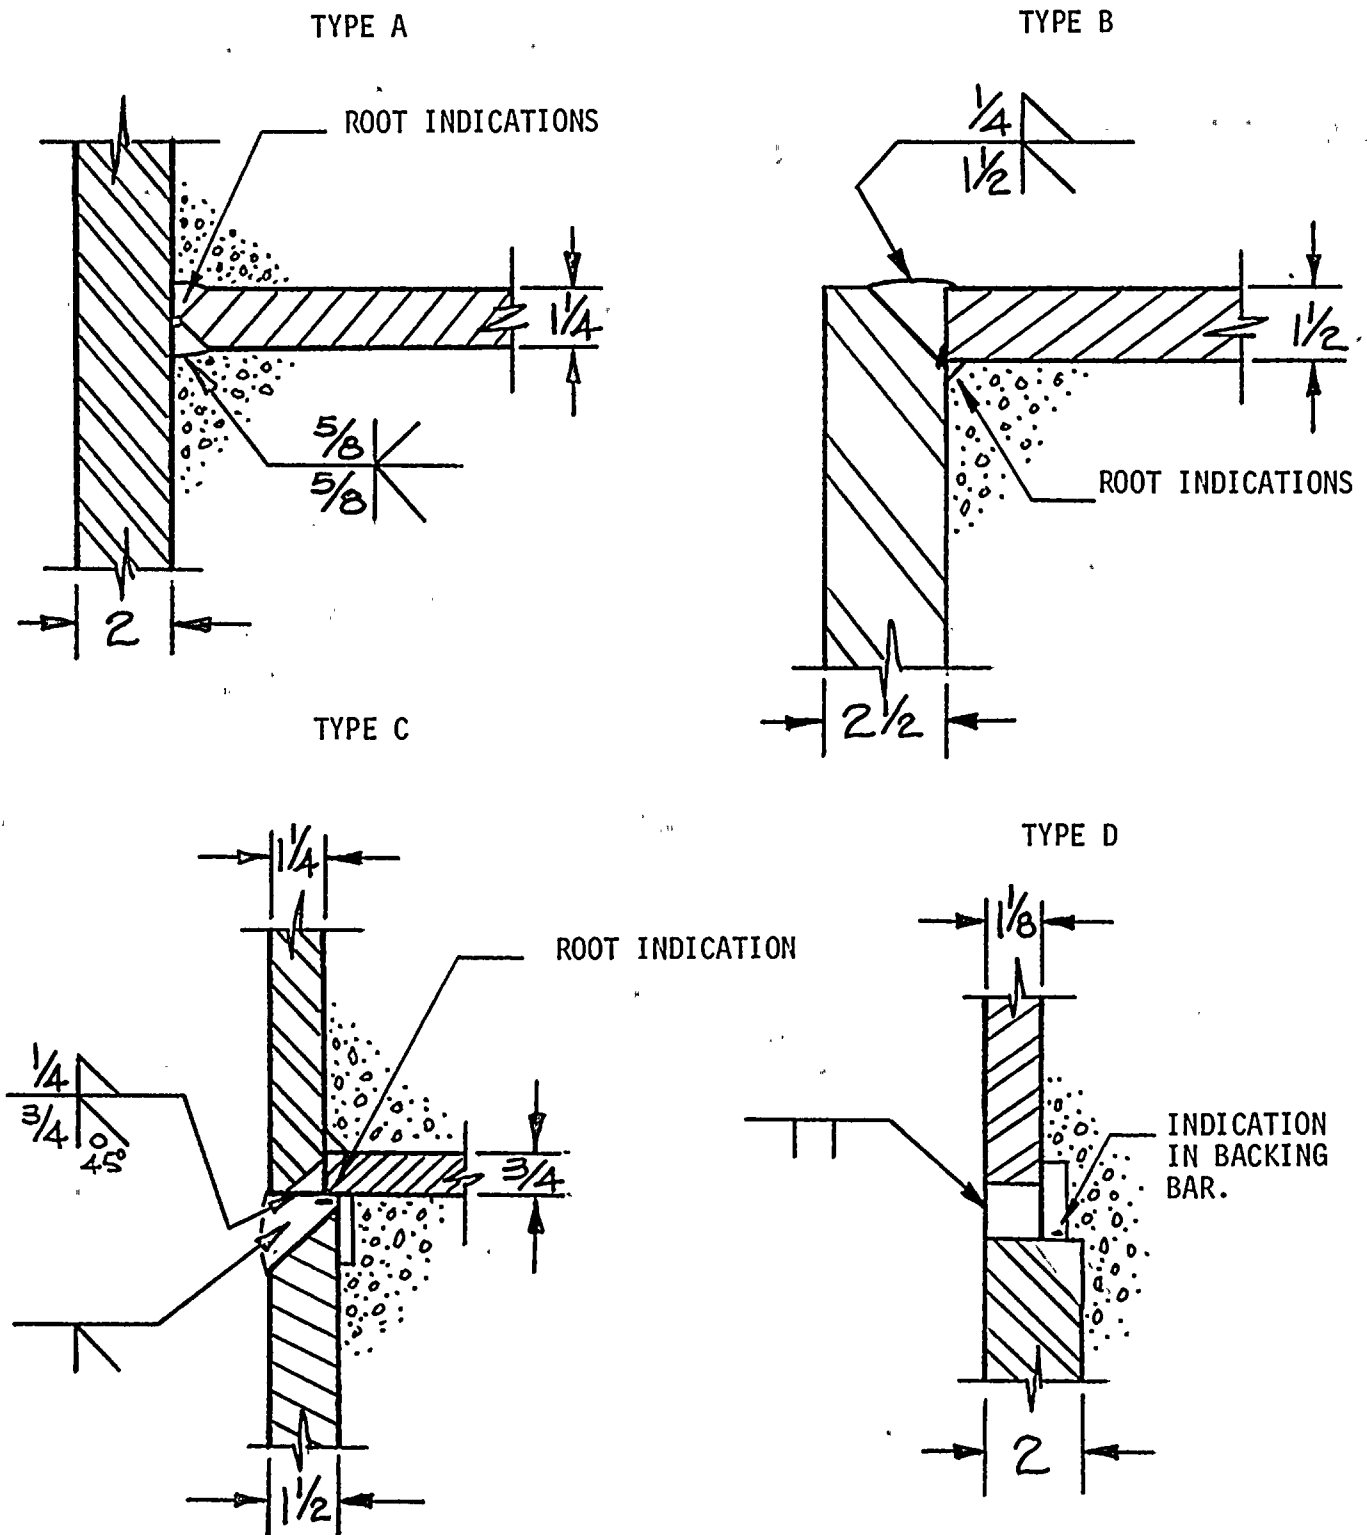
FIGURE 1

SMAW
Weld Location: E1 528' Az 330°
Type Inspection: VT, UT
Defect Description: Incomplete penetration in Type C weld. (Figure 1)

Type Inspection: VT, UT
Defect Description: Incomplete penetration in Type A weld joint. (Figure 1)

Defect Description: Incomplete penetration in
Type A weld joint (Figure 1)

Defect Description: Defect is 15" long with a DB rating of +3 which makes it a large reflector per AWS D1.1 for electroslag welds. Defect is located at 1-5/8" from the outside surface of the SSW. See weld type D (Figure 1).

Defect Description: Incomplete penetration in
Type A weld joint. (Figure 1)

Defect Inspection: Incomplete penetration in Type A
weld joint (Figure 1)

Defect Description: Incomplete penetration in
Type B weld joint. (Figure 1)

Defect Description: Incomplete penetration in Type B
weld joint (Figure 1)

Defect Description: Incomplete penetration in Type A weld joint (Figure 1)

CATEGORIES OF WELD JOINTS WHICH
CONTAIN BURIED DEFECTS, DETECTED BY UT

NOTE: STRUCTURAL ACCEPTABILITY OF THESE DEFECTS WAS DETERMINED AND REPORTED
IN REFERENCE #1.

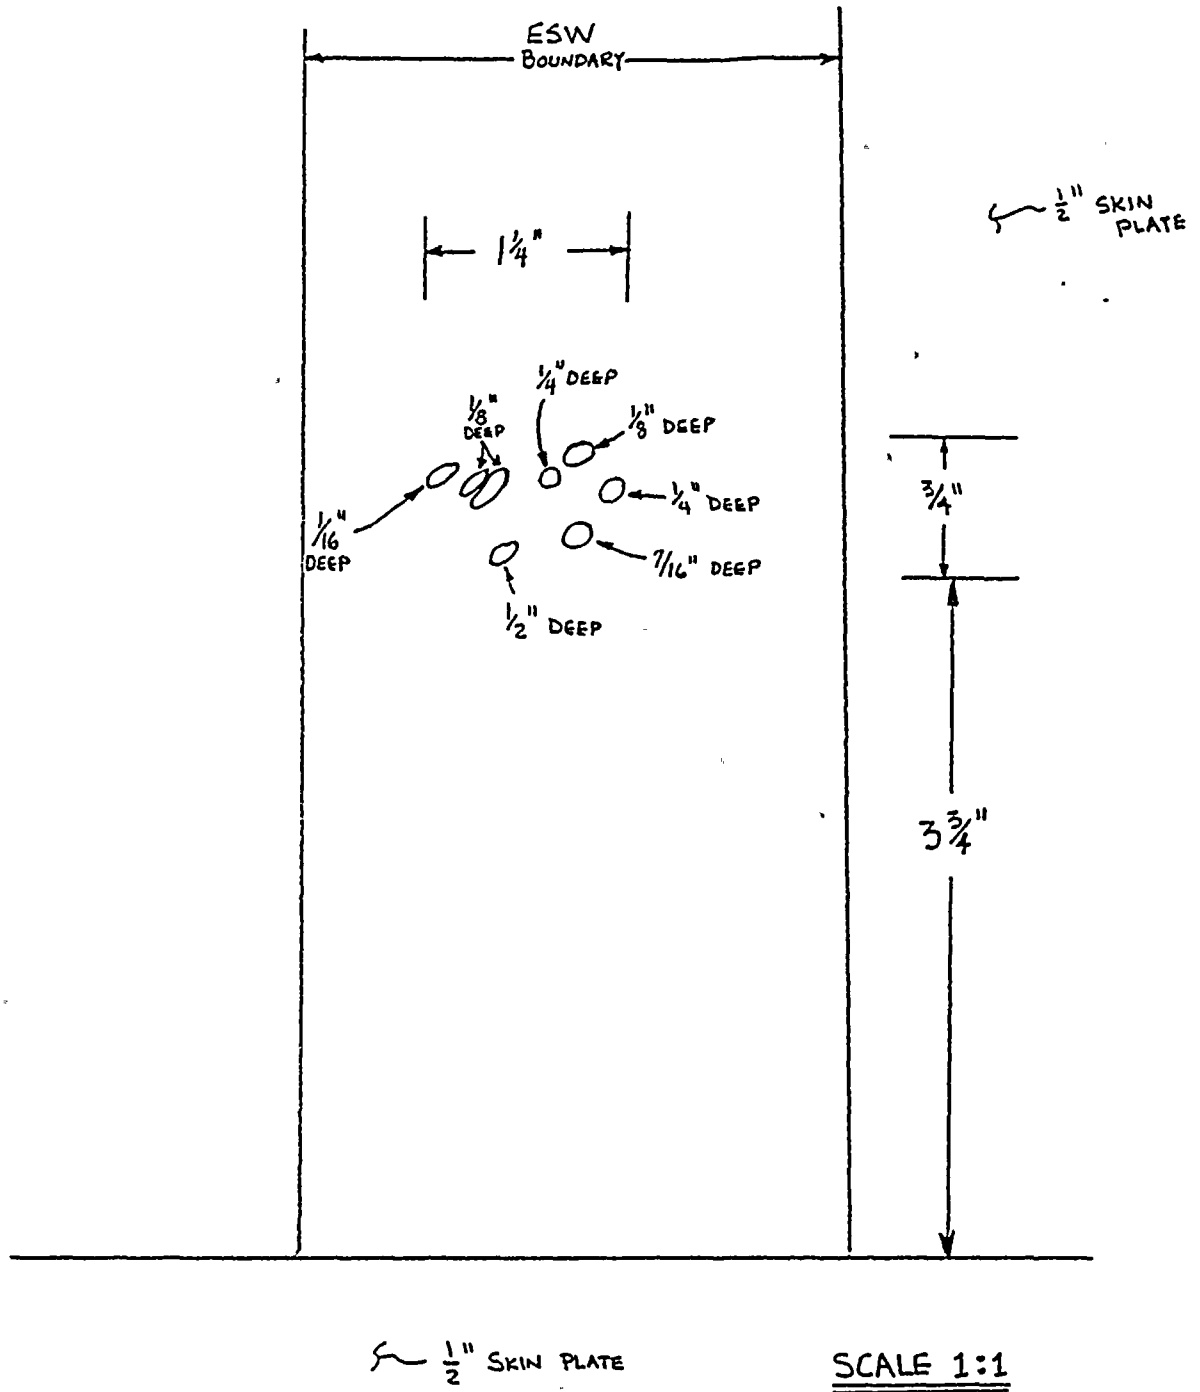
Figure 2
Porosity Detail

(2) Weld No.: W3-92 Weld Type: Electroslag Weld

Defect Description: Porosity - See figure 2 for detail.

Defective area is highly restrained per criteria of Table 1. Defective area is adjacent to skin plate fillet weld and is approximately 6-1/2" from a pipe whip restraint fillet weld. The thickness of the material at the location of the defect is 1-1/2".

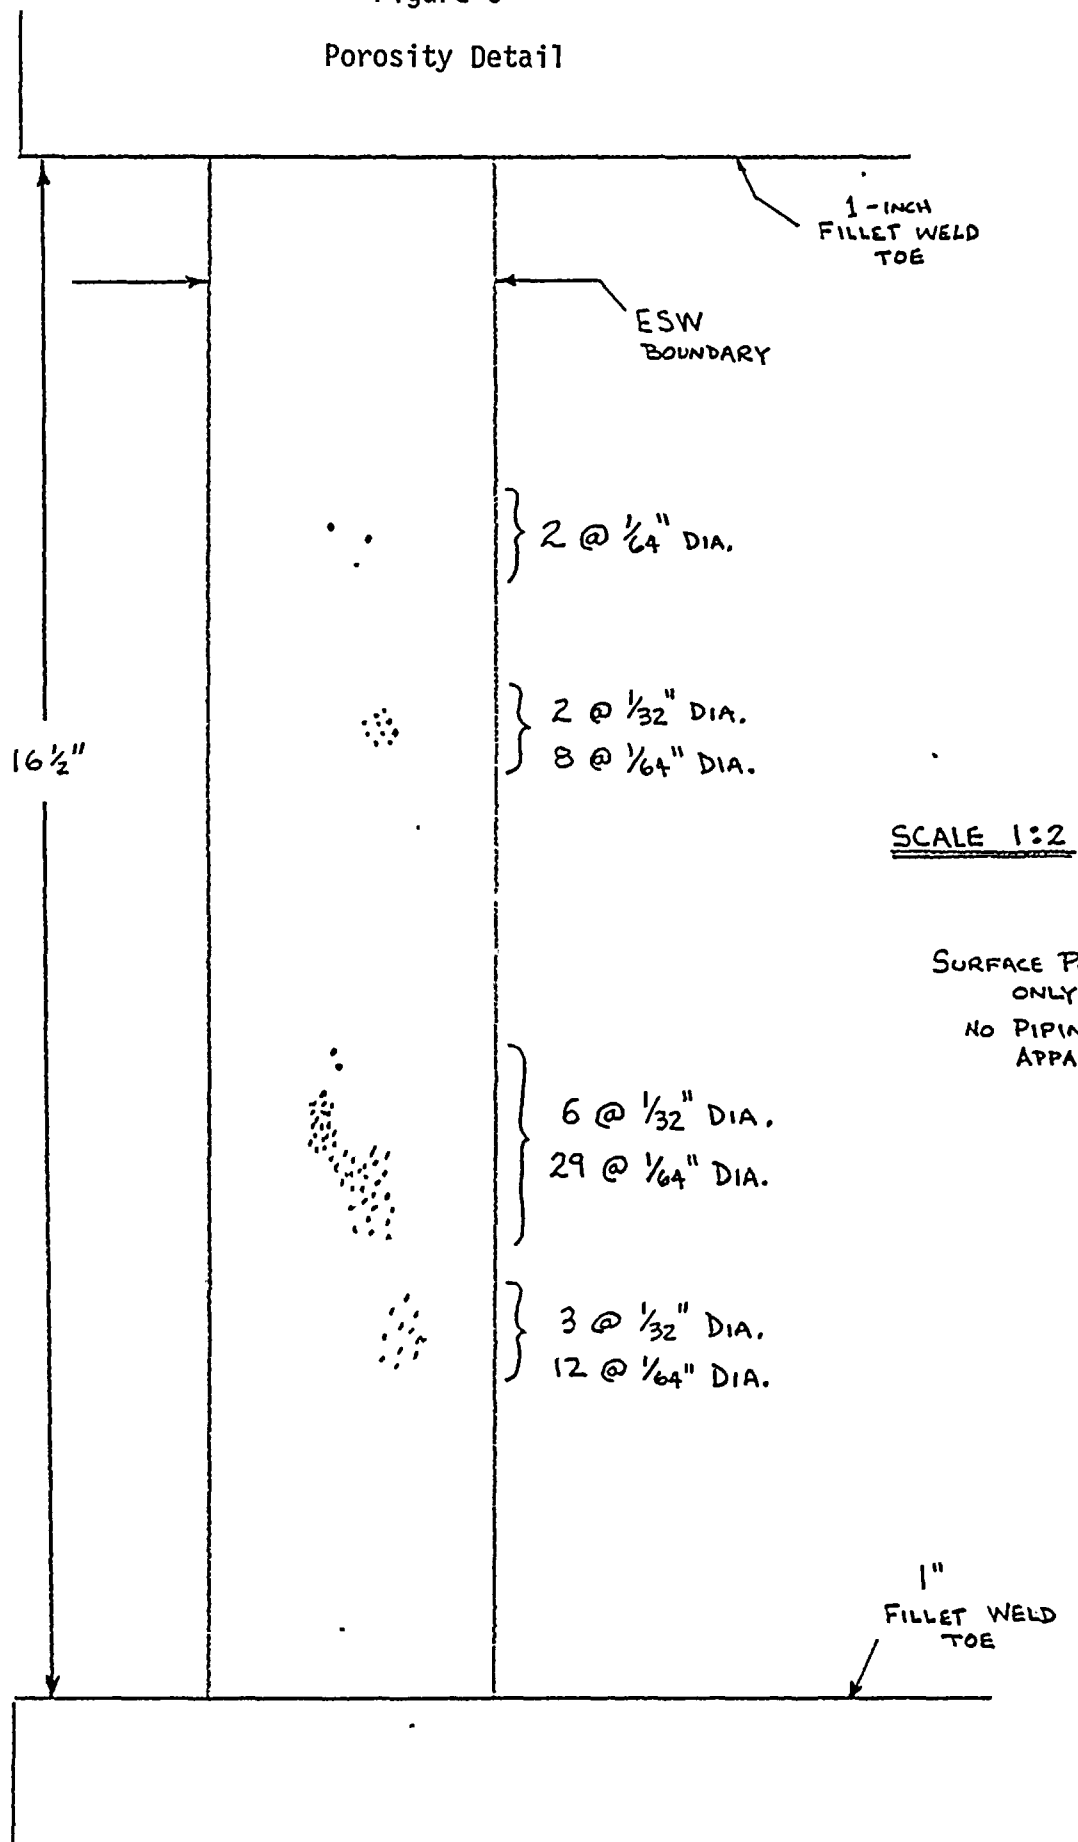
Figure 3
Porosity Detail

- (5) Weld No.: W23-24 Weld Type: Vertical Electroslag
Weld Location: E1 533' Az 160°
Type Inspection: VT
Defect Description: Porosity - See Figure 3 for detail.
Justification for Hardship:

Repair will possibly require excavation through thickness of electroslag weld to remove porosity. This will require chipping of concrete, fitting of backing plate and rewelding. Also if pores extend along length of weld, skin plates will have to be removed and weld excavated.

The nature of this defect does not warrant repair since the extensive nature of this repair increases risk of generating more serious defects.
