Supplement #3

THE FINAL SUPPLEMENT TO THE
"ENGINEERING EVALUATION OF THE WNP-2
SACRIFICIAL SHIELD WALL" SUBMITTED TO NRC
IN AUGUST 1980

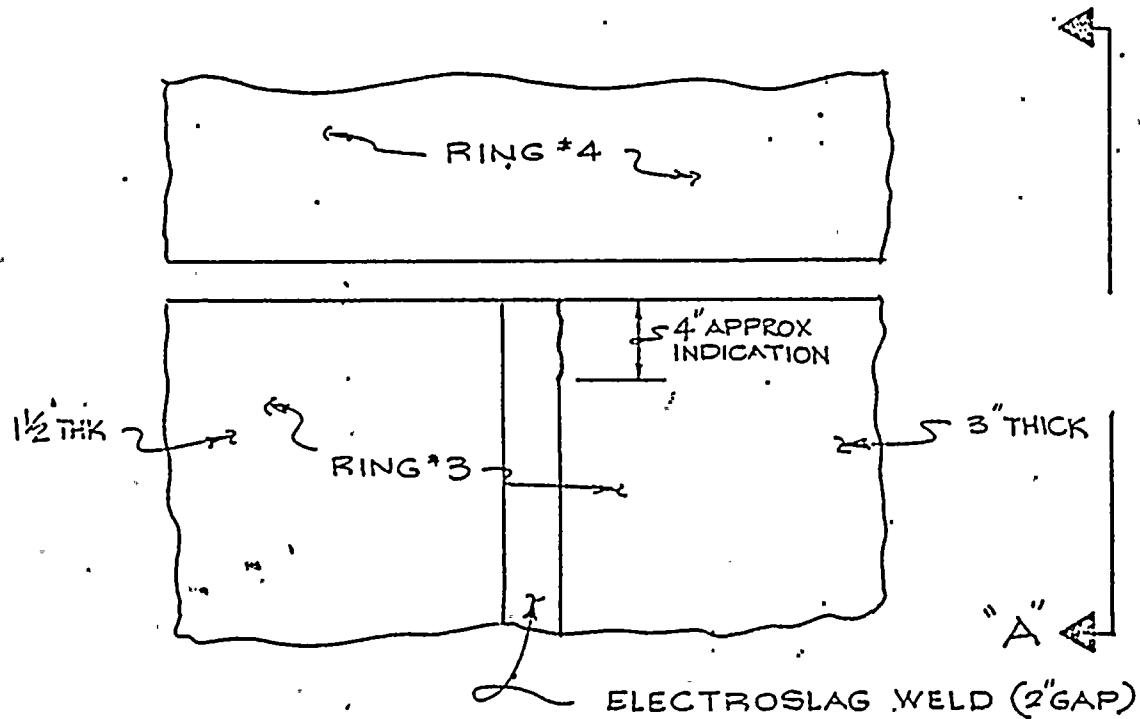
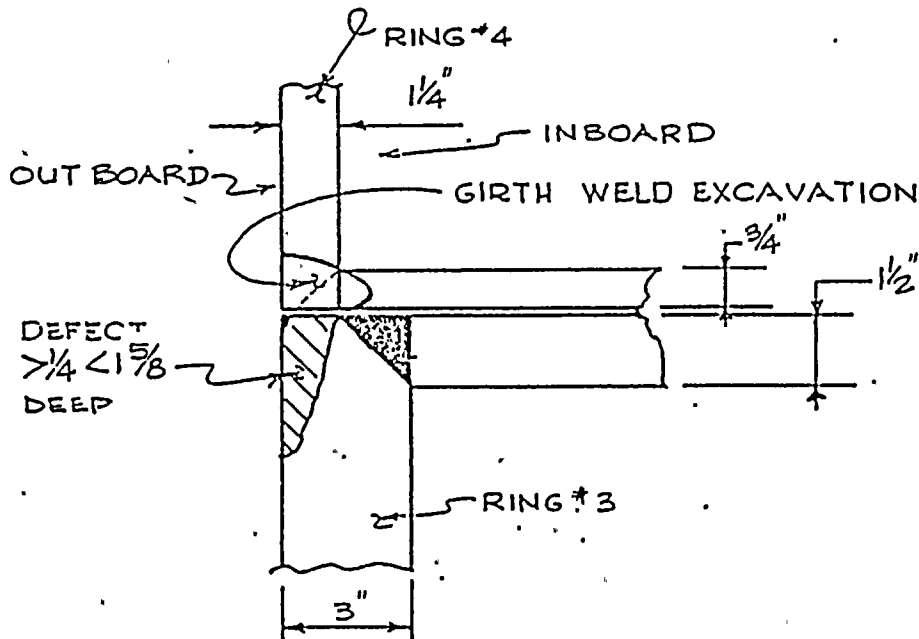
FIG 1. LINEAR INDICATION IN RING 3 AT 135°-150° AZ

- (i) Linear indications in electrosag welds were discovered adjacent to the girth weld. Details of this deficiency are given in Figures 1 and 2. This deficiency was detected in two of the thirty-two electrosag welds in ring #3 which intersect the girth weld.
- (ii) Linear indications, slag inclusions and porosity were discovered in guide plate welds (see Figure 3).
- (iii) Lack of penetration existed at the weld joint between the bottom flange of ring beam #4 and the exterior web plate. Details of this deficiency are shown in Figure 4. For further discussion and clarification see Part 5.
- (iv) Linear indications in the girth weld excavation probably resulted from the repair of deficiency (iii) above.

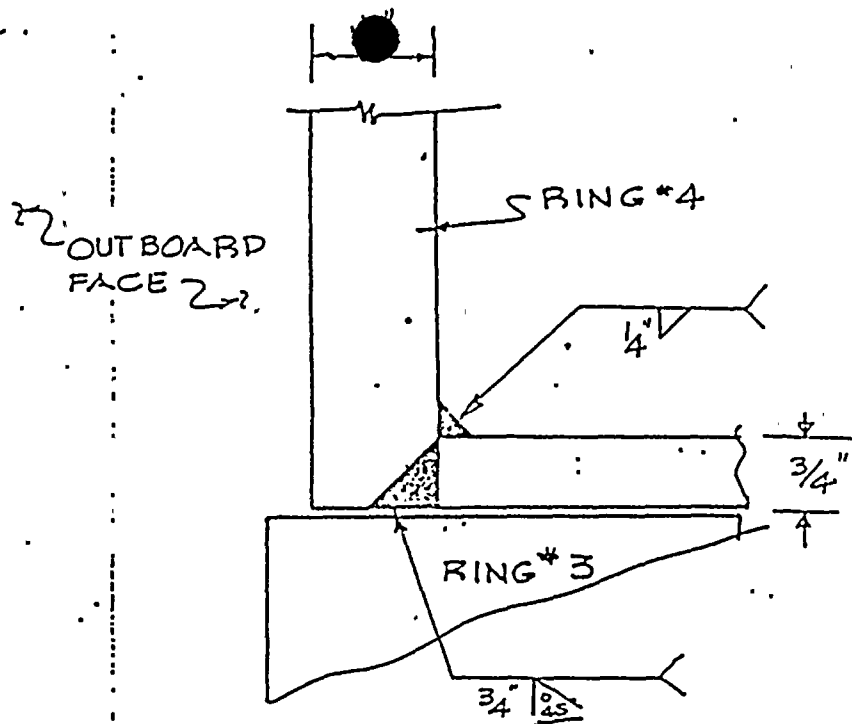
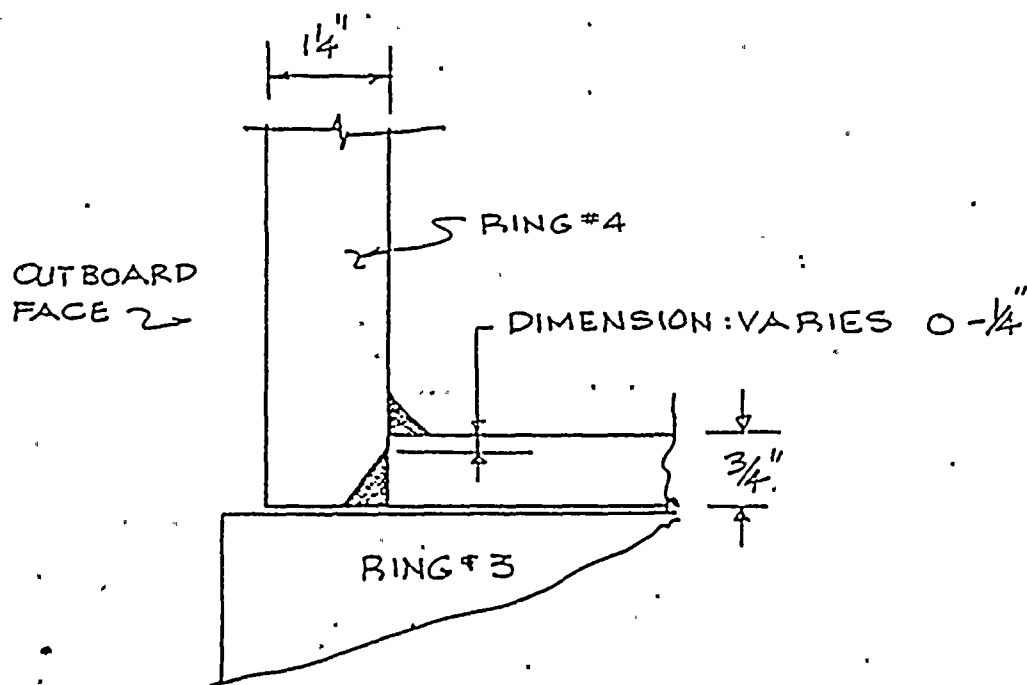
FIG. 4. LACK OF PENETRATION AT AZ. 90°-105°, 0°-15° AND 180°-195°.

B: AS-BUILT CONDITION AT AZ. 90°-105°, 0°-15°, AND 180°-195°.
