Supplement #3

THE FINAL SUPPLEMENT TO THE
"ENGINEERING EVALUATION OF THE WNP-2
SACRIFICIAL SHIELD WALL" SUBMITTED TO NRC
IN AUGUST 1980

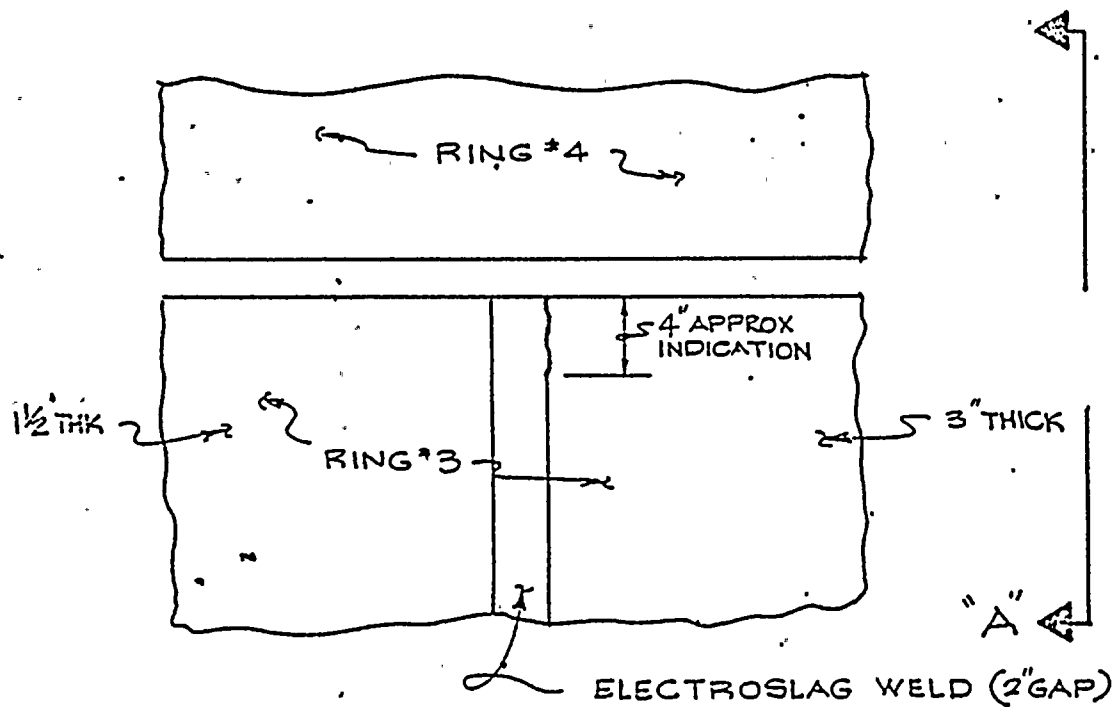
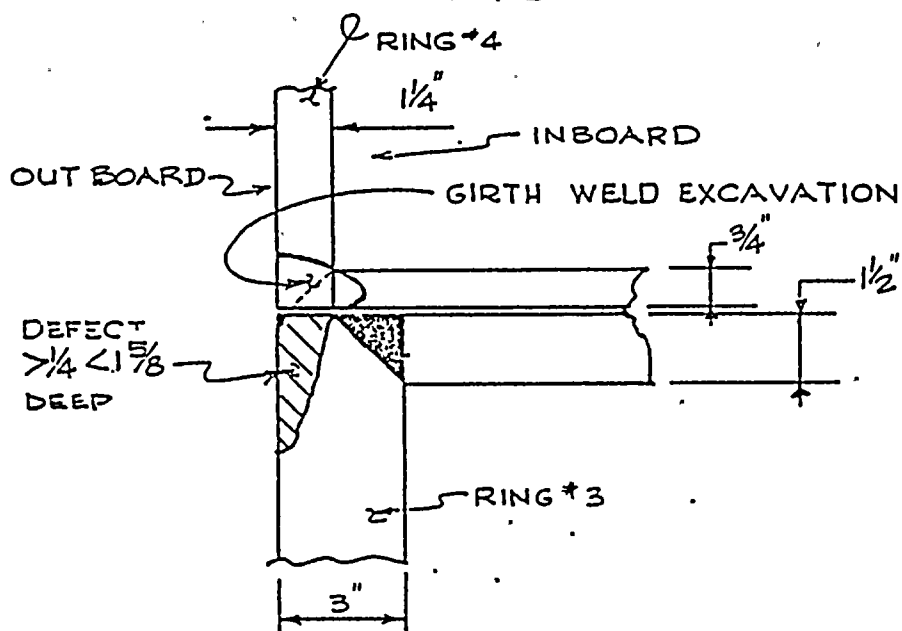
FIG 1. LINEAR INDICATION IN RING 3 AT 135°-150° AZ

- (i) Linear indications in electrosag welds were discovered adjacent to the girth weld. Details of this deficiency are given in Figures 1 and 2. This deficiency was detected in two of the thirty-two electrosag welds in ring #3 which intersect the girth weld.
- (ii) Linear indications, slag inclusions and porosity were discovered in guide plate welds (see Figure 3).
- (iii) Lack of penetration existed at the weld joint between the bottom flange of ring beam #4 and the exterior web plate. Details of this deficiency are shown in Figure 4. For further discussion and clarification see Part 5.
- (iv) Linear indications in the girth weld excavation probably resulted from the repair of deficiency (iii) above.

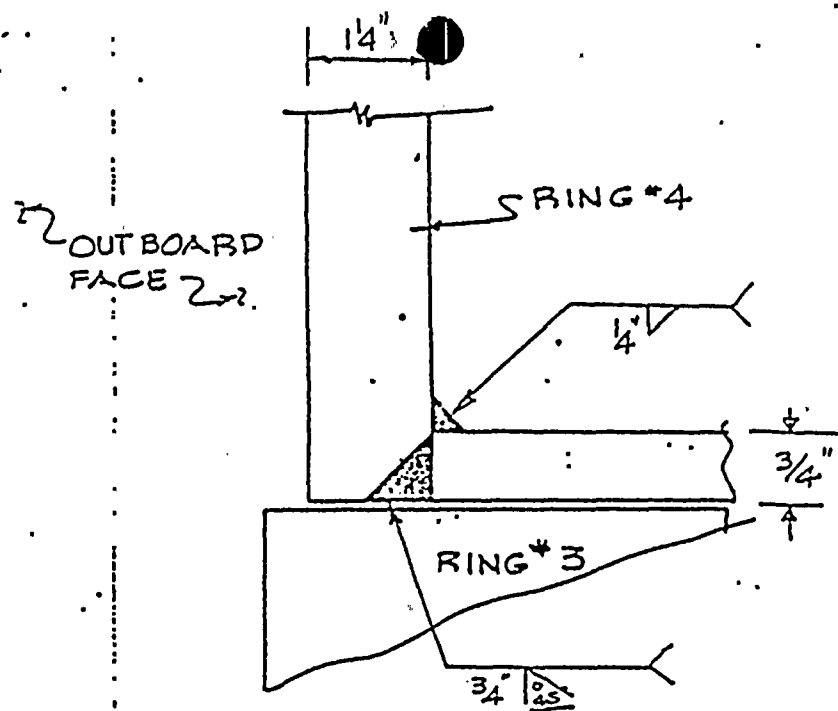
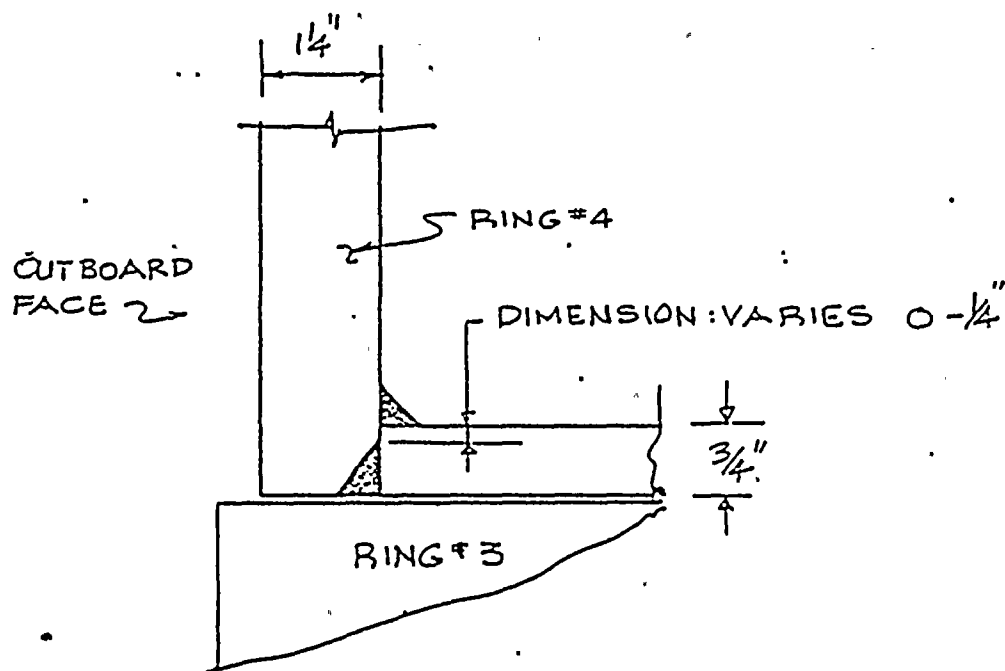
FIG. 4. LACK OF PENETRATION AT AZ. 90°-105°, 0°-15°, AND 180°-195°.

B: AS-BUILT CONDITION AT AZ. 90°-105°, 0°-15°, AND 180°-195°.
