RESPONSE TO
NRC HUMAN FACTORS ENGINEERING
PRELIMINARY DESIGN ASSESSMENT AUDIT
REPORT OF AUGUST 26, 1983

WASHINGTON PUBLIC POWER SUPPLY SYSTEM
NUCLEAR PROJECT NO. 2 (WNP-2)

October 7, 1983

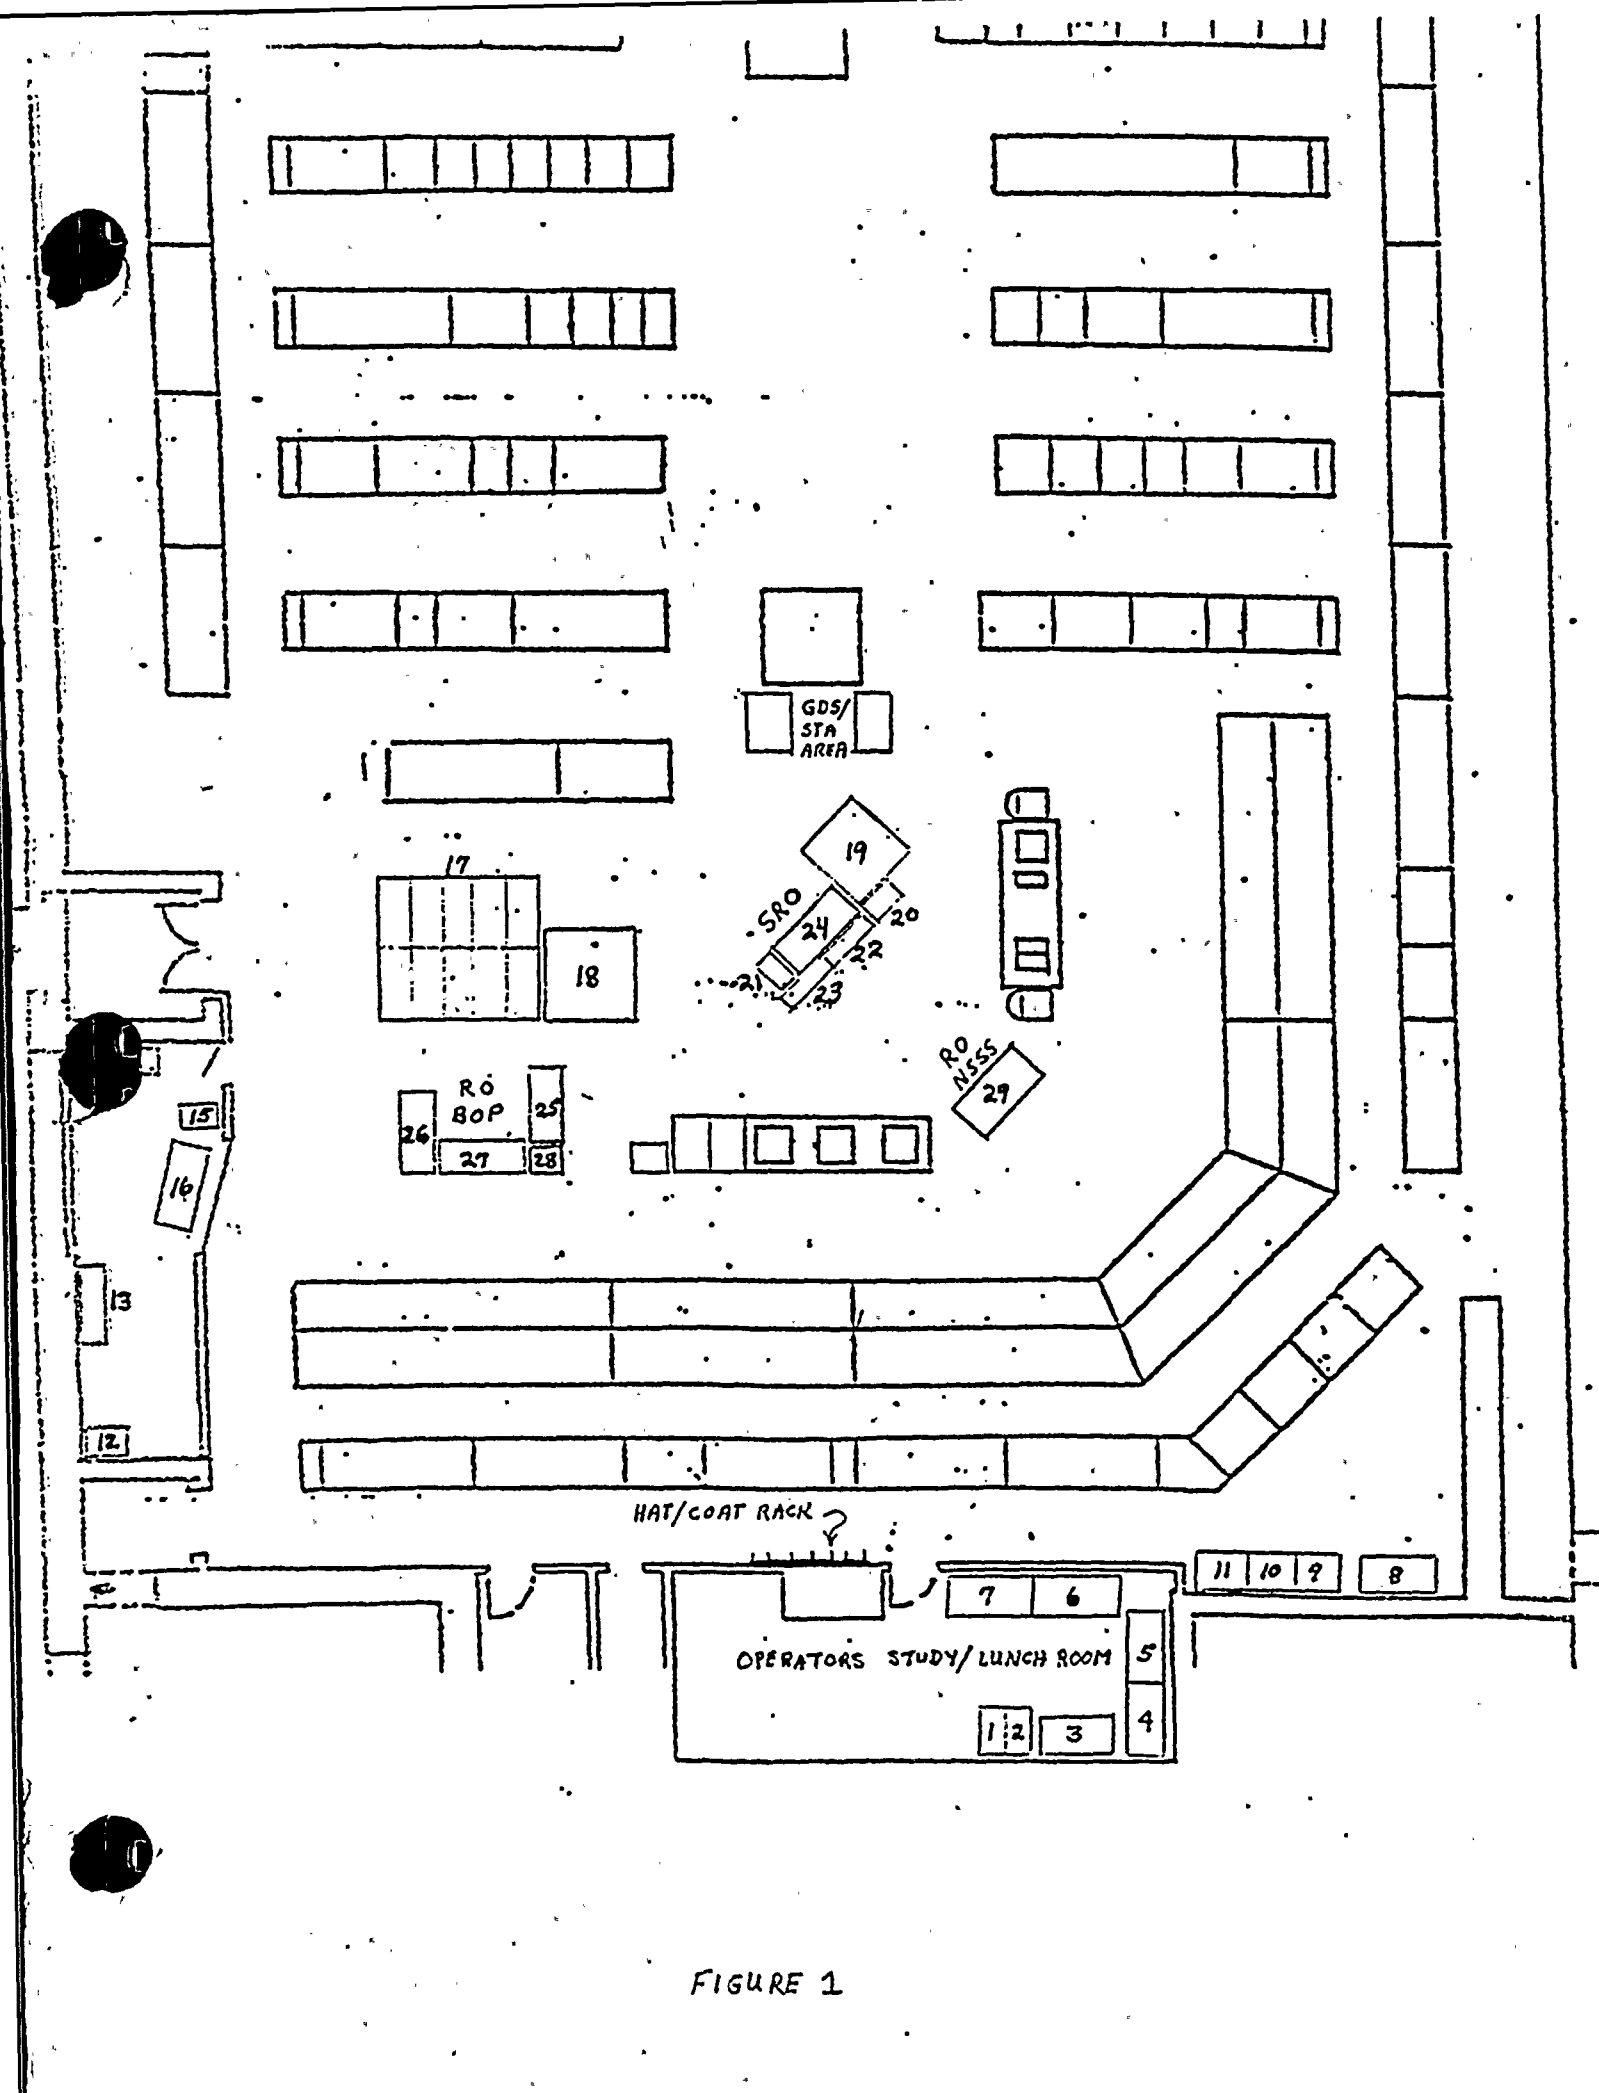
FIGURE 1

Control room furnishings and equipment were not completely installed. Adequacy of furnishings, obstacles to operator movement, and presence of unnecessary furnishings and equipment could not be evaluated.

RESPONSE: The control room primary operating area has been essentially arranged in its final configuration (see Figure 1). Two concerns were noted:

1. Access to print table (item 18) was poor for the senior RO and NSSS operator. The print files (item 17) and the print table were reversed in sequence. This provides improved access and also improved visibility for the BOP operator from his desk to Panel P851 (Board S).
2. The two black and white CRTs located between the senior RO and Panel P601 are at such a height that the senior RO's view is partially obstructed. See NRC Finding D-7.3 for response on this item.

With the above changes, furnishings appear adequate; operator movement is unobstructed within their areas of responsibility; communications is adequate at all work stations; procedures are readily accessible from a central location; operator visibility from their respective work stations to the panels is unobstructed, including from the shift manager's office; and access to emergency equipment and spare parts is adequate. In general, the arrangement provides a functional control room for both normal and abnormal operation.

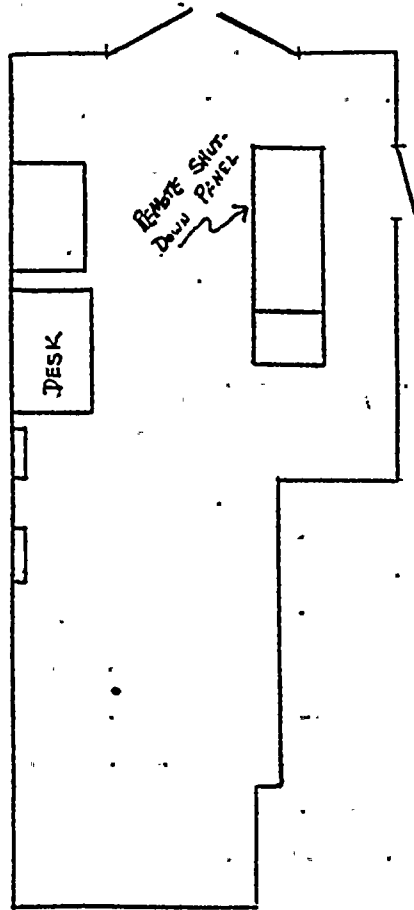
REMOTE SHUT DOWN ROOM LAYOUT

RESPONSE: Document organization and storage provisions will be in their final form prior to fuel load. See Figures 1 and 2 for proposed layout. The desk located in the Remote Shutdown Room will contain required procedures, spare parts, and communications equipment. Document organization within the bookcases will be reviewed prior to fuel load.
