DESIGN ENGINEERING REPORT

WNP-2 FEEDWATER PIPING THERMAL DEFLECTION EVENTS

Washington Public Power Supply System Nuclear Plant No. 2

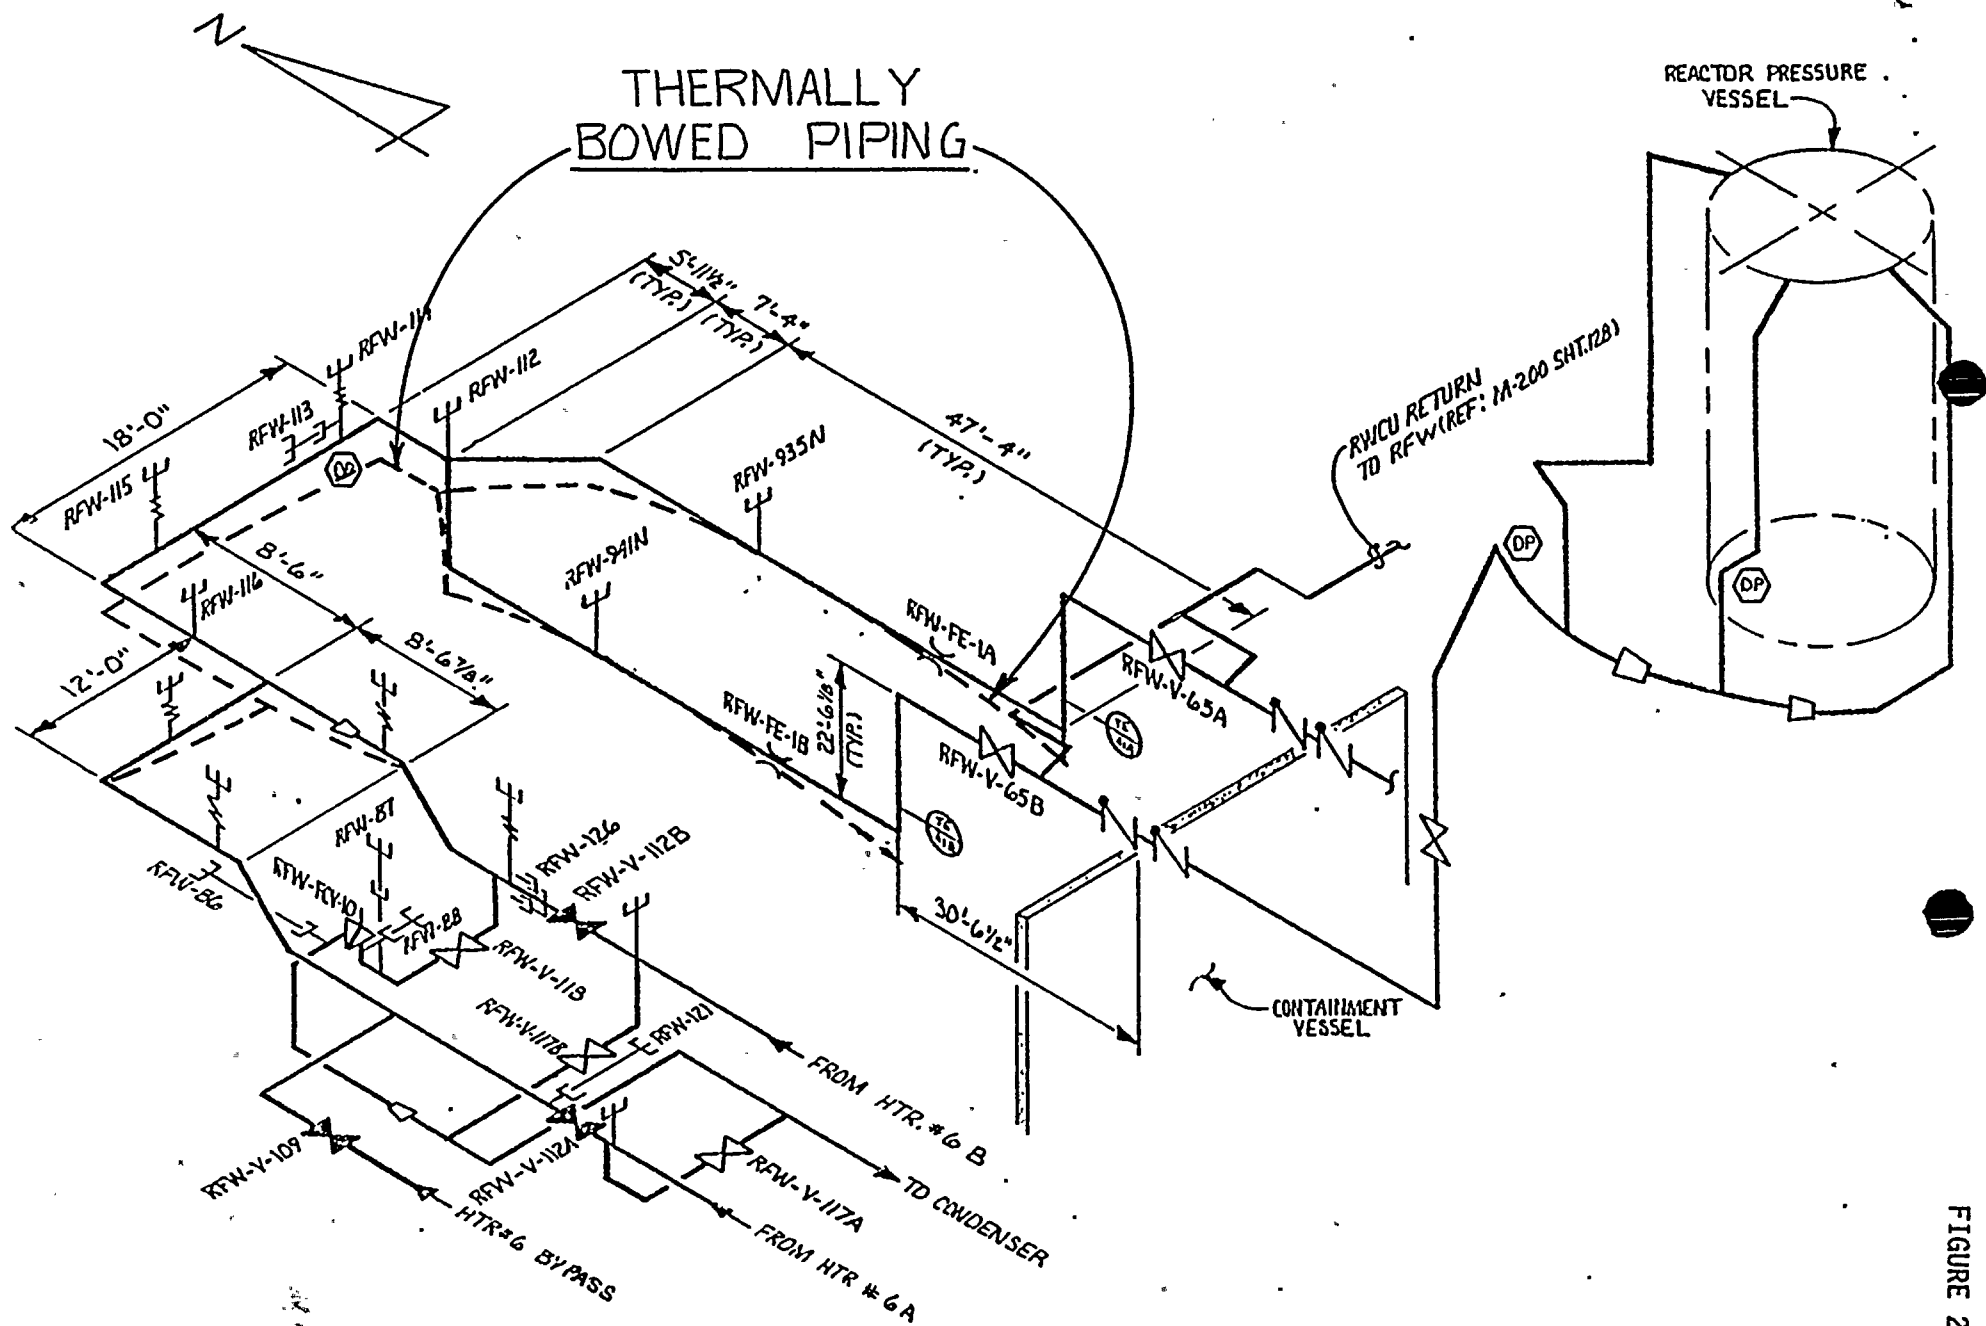
FIGURE 2

Pipe support damage was determined to have been the result of very high loads and displacements at the support locations. Traditional methods used to evaluate thermal expansion and/or water hammer effects do not predict sufficient displacement to cause the observed failures. Rather, it was found that large top to bottom temperature gradients in a long horizontal run of piping were the cause of the large displacements. Temperature differences of up to 200°F were measured between the top and bottom of the pipe with the higher temperature being on top. Thermal expansion of the top of the pipe exceeds that of the bottom resulting in the pipe assuming a bowed down shape with several inches of unrestrained vertical displacement at the endpoints of the horizontal run. Displacements in excess of support capability occurred at several locations. Figure 1 shows the general piping arrangement and Figure 2 illustrates the concept of bowing as described above.

Conditions as described above can occur in a variety of ways, an example of which is startup from a hot shutdown condition. In addition, the same effect can be generated by injecting hot Reactor Water Cleanup (RWCU) into a cold RFW pipe. The hot water stratifies at the top of the pipe, the colder water is displaced to the bottom and the horizontal piping run thermally expands to a bowed down shape.

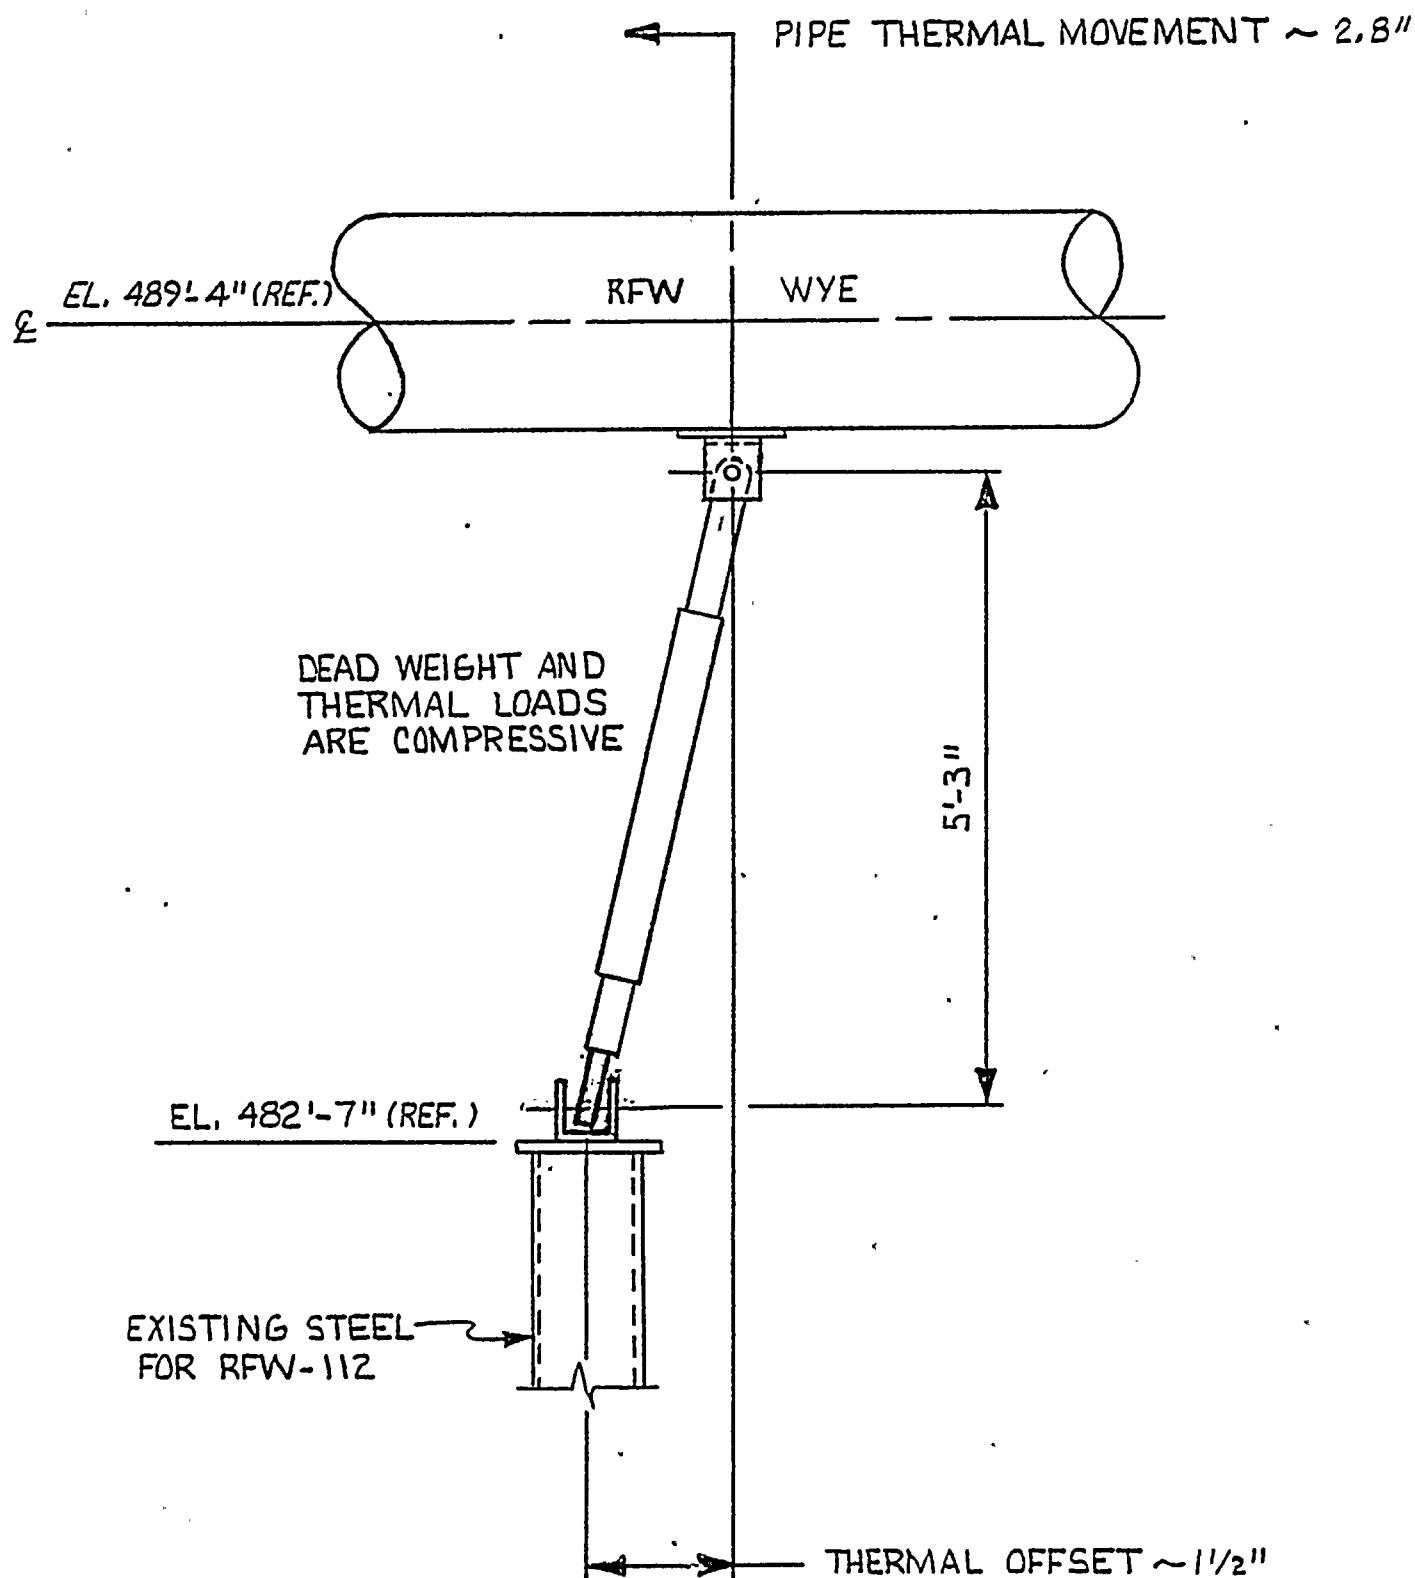
FIGURE 3

On June 20, with the reactor in hot standby, hanger RFW-112 was found buckled. The immediate cause of the failure was uncertain and a thorough inspection of adjacent hangers and piping was completed while looking for clues. No other damaged hangers or snubbers were found and no evidence of pipe movement could be found at points where the RFW piping insulation was in close proximity or touching adjacent structures or piping. Although initially suspected, it was therefore concluded that water hammer was not the mechanism which caused the failure. Further examination of the damaged strut revealed gouging marks on the attachment, or paddle ends. This evidence was combined with a review of the piping thermal movements, reactive loads, and the general design concept of hanger RFW-112. The conclusion was that failure resulted from excessive preload on the strut combined with paddle binding within its attachment end brackets as the piping system was thermally expanding in the plane of the long horizontal pipe runs. (See Figure 3) To help confirm this conclusion, motion detectors were installed in the vicinity of hanger RFW-112 and signals routed to a recorder.

THERMAL OFFSET OF RFW-112

As a result of the buckled strut, analyses were performed to verify the design basis analysis and pressure boundary integrity. These analyses found no anomalies and that the piping system was unaffected by the event. The buckled strut was removed and replaced with a similar strut. Re-alignment of the system to its original position was easily achieved, which supported analysis conclusions that the piping system (pressure boundary) was unaffected by the thermal transient. To preclude reoccurrence of hanger RFW-112 failure, the deadweight compressive load was relieved from the strut by minor adjustment of adjacent spring hangers. By removing the deadweight preload, the potential for strut binding was judged to be mitigated and enhanced freedom of movement for the large thermal movement (approximately 2.6 inches) would thus be attained. This action was considered adequate while the Supply System's Stress Group reanalyzed this anchor group in an effort to totally eliminate hanger RFW-112. This work was prompted by the analysis conclusion that hanger RFW-112, as originally designed, was a marginal concept for supporting the piping deadweight load. Specifically, utilization of a bottom mounted, compressively loaded, slender sway strut which incorporated large offsets to accommodate thermal movements was deemed not advisable, see Figure 3. Finally, it should be noted that it was not BRI's design practice to utilize sway struts as primary compressive elements with large imposed thermal movements, and as such hanger RFW-112 was essentially unique in the plant pipe support design.

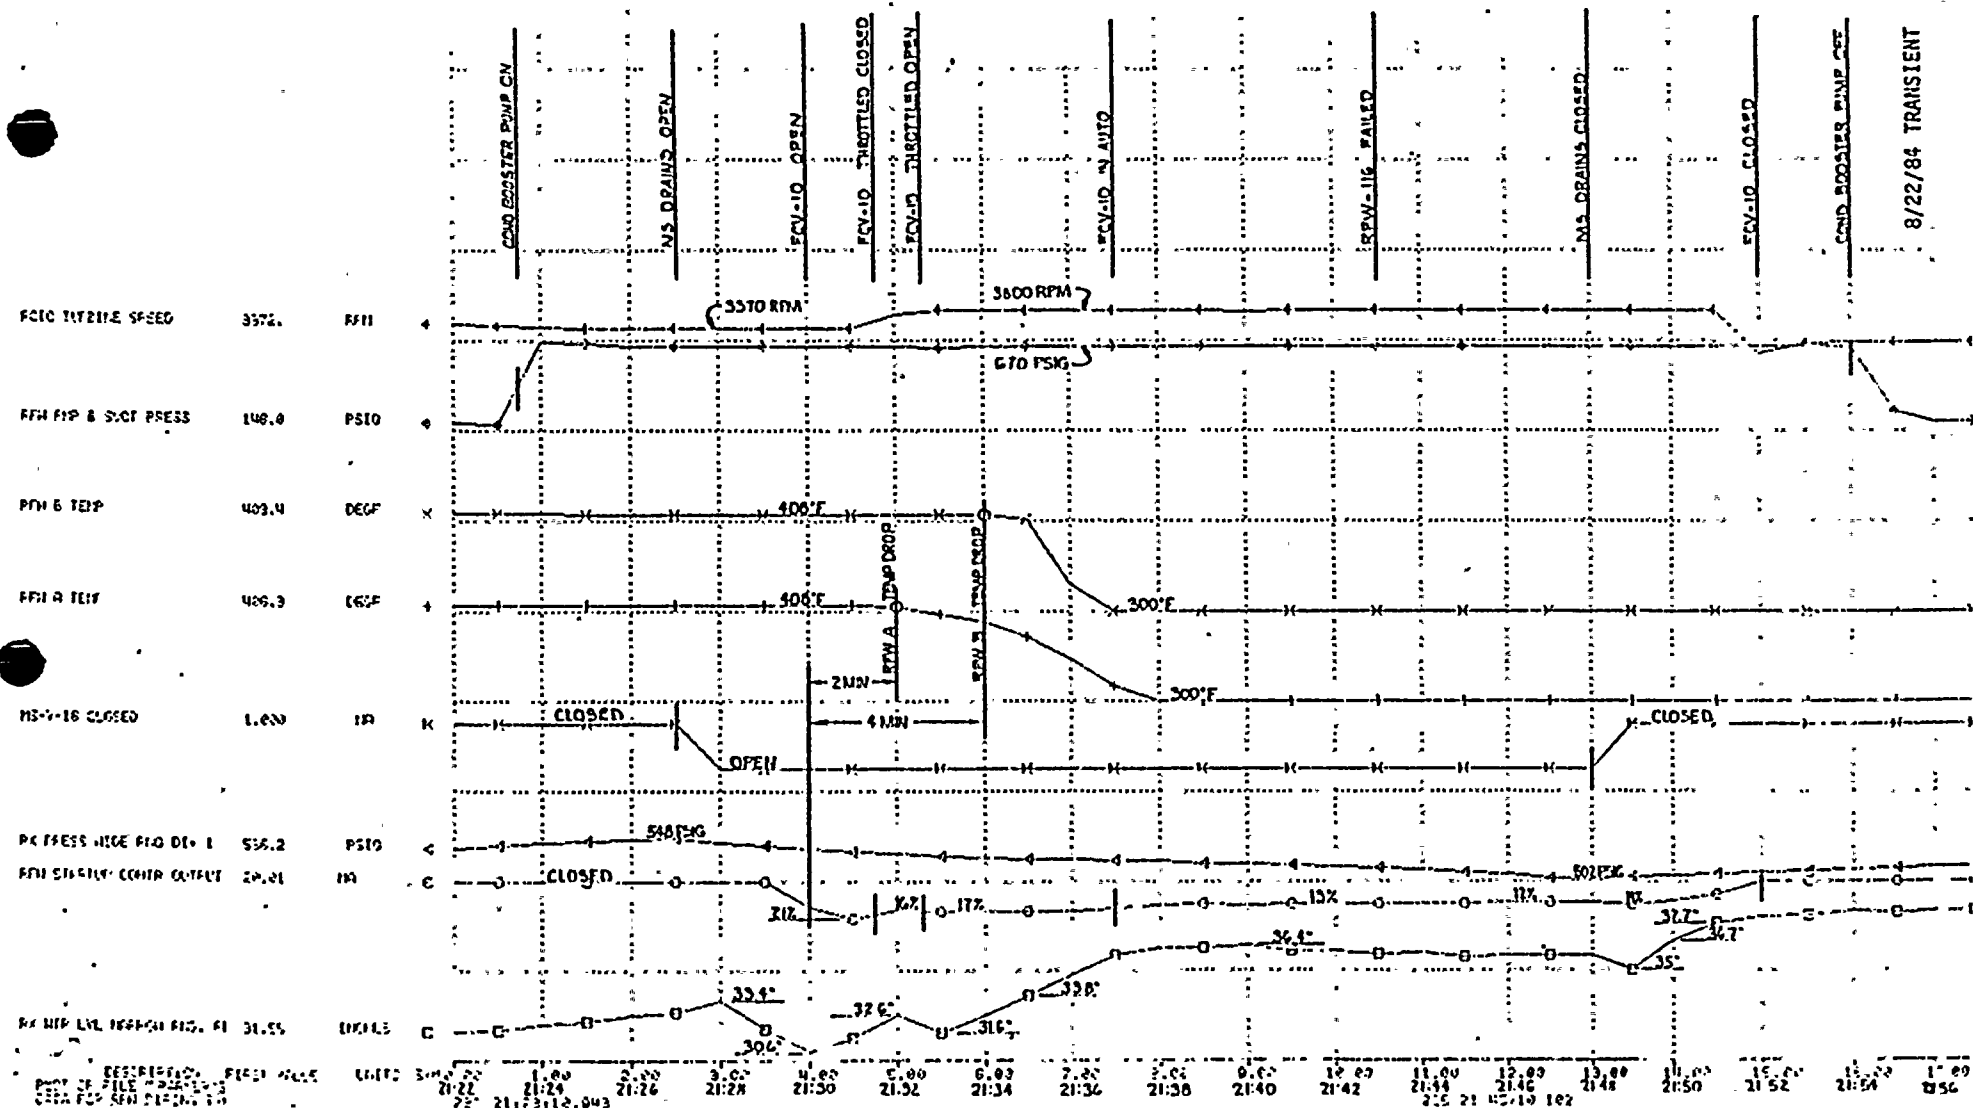
FIGURE 4

The following summarizes significant events leading up to and following the failure of several feedwater piping supports on Wednesday, August 22, 1984. The plant had previously been operating at about 60% power and was shutdown during testing. Attempts to restart were delayed pending resolution of high conductivity in the condensate system. For approximately five days the reactor was held in hot standby (approximately 1% power) with RWCU being returned to the vessel via the RFW piping. The condensate and RFW systems were completely shutdown. Refer to Figure 4 for graphic representation of pertinent data.

21:45*	Hanger RFW-116 pulled from the ceiling, hanger RFW-114 attachment welds failed, and hanger RFW-112 was observed buckled.
	21:48*	Flanges on the flow straightening sections began leaking. (3 of 4 sets)

The plant personnel who observed hanger RFW-116 pulling from the ceiling reported that a dull thud was heard as concrete was falling. However, no loud bangs or rapid piping movements associated with classical water hammer were evident.

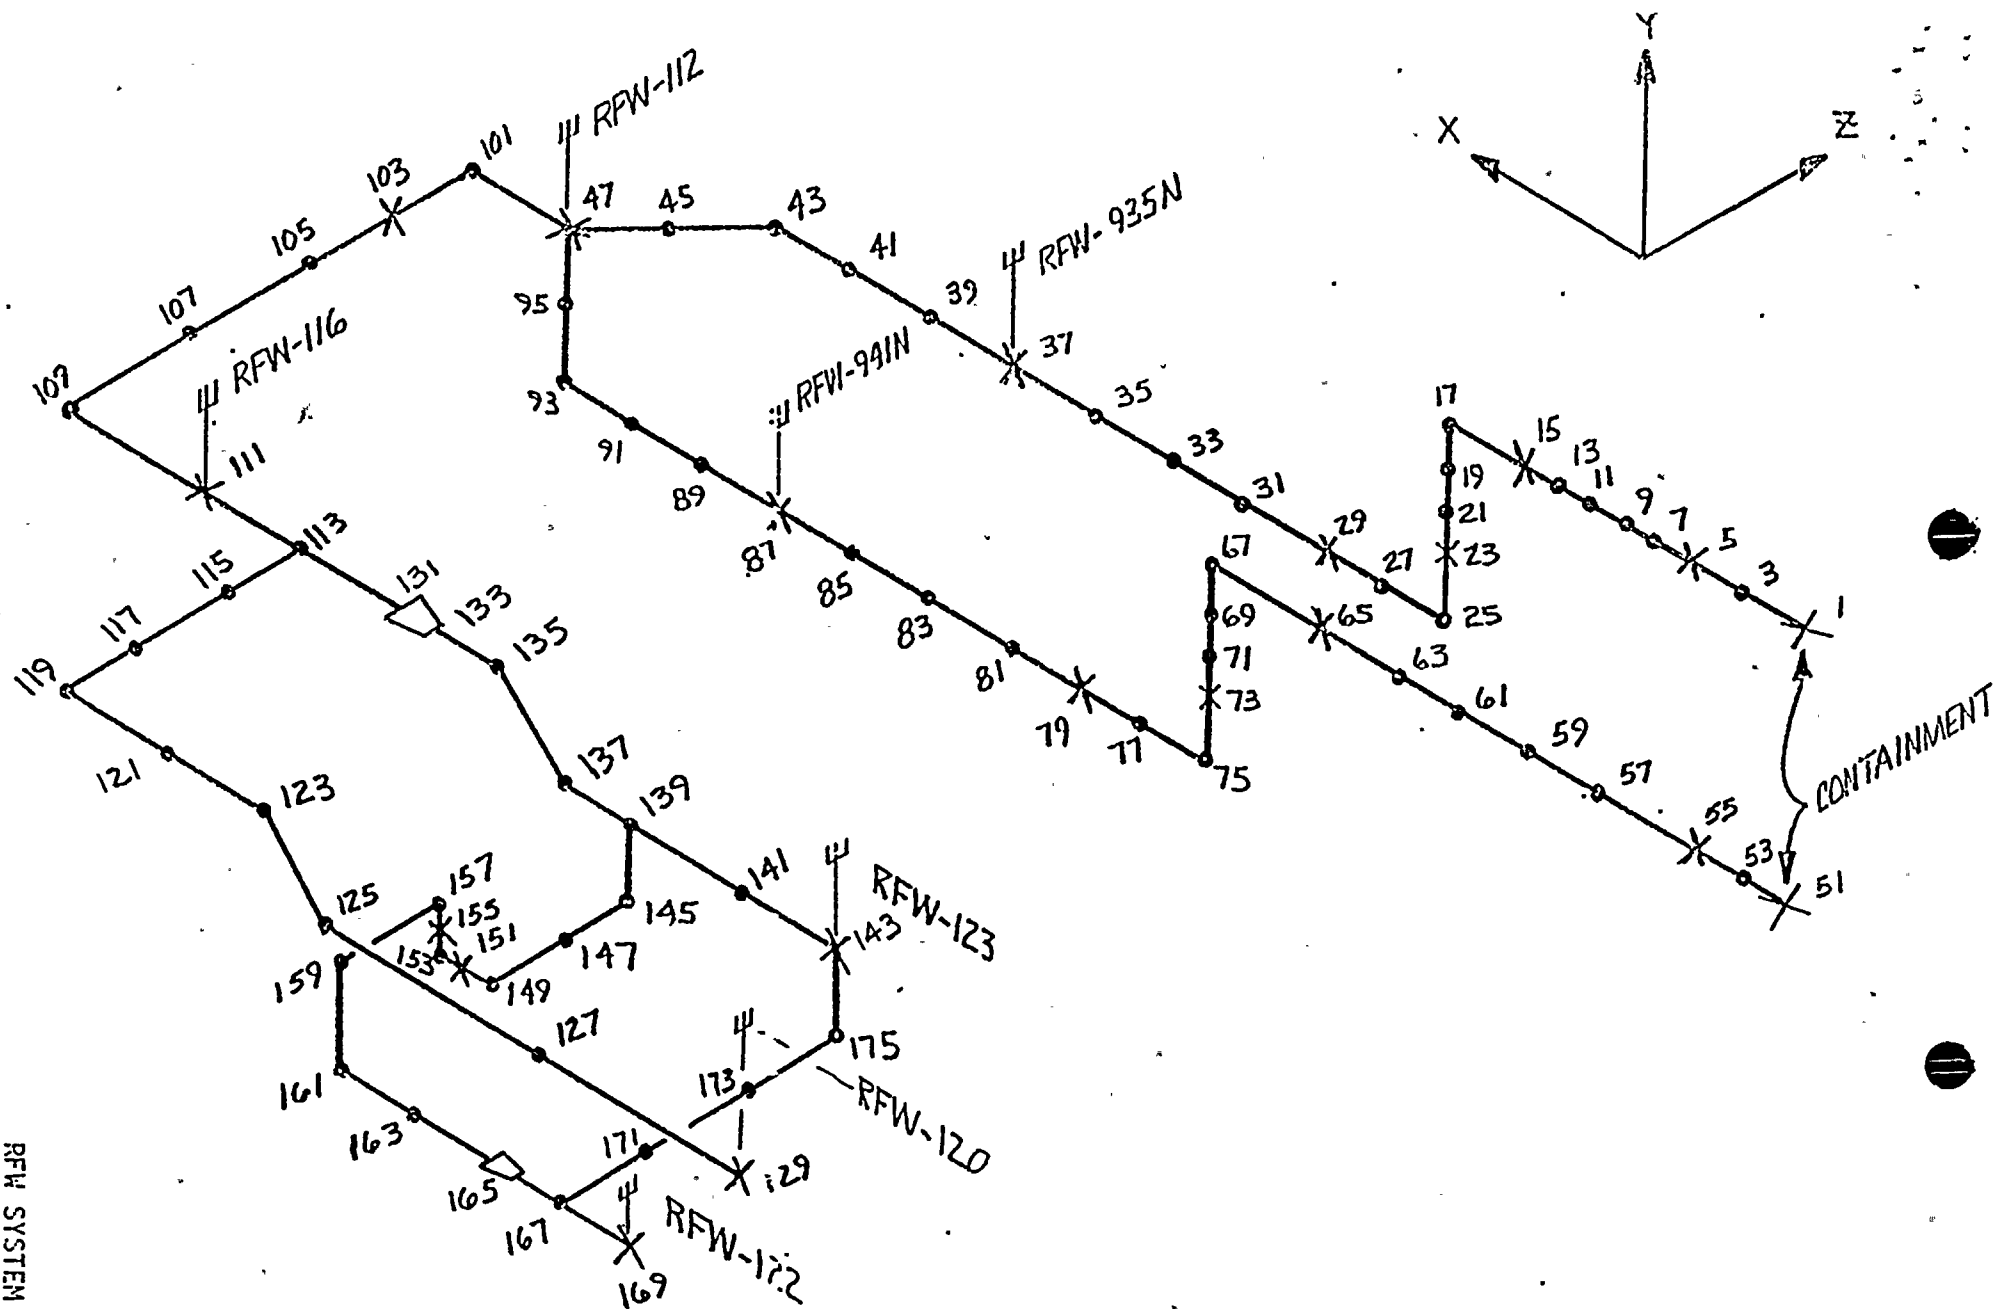
Since ADLPIPE cannot evaluate thermal bowing gradients an ANSYS finite element model was generated. The model utilizes ANSYS "Stiff-4" beam elements with equivalent piping section properties. The Stiff-4 element will accept cross sectional or top-to-bottom thermal variations. The piping system was nodalized into approximately five foot long sections and truncated at the rigid vertical supports upstream of RFW-116, see Figure 5. The ANSYS model was checked against the ADLPIPE model by repeating load Case A from Table 2. The reaction loads computed by ANSYS compared very favorably with the the ADLPIPE results. Therefore, the ANSYS model approximation was proved sufficiently accurate for the thermal bowing studies.

Table 3 summarizes the thermal bowing load cases. These results include no deadweight loads. However, the deadweight reactions can be obtained from the ADLPIPE analyses (e.g. 15 kips at RFW-112). A survey of the results revealed that load Case 5 yields thermal loads of sufficient magnitude to cause buckling of RFW-112. This load case imposed thermal gradients ($\Delta T = 300^{\circ}\text{F}$) over the region from the wye downstream to the elbows at the entrance to the steam tunnel (nodes 47 to 75 or 25, see Figure 5). Load Case 7 revealed that with RFW-112 removed (or failed) and the same worst case thermal loading imposed, sufficient load was then applied to cause failure of RFW-116 (i.e. 72 kips plus 17 kips dead load).

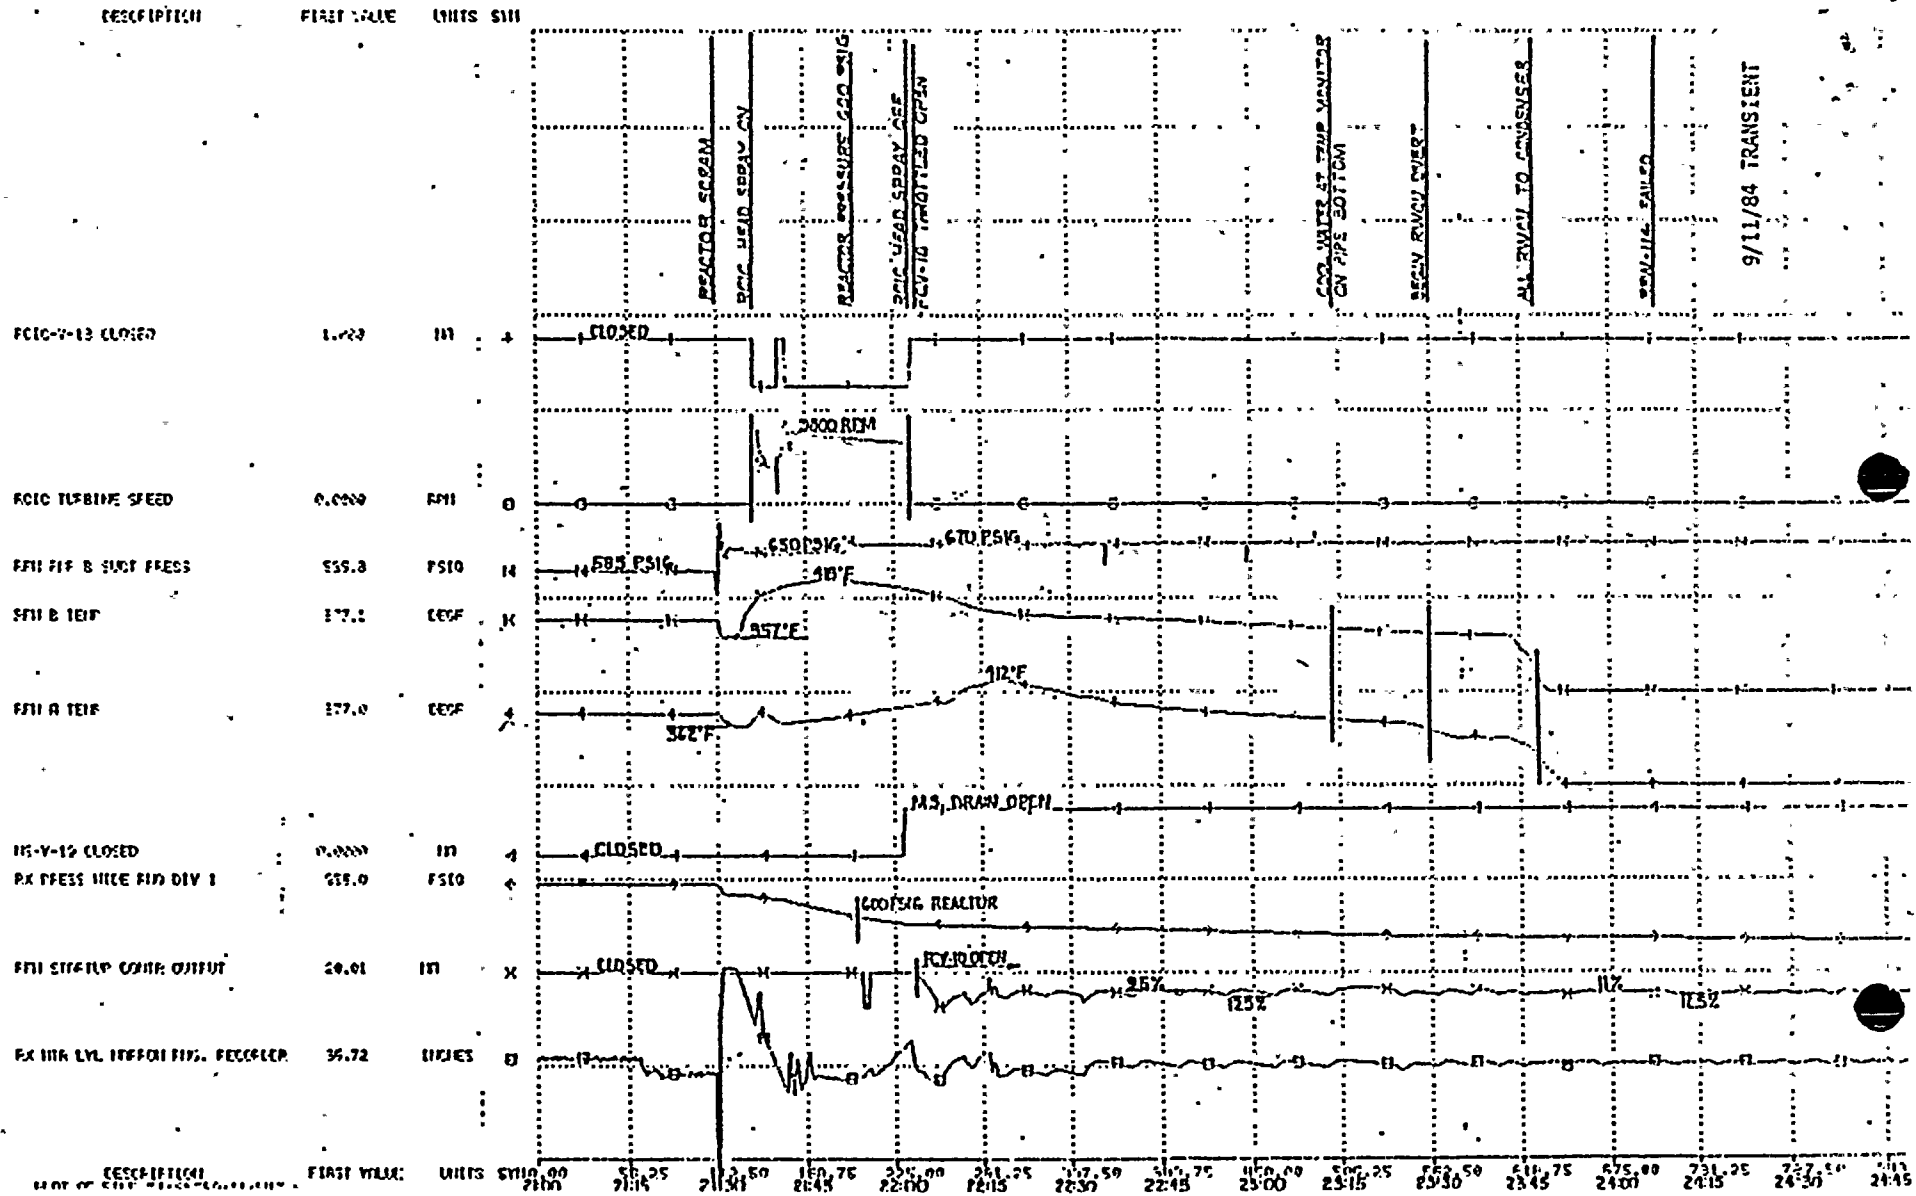
FIGURE 6

The following summarizes significant events leading up to and following the failure of feedwater piping support RFW-114. The plant had been running at approximately 75% power and the reactor was shutdown during testing. See Figure 6 for graphic representation of pertinent data.

<u>Date</u>	<u>Time</u>	<u>Event</u>
9/10/84	21:28	Reactor Feedwater 377.1°F Reactor Vessel Level 34 inches Reactor Pressure 958.0 psig
	21:29	Reactor Scram (Shutdown)
	21:31	Both reactor feedwater pumps tripped (one manually, one on high reactor water level).
	21:33	Feedwater temperature at RFW-TE-41A and 41B at approximately 360°F.
	21:35	RCIC Head Spray on
	21:50	Feedwater at RFW-TE-41B peaked at 418°F.
	21:53	Vessel pressure at 600 psig.
	22:02	Main Steam drains open.
	22:03	RCIC head spray off.
	22:04	RFW-FCV-10 open and controlling vessel level.
	22:20	Feedwater at RFW-TE-41A peaked at 412°F.
	23:13	Cool feedwater reached RFW piping bottom test thermocouples.
	23:30	RWCU diversion to condenser began.
	23:43	Sharp decrease in RFW temperature at RFW-TE-41A and 41B.
	23:48	RWCU diversion to condenser complete.
	24:08	RFW-114 failed.

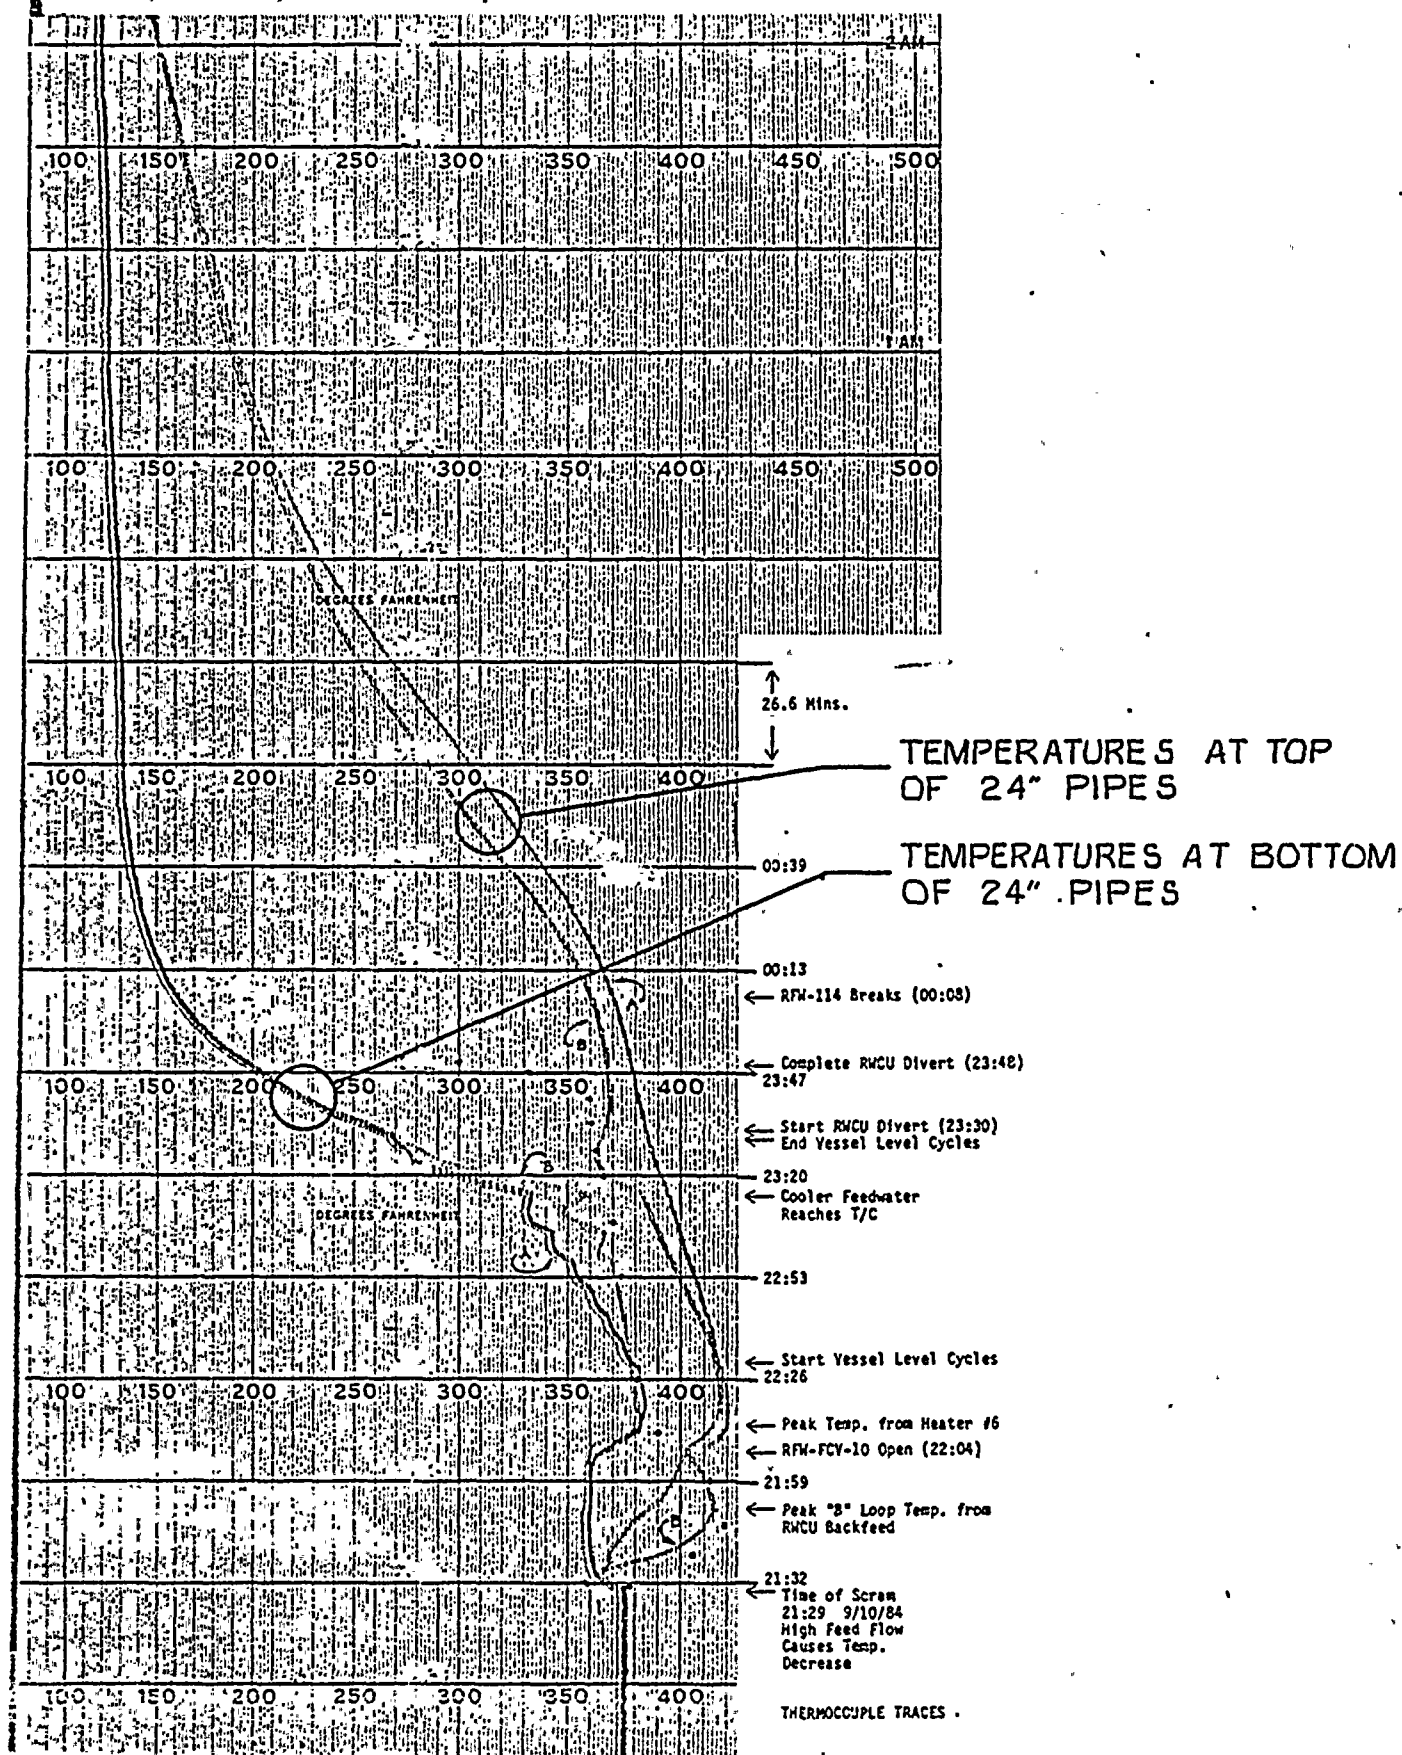
FIGURE 8

As a result of normal reactor shutdown, stratification occurred from two sources. Shortly after the scram both reactor feed pumps tripped dropping the pressure upstream of the RFW containment isolation valves to approximately 600 psig. Because reactor pressure was higher than 600 psig, RWCW flow into the RFW line flowed backward and down to the flow straightening sections. The hot RWCW water stratified at the top of the line. Inspection of Figure 8 shows that shortly after scram, top pipe temperatures rise to about 420°F while bottom temperatures remain below 380°F.

When the reactor pressure dropped below 600 psig, condensate flow was allowed to flow to the reactor through RFW-FCV-10. This flow eventually depleted the residual heat in the feed-water heaters and cool water was sent into the hot flow straightening sections. The cool water stratified at the bottom of the pipe resulting in peak top-to-bottom differential temperatures of 220°F.

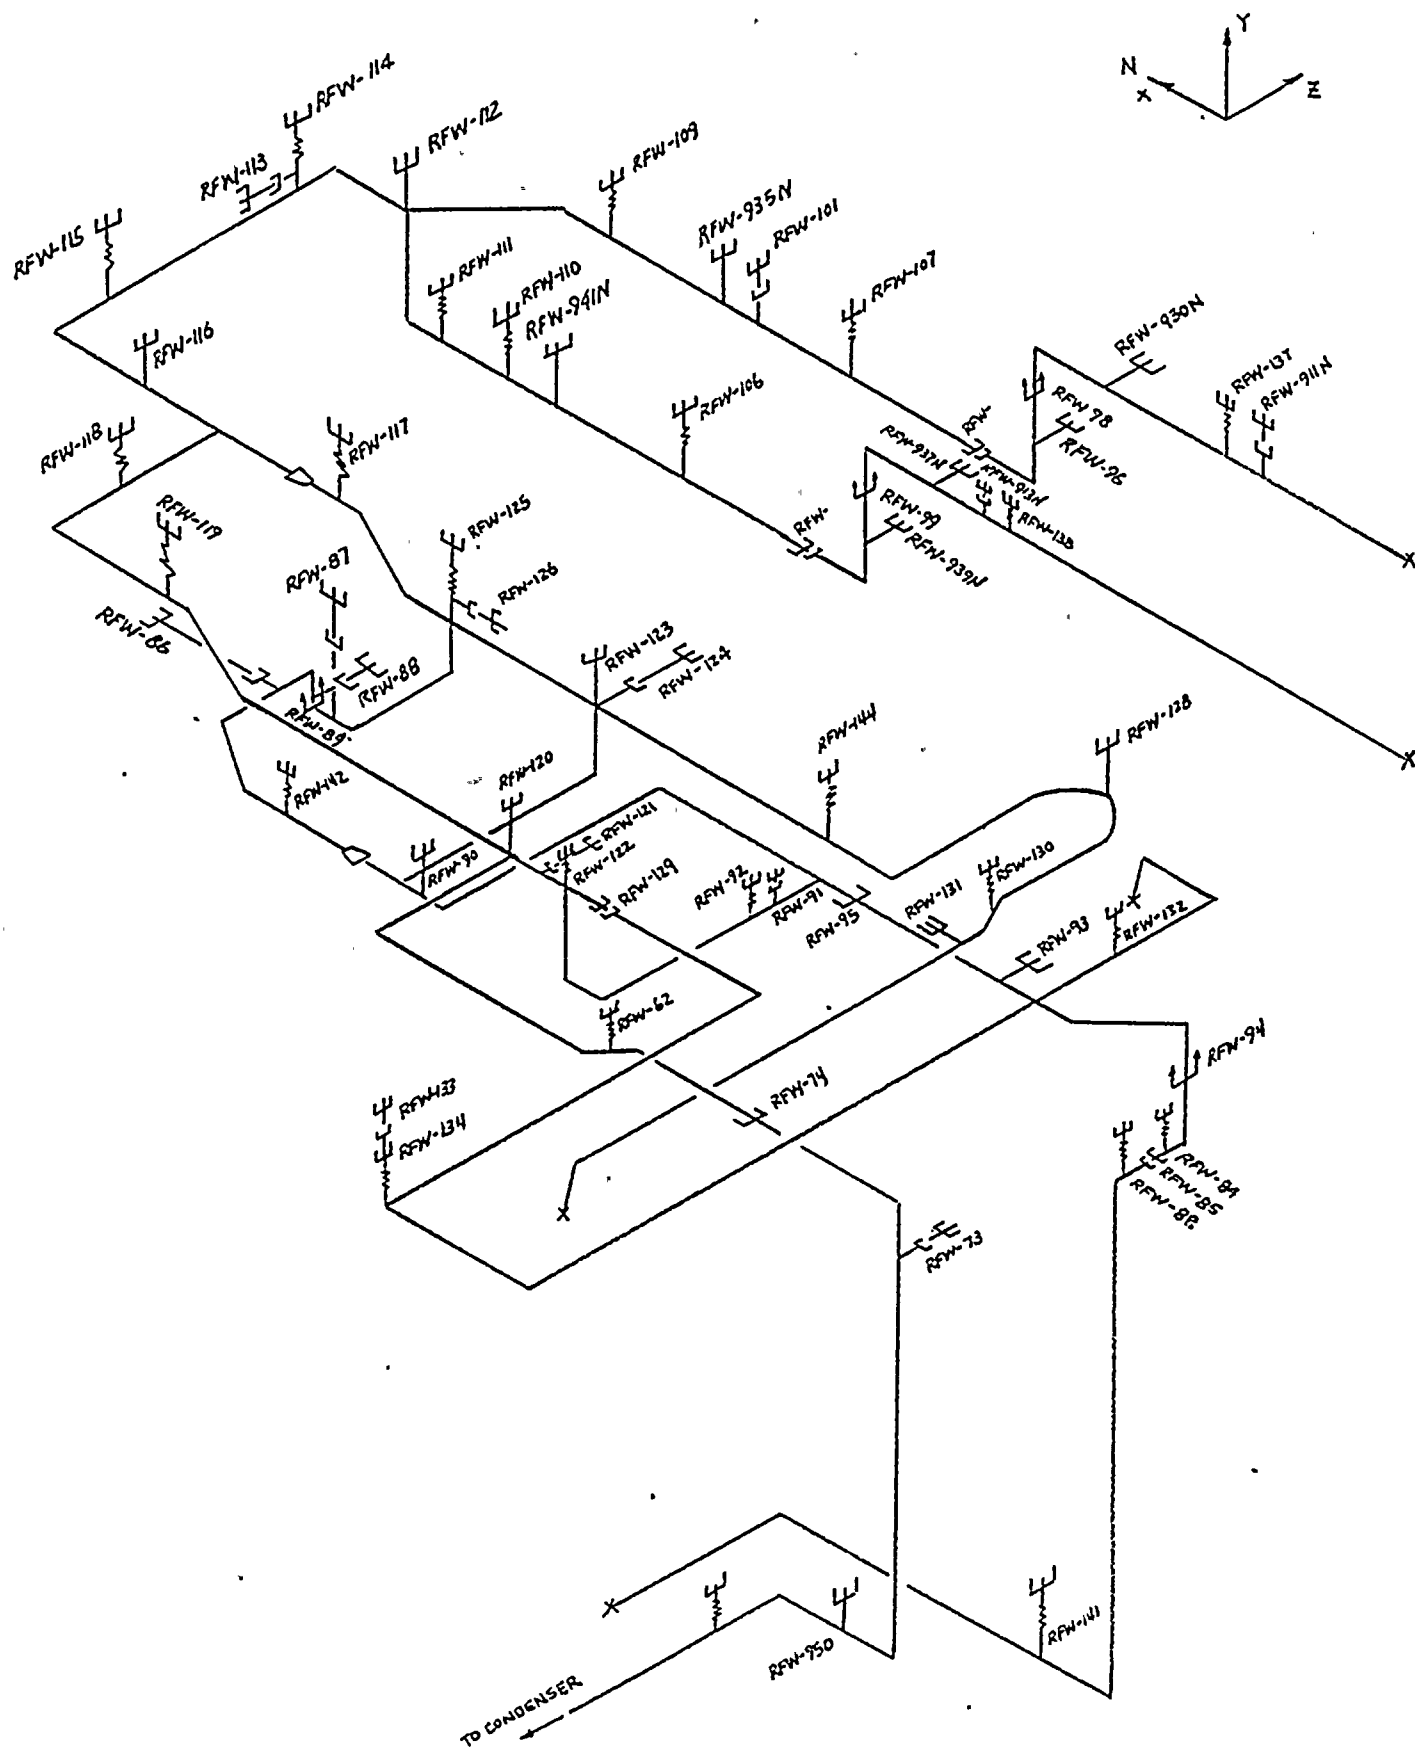
FIGURE 9

With the field test data in hand the redesign mission became self evident. That is, stratification was proved and the system's supports would have to be modified to accommodate the thermal bowing response. Stemming from the analysis efforts of the August 22 event, the ANSYS model was further refined (see Figure 9) to predict the system's bowing response. A design basis bowing T of 250°F was imposed on the ANSYS model from the wye to the elbows at the riser section upstream of the isolation valves. This thermal gradient resulted in a four inch downward deflection in the area of RFW-114, 115 and 116. Table 4 summarizes the specific hanger modifications required to accommodate the design basis bowing response. To requalify the system per the governing piping code requirements, the entire anchor group model (ADLPIPE) was re-executed with the modifications cited by Table 4 in deadweight, thermal and seismic load cases.

RFW SYSTEM ANSYS MODEL
