CONTROL ROOM DESIGN REVIEW
and
EMERGENCY PROCEDURE
FUNCTIONAL TASK ANALYSIS
SUMMARY REPORT

September, 1985

W N P - 2

WASHINGTON PUBLIC POWER SUPPLY SYSTEM

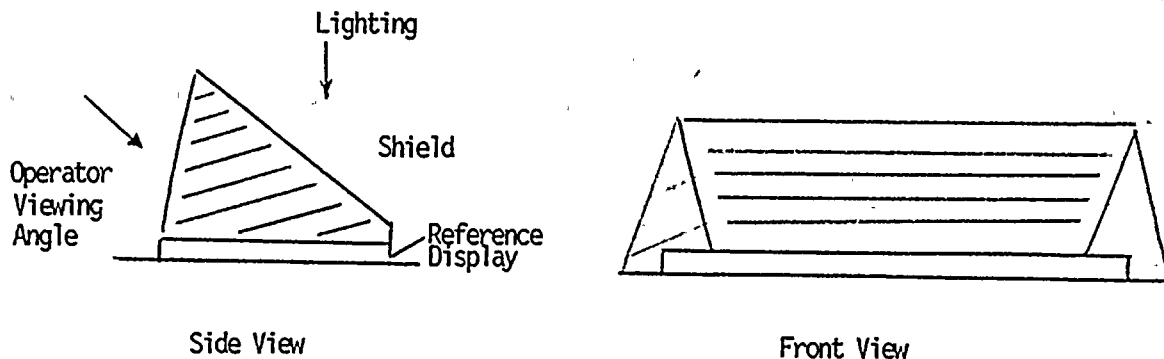
Temporary shields have been placed over each of the four reference displays to reduce the effect of overhead lighting glare. Permanent shields are being designed and will be installed by or during the first refueling outage.

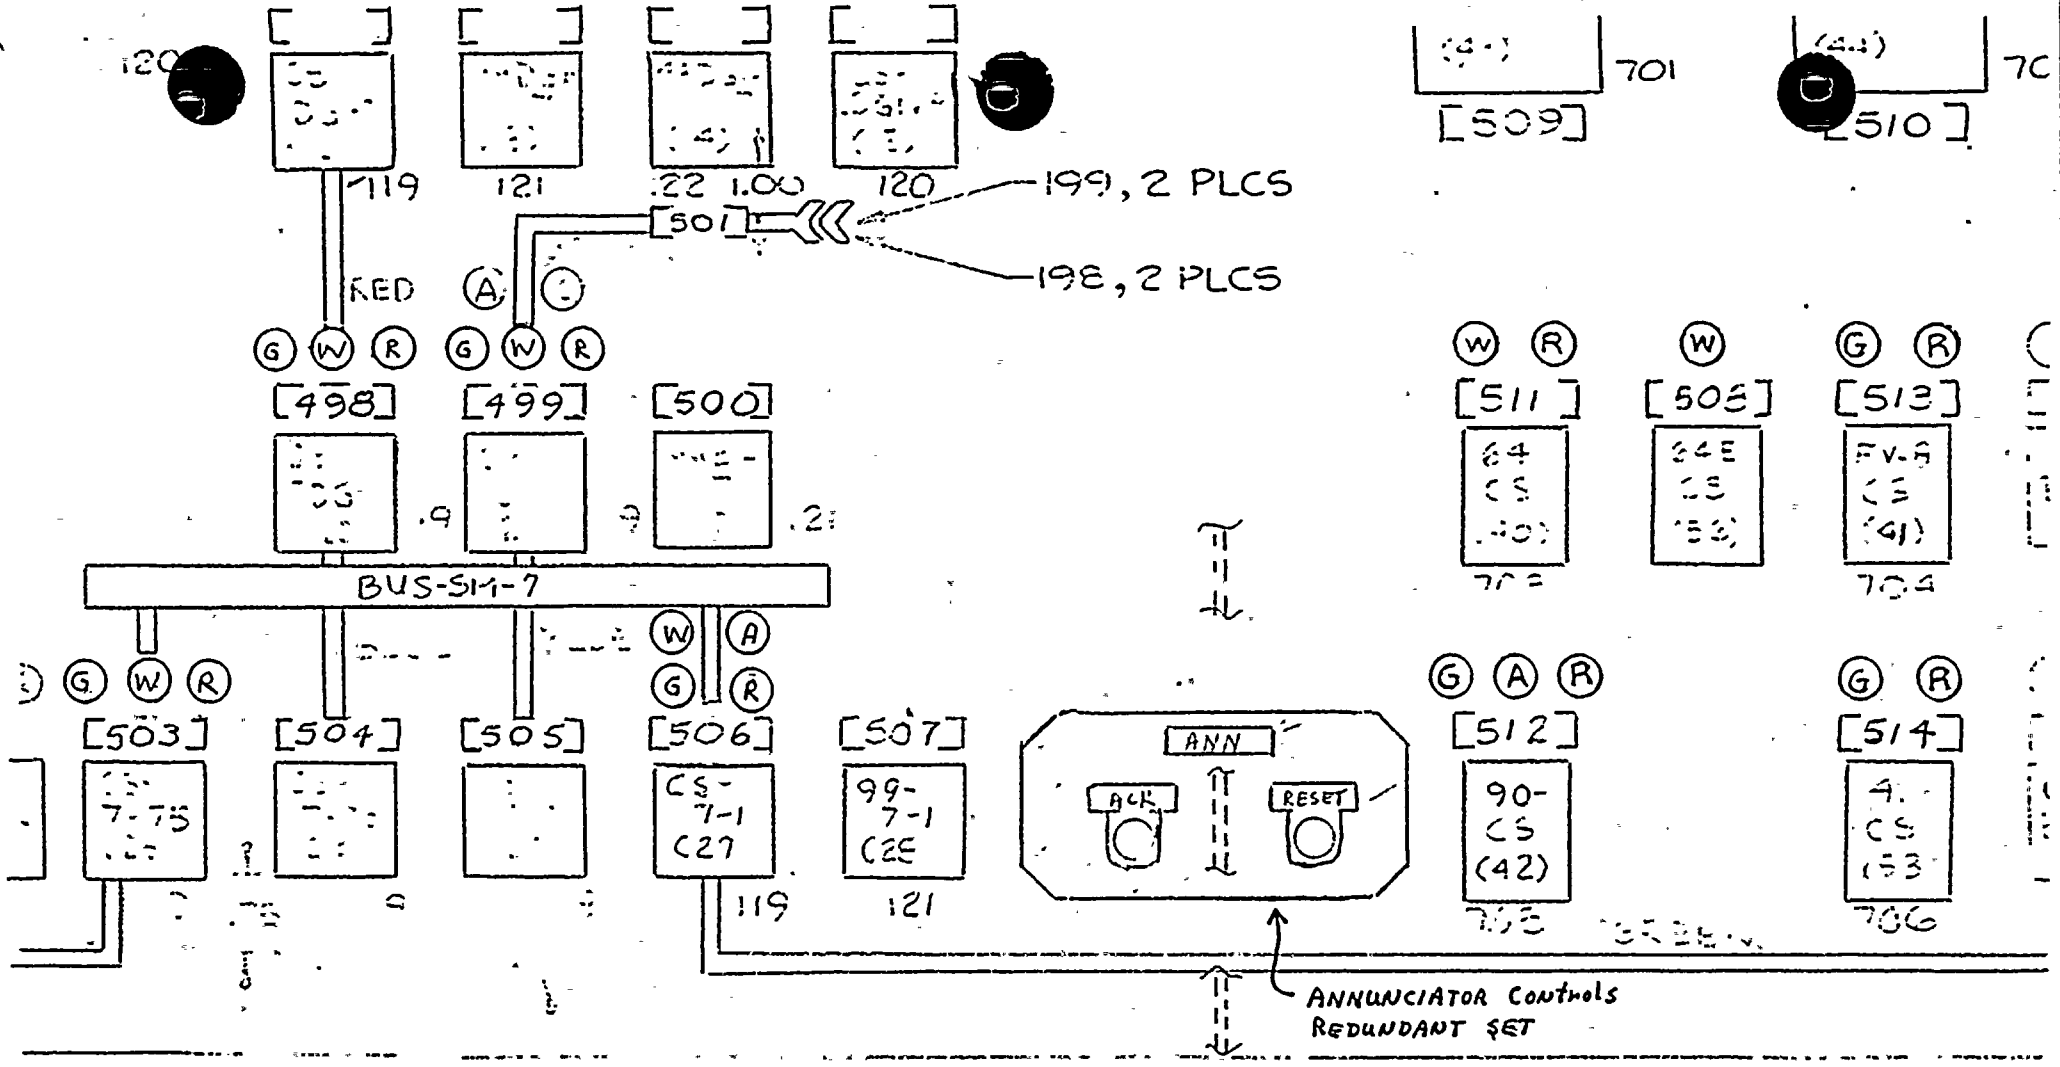
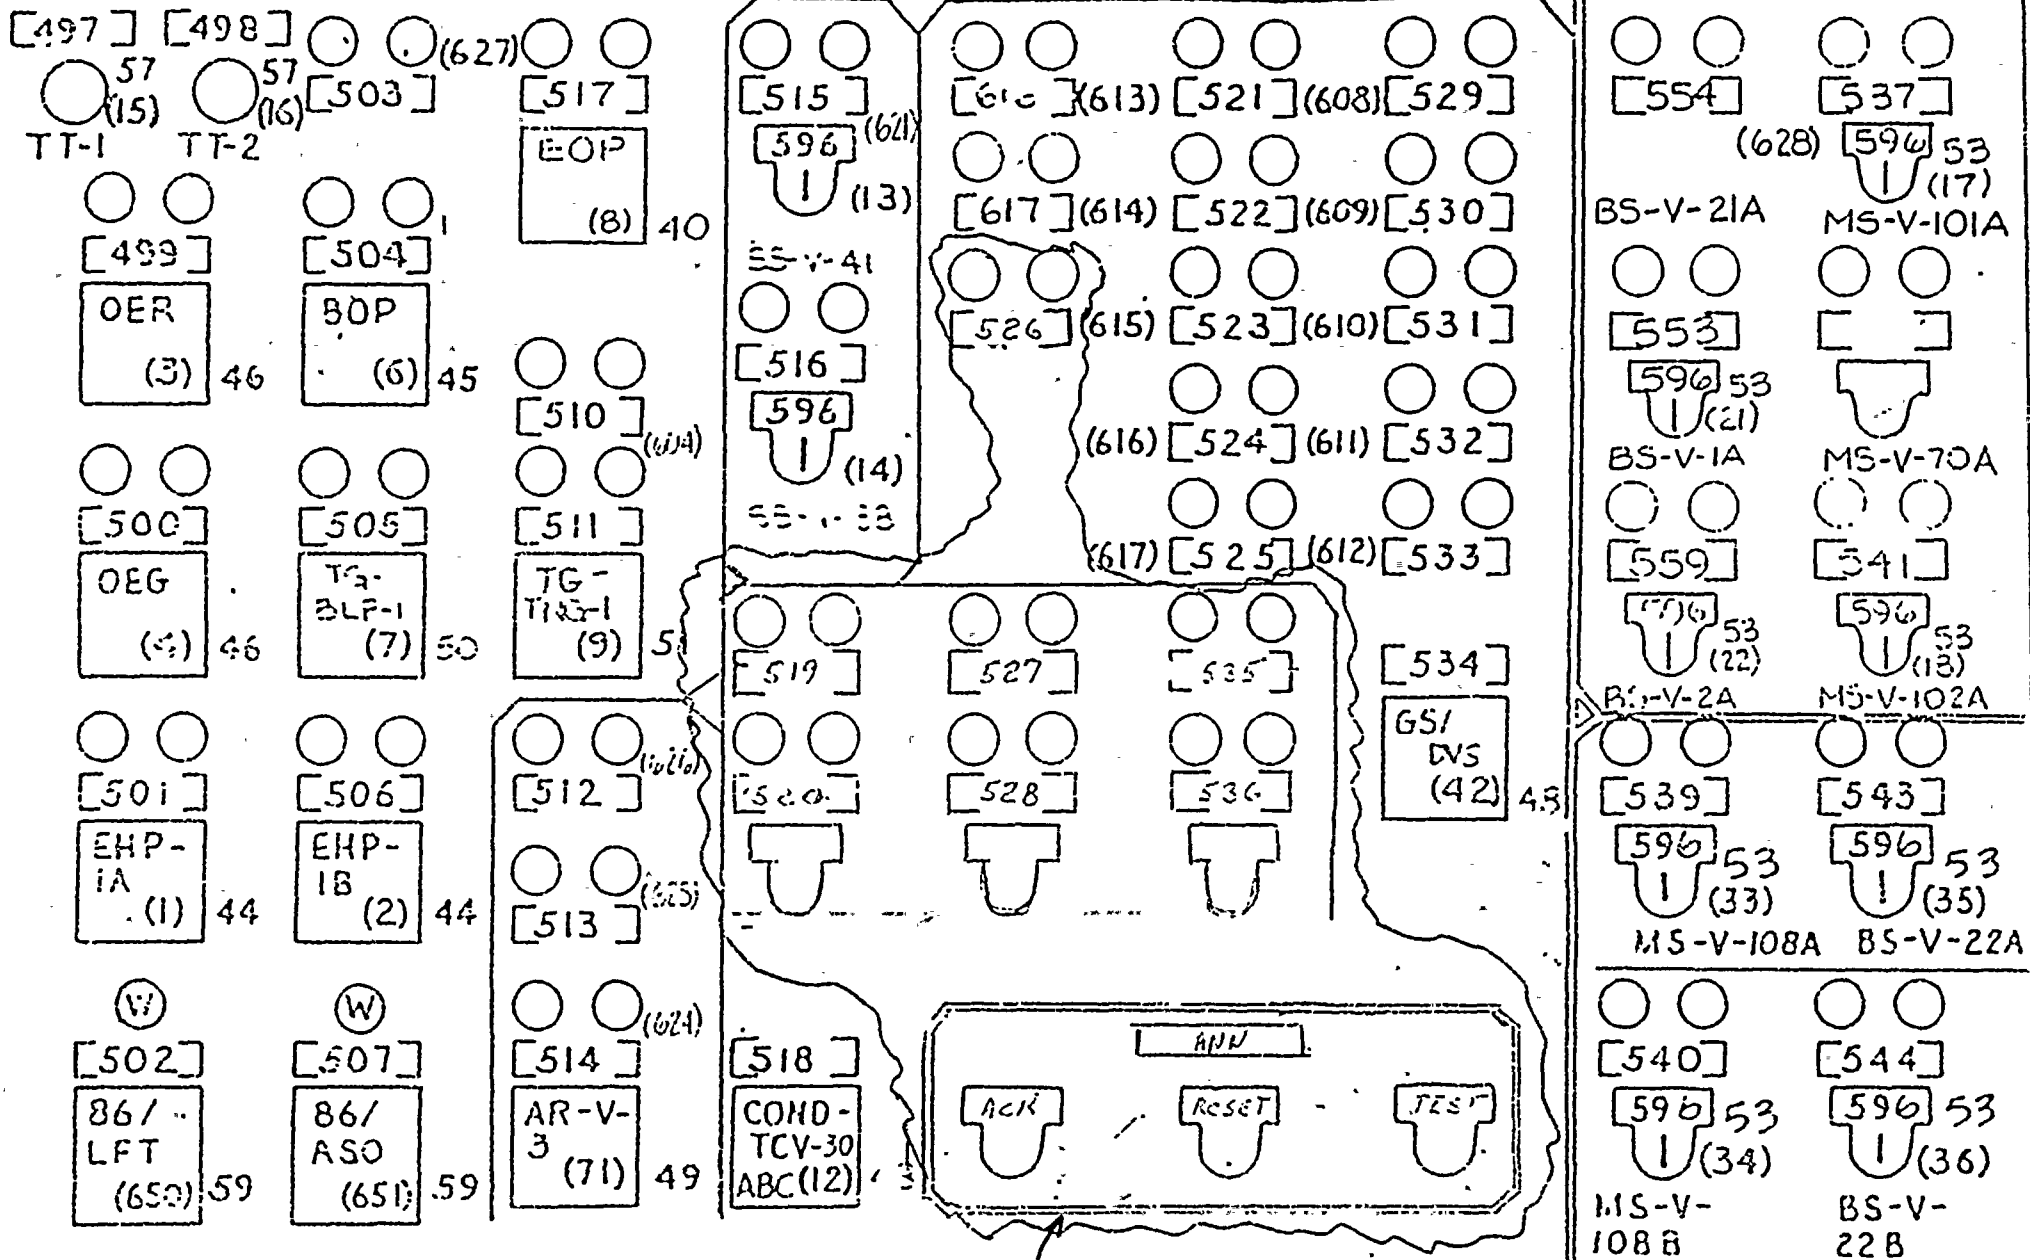
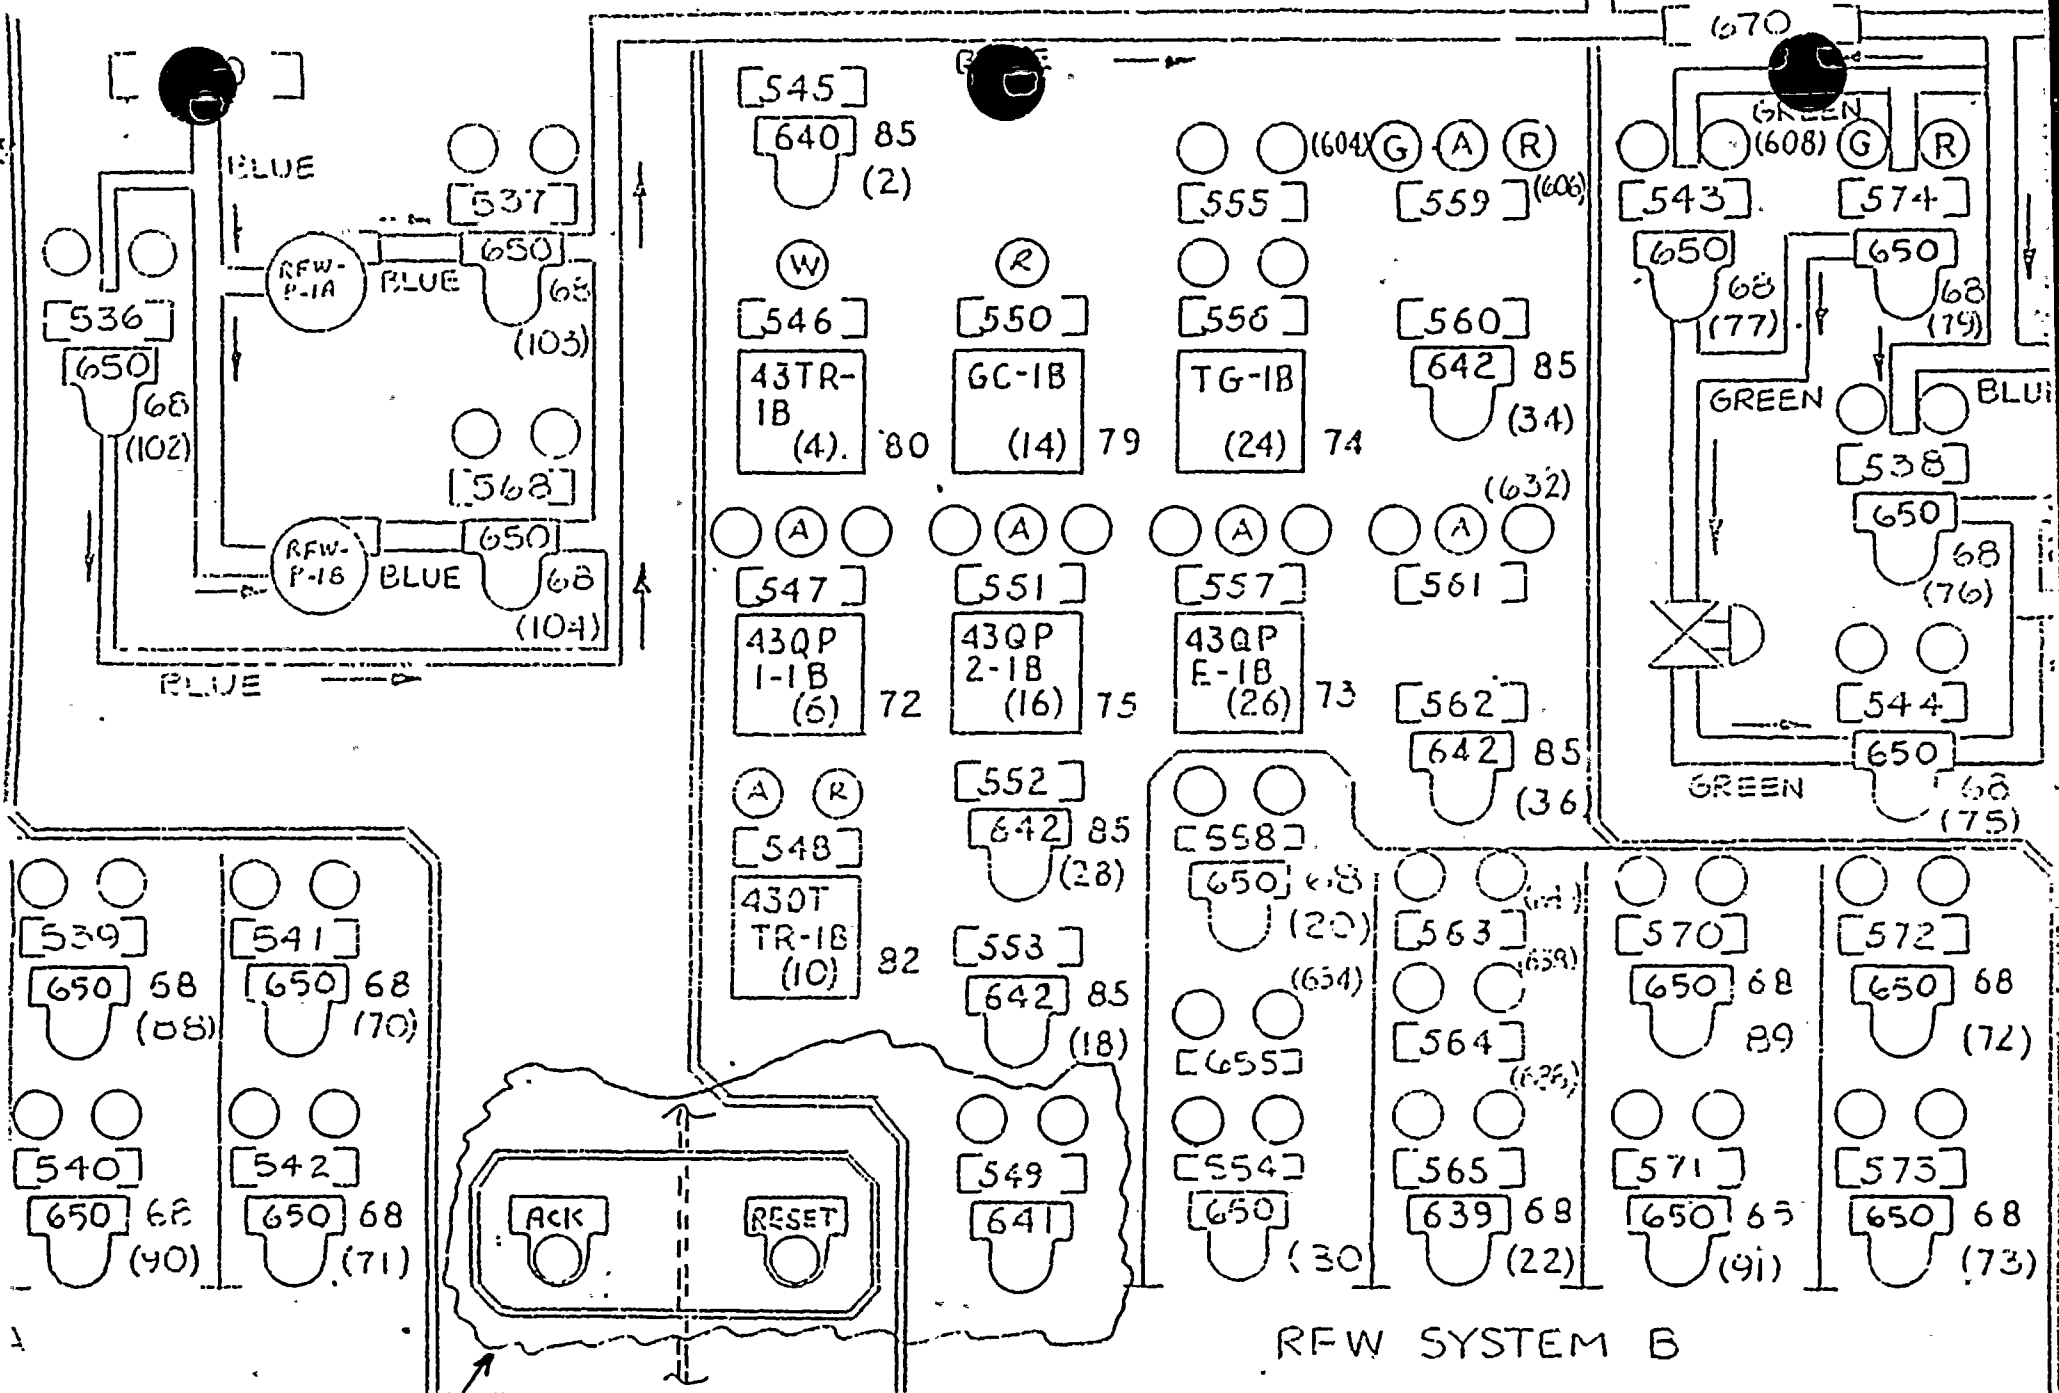
The potential for an operator not to have all alert alarms within a readable viewing range prior to acknowledging is only apparent at Panels P-601, P-840 and P-800. Per the control location and arrangement findings noted above, these panels will have redundant control sets at each end of the panel to reduce this concern. A design review was also performed relative to splitting the acknowledge feature of these control circuits such that the above panels could be split into two halves. That is, the annunciators on the left side of the panel visual alert feature could only be acknowledged by the panel's left side acknowledge control and visa-versa.

WNP-2 has two different control circuit designs for the NSSS and BOP annunciator panels. To split the acknowledge feature would require extensive redesign of the control and interface cards and realigning of circuits. Based on operating history to date, discussions with operators and the proposed control set changes noted earlier, additional changes to either a separate silence control or further splitting of the acknowledge feature would provide only a minimal improvement per the engineering efforts and costs involved.

Proposed recommendations and corrective actions are scheduled for implementation during the first refueling outage.
