Results of the Examination

In accordance with the WNP-2 FSAR, Section 4.2.4.3, a visual inspection of discharged fuel assemblies from WNP-2, Cycle 1, was performed.

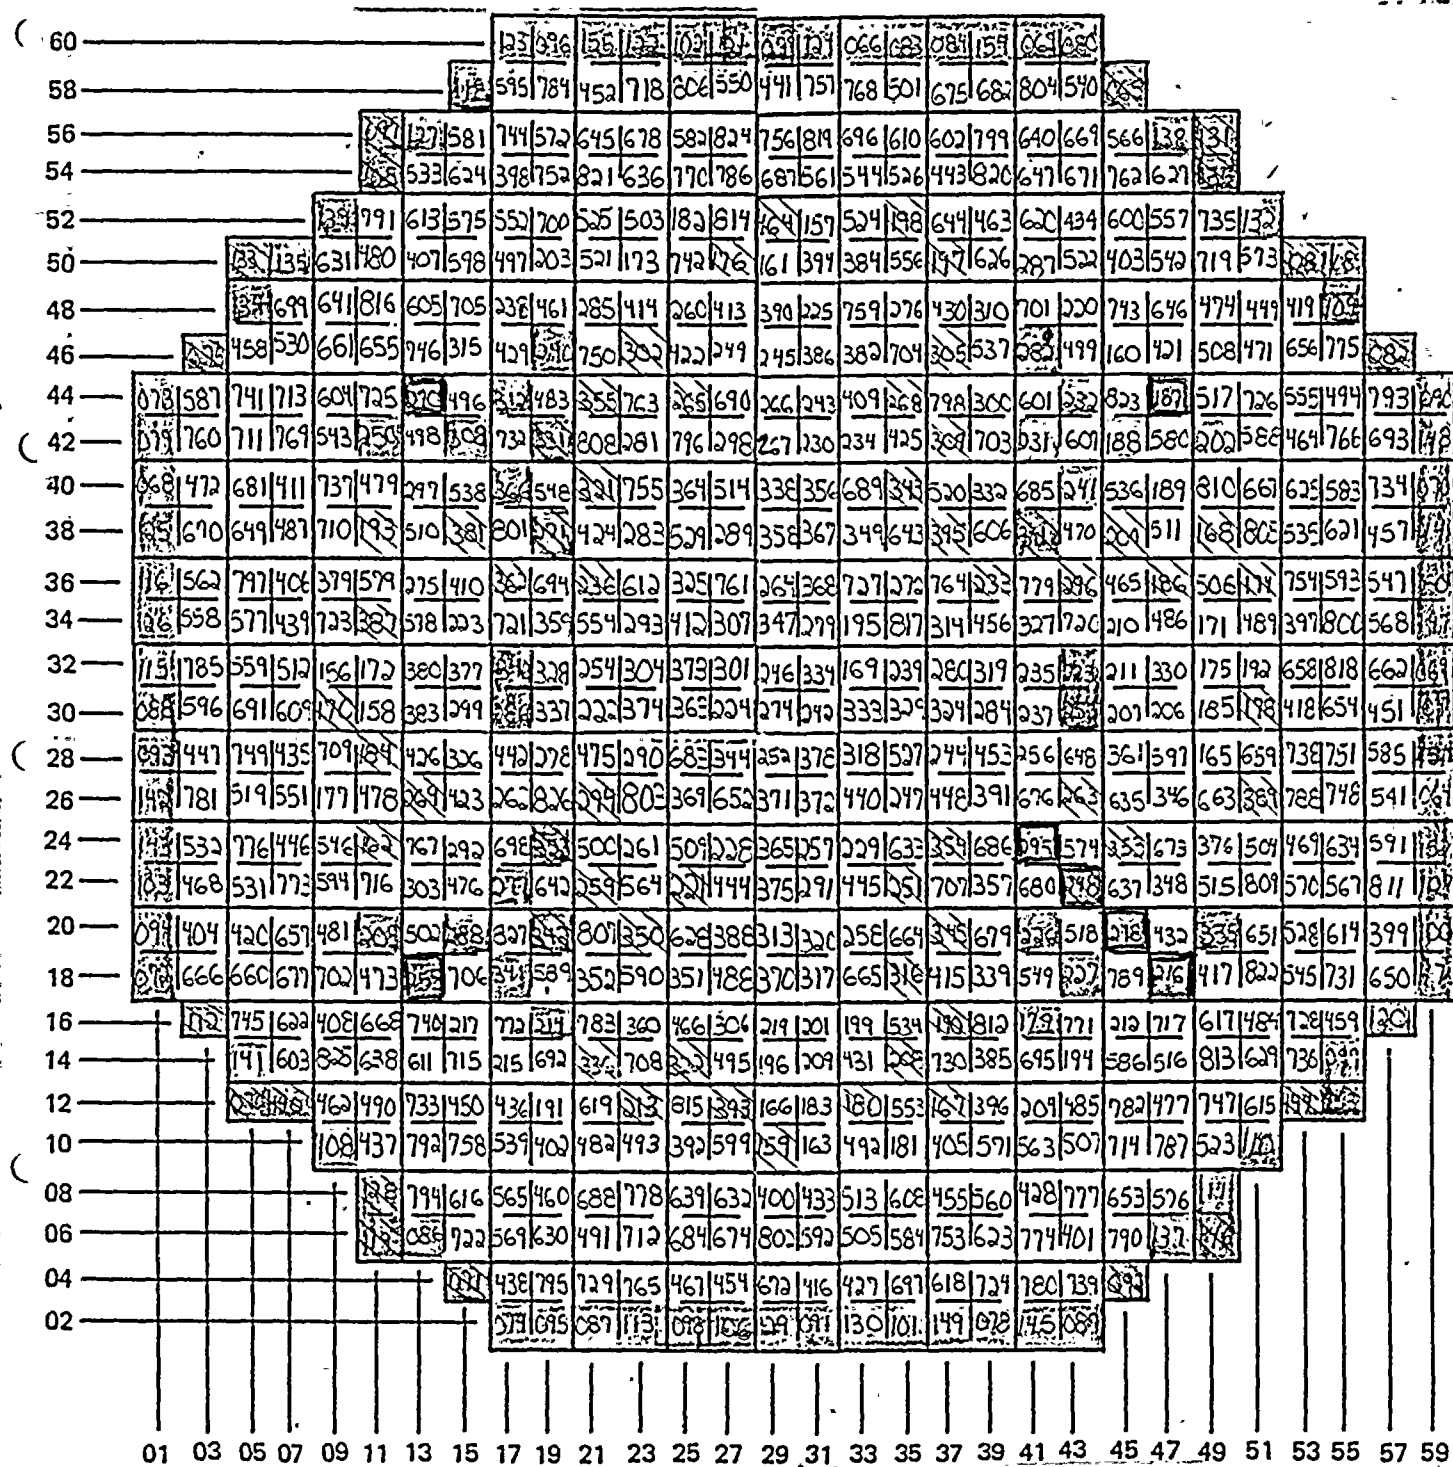
FIGURE 1 - CORE MAP

Eight assemblies were selected for inspection representing greater than 5 percent of the discharged fuel (see Figure 1 attached). The selected assemblies included seven medium enriched assemblies and one natural assembly. They were selected to be representative of the total discharged fuel batch. Four assemblies, LJT 270, LJT 187, LJT 255, and LJT 216 were located in symmetric locations in the core and, in addition, are the high burnup assemblies discharged at the end of Cycle 1. They are all medium enriched assemblies. Three assemblies, LJT 295, LJT 248, and LJT 218, when combined with LJT 216 mentioned above, constitute a radial line from the high burnup location towards the core center. These three assemblies are also medium enriched. LJT 144 is a natural enriched bundle located on the core periphery along the same radial line defined by LJT 295, LJT 248, etc. Given the excellent core power symmetry that WNP-2 observed during Cycle 1, the selected pattern of assemblies to be inspected represents the spatial and exposure effects of the total discharge batch from Cycle 1.
