WASHINGTON PUBLIC POWER SUPPLY SYSTEM

Subject: NUCLEAR PLANT NO. 2  
LICENSE NO. NPF-21,  
EQUIPMENT QUALIFICATION AUDIT,  
AUDIT NO. NRC-IR-86-12

#### POTENTIAL ENFORCEMENT/UNRESOLVED ITEM (ROSEMOUNT)

## SUPPLY SYSTEM RESPONSE

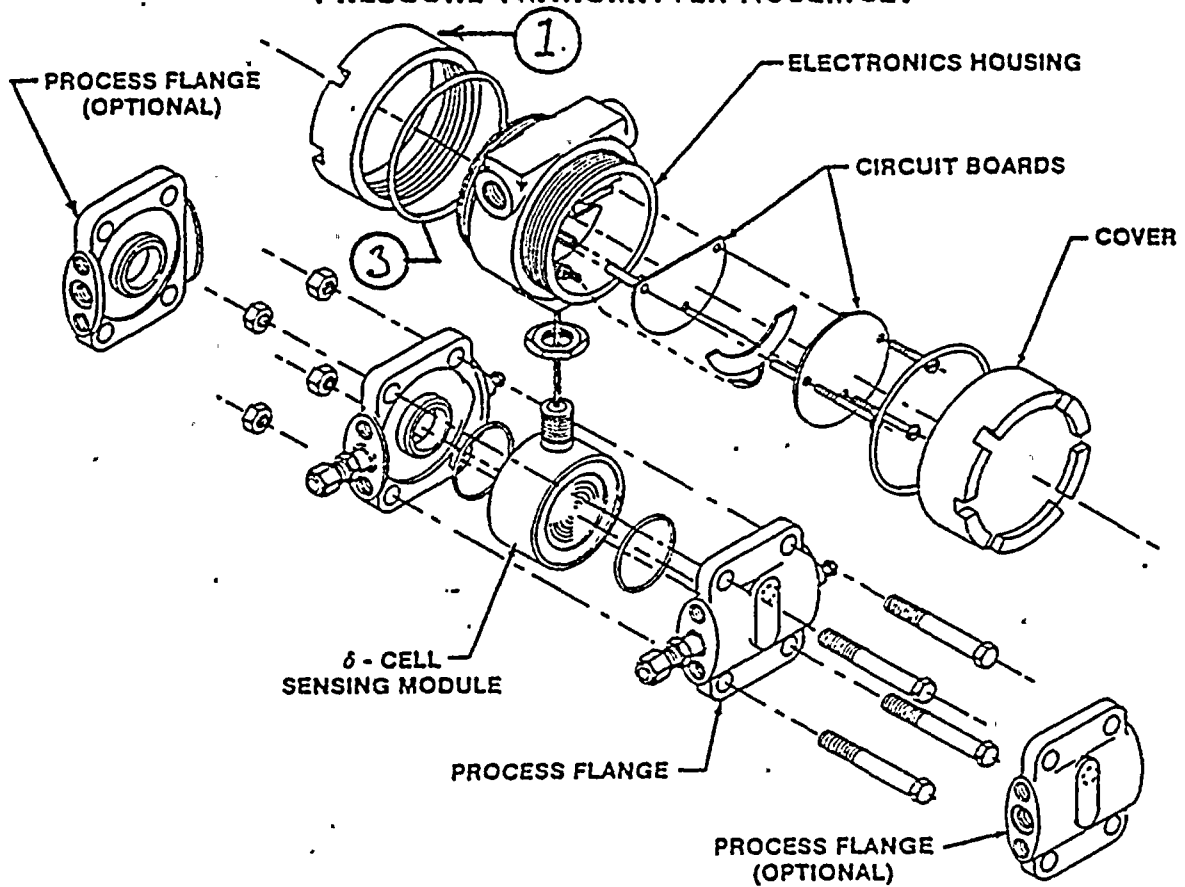
FIGURE 1

PROCEDURE FOR SEALING CONDUIT  
ENTRY INTO ROSEMOUNT MODEL  
1153 SERIES B PRESSURE TRANSMITTER

1. Remove cover (part 1 of Fig. 1) to allow access to wiring terminals and conduit entry cavity (Area 2 of Fig.1).
2. Prepare and apply Dow Corning 3-6548 silicone foam to fill the wire entry cavity and into the conduit entry, taking care to separate wires and providing a complete seal to the cavity walls and wire surfaces. Preparation and application of the foam material shall be carried out in accordance with PPM 102923.
2. After foam has fully cured, replace seal ring (part 3 of Fig. 1) and replace cover.
