SUBJECT: LER 88-006-00:on 880213,low reactor pressure vessel level  
 reactor protective sys actuation.

FACILITY NAME (1) Washington Nuclear Plant - Unit 2										DOCKET NUMBER (2) 0 5 0 0 0 3 9 7 1				PAGE (3) 1 OF 0 9								
TITLE (4) Low Reactor Pressure Vessel Level Reactor Protective System Actuation As a Result of Procedural Inadequacy																						
EVENT DATE (5)			LER NUMBER (6)				REPORT DATE (7)			OTHER FACILITIES INVOLVED (8)												
MONTH	DAY	YEAR	YEAR	SEQUENTIAL NUMBER	REVISION NUMBER	MONTH	DAY	YEAR	FACILITY NAMES				DOCKET NUMBER(S)									
2	1	3	8	8	8	0	0	6	0	0	0	3	1	4	8	8	0	5	0	0	0	0
OPERATING MODE (9) 3		THIS REPORT IS SUBMITTED PURSUANT TO THE REQUIREMENTS OF 10 CFR §: (Check one or more of the following) (11)																				
POWER LEVEL (10) 0 0 10		20.402(b)				20.406(c)				<input checked="" type="checkbox"/> 50.73(a)(2)(iv)				73.71(b)

Subject: NUCLEAR PLANT NO. 2  
LICENSEE EVENT REPORT NO. 88-06

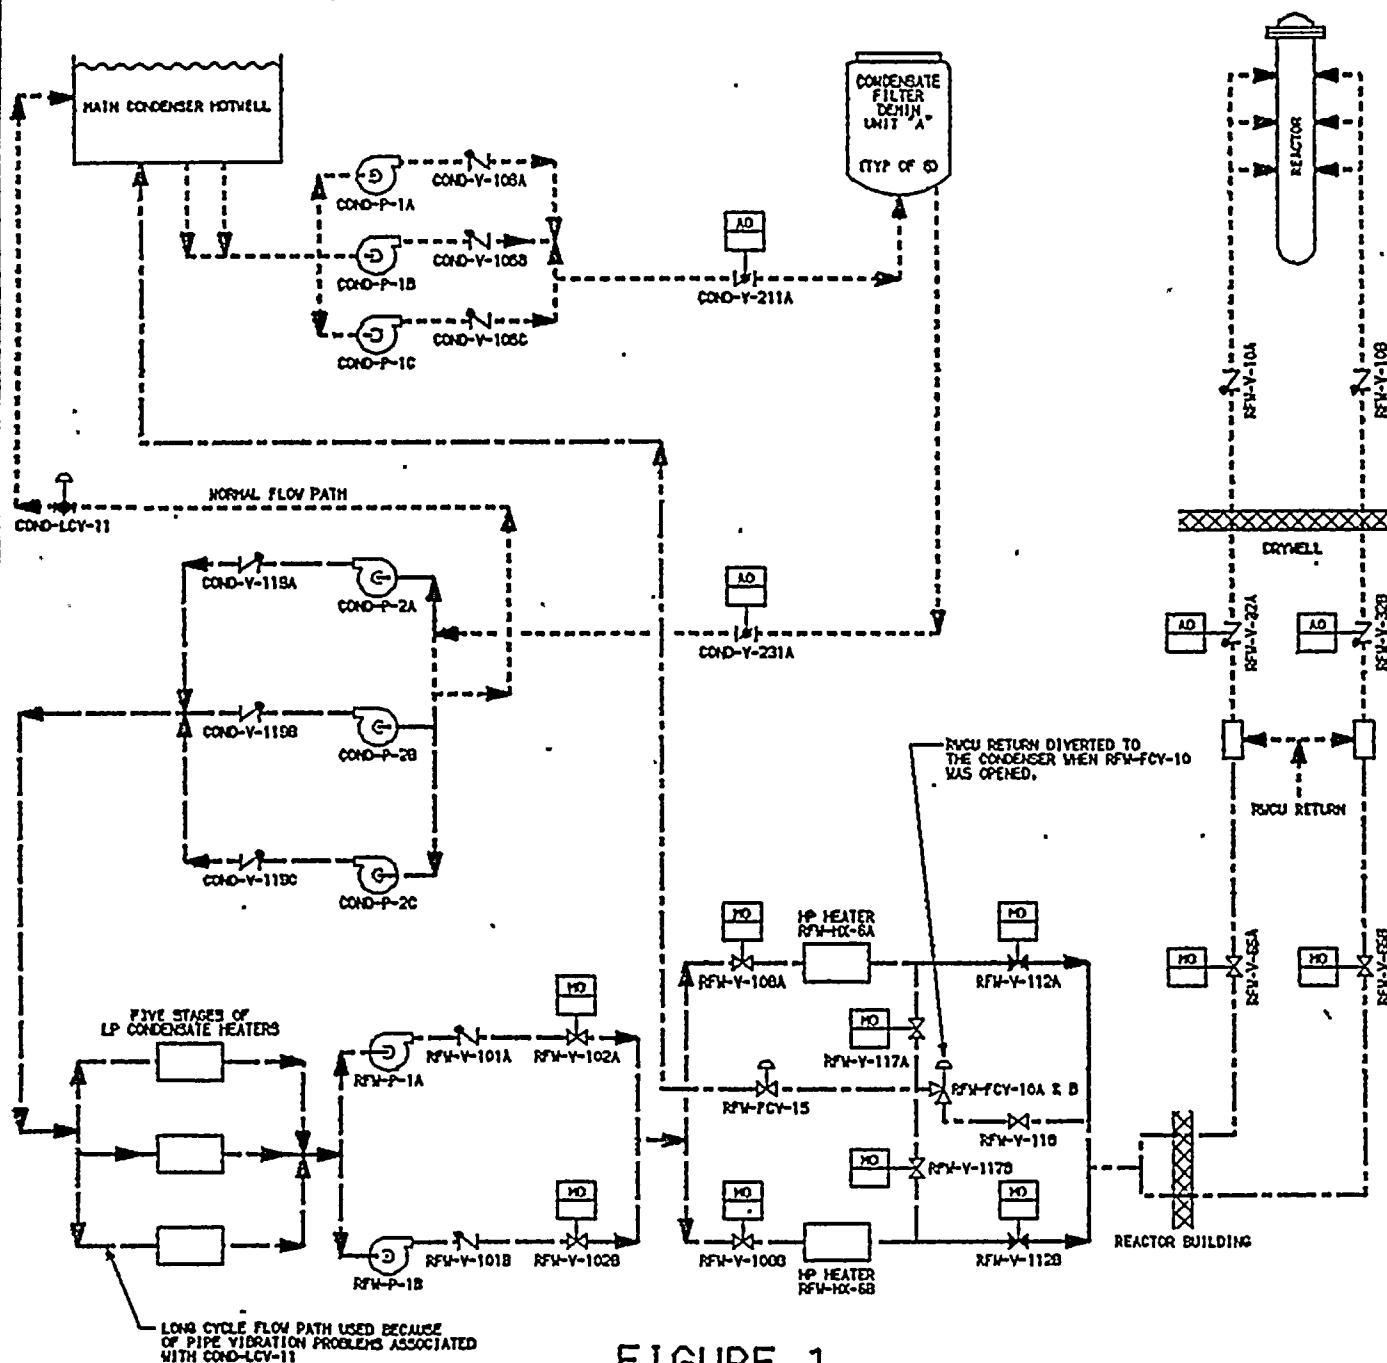
FIGURE 1  
CONDENSATE AND FEEDWATER FLOWPATH

- o Time 15 minutes, 54 seconds - Startup Flow Control Valve RFW-V-10A was manually opened in preparation for using the condensate booster pumps to supply feedwater to the RPV when pressure decreased to within the capability of the pumps. RPV level had dropped into the normal level control range of +35 inches at this point. RPV level immediately began to decrease at approximately 20 inches per minute. (See Figure 1 for Condensate and Reactor Feedwater System lineup).

3. The immediate cause of the low RPV level RPS actuation was determined to be the opening of the Startup Flow Control Valve RFW-FCV-10A while RPV pressure was 250 psig greater than Reactor Feedwater System pressure. Because the Long Cycle Cleanup Valve RFW-FCV-15 had been previously opened to the condenser hotwell, opening RFW-FCV-10A resulted in a rapid diversion of water inventory from the RPV through the RWCU System backwards through RFW-FCV-10A to the condenser via RFW-FCV-15. The cause of this loss was unknown during the event.

4. The root cause of the low RPV level RPS actuation was determined to be procedural deficiency. The Reactor Scram Recovery Procedure did not contain adequate information to properly direct operation of the Reactor Feedwater System during conditions in which RPV pressure is greater than Reactor Feedwater System pressure. This allowed the Startup Flow Control Valve to be opened to inadvertently establish an unrecognized diversion path of reactor coolant from the RPV via RWCU to the condenser hotwell. This diversion flow path was the primary cause for RPV level dropping from +35 inches to the +13 inch RPS actuation setpoint.

3. Operating procedures have been modified to include additional information concerning control of RPV level during shutdown conditions with RPV pressure greater than feedwater system pressure.
