SUBJECT: LER 88-012-00: on 880606, potential existence of unmonitored radiological effluent release path during certain emergency conditions determined. Cause unknown. Fan disabled.
 W/880606 ltr.

FACILITY NAME (1) Washington Nuclear Plant - Unit 2										DOCKET NUMBER (2) 0 5 0 0 0 8 1 9 7										PAGE (3) 1 OF 0 1 5																					
TITLE (4) Potential Unmonitored Effluent Release Path Due To Design Error By Architect/Engineer Cause Unknown																																									
EVENT DATE (5)						LER NUMBER (6)						REPORT DATE (7)						OTHER FACILITIES INVOLVED (8)																							
MONTH			DAY			YEAR			YEAR			SEQUENTIAL NUMBER			REVISION NUMBER			MONTH			DAY			YEAR			FACILITY NAMES						DOCKET NUMBER(S)								
0 5			0 6			8 8			8 8			0 1			2			0 0			0 6			0 6			8 8									0 5 0 0 0					
0 5			0 6			8 8			8 8			0 1			2			0 0			0 6			0 6			8 8									0 5 0 0 0					
OPERATING MODE (9) 5						THIS REPORT IS SUBMITTED PURSUANT TO THE REQUIREMENTS OF 10 CFR §: (Check one or more of the following) (11)																																			
POWER LEVEL (10) 0 1 0 0						20.402(b)						20.405(c)						50.73(a)(2)(iv)						73.71(b)

Subject: NUCLEAR PLANT NO. 2
LICENSEE E

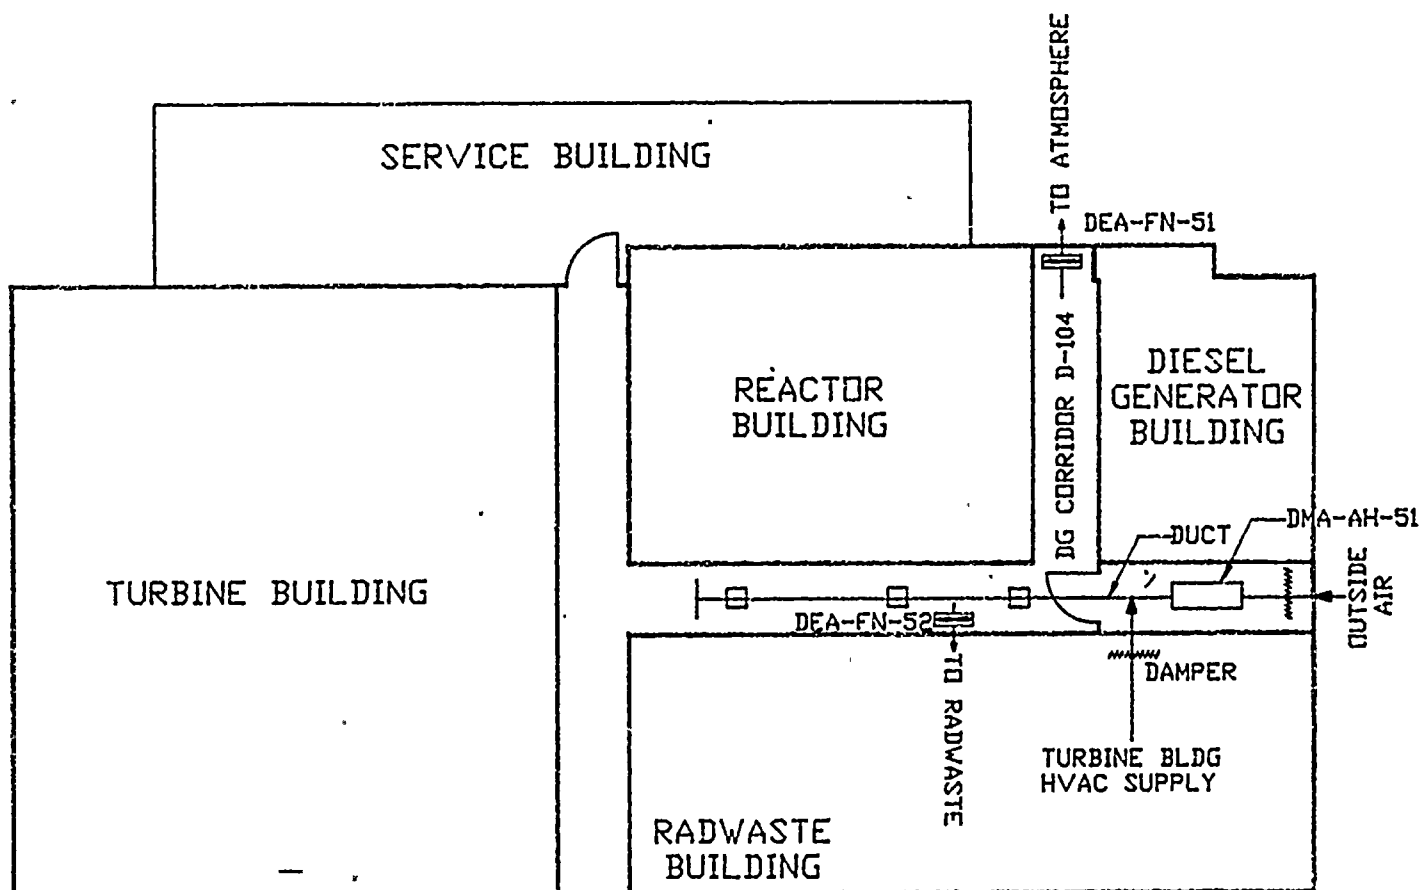
FIGURE 1

During normal Plant operations DEA-FN-51 draws clean air down the diesel generator corridor (D104) which is supplied by the Turbine Building HVAC System. During some emergency conditions DEA-FN-51 and DEA-FN-52 are supplied outside air by the supply air handling unit (DMA-AH-51) when the outside air temperature is greater than 40°F or recirculated room air when the temperature is less than 40°F. However, if during these emergency conditions DMA-AH-51 is not operable, air from the Turbine Building could be drawn in by DEA-FN-51 and exhausted to the atmosphere. A main steamline break in the Turbine Building would result in a source whose maximum concentration is 3.312×10^{-4} uCi/cc. (The source concentration was calculated by dividing the total main steamline break source by 10% of the volume of the Turbine Building.) The above concentration level is within the range specified in Regulatory Guide 1.97 Table 2 (between 10^{-6} uCi/cc and 10^2 uCi/cc) and, therefore, this release path should have been monitored.

An Engineering Assessment determined that DEA-FN-51 was not required for cable cooling during normal or emergency conditions. The fan was disabled by removing its power fuses and by closing the back draft damper.

A Plant Modification Request is being processed to remove DEA-FN-51 and its associated accessories and to seal the opening created by the removal of the fan.
