SUBJECT: LER 88-006-00:on 880208,emergency svc water sys inoperable
 due to isolation valve failures & design deficiency.

| FACILITY NAME (1) SHEARON HARRIS NUCLEAR POWER PLANT - UNIT 1 | | | | | | | | | | DOCKET NUMBER (2) 0 5 0 0 0 4 0 0 | | | | PAGE (3) 1 OF 0 4 | | |
| TITLE (4) BOTH EMERGENCY SERVICE WATER SYSTEMS INOPERABLE DUE TO ISOLATION VALVE FAILURES AND DESIGN DEFICIENCY | | | | | | | | | | | | | | | | |

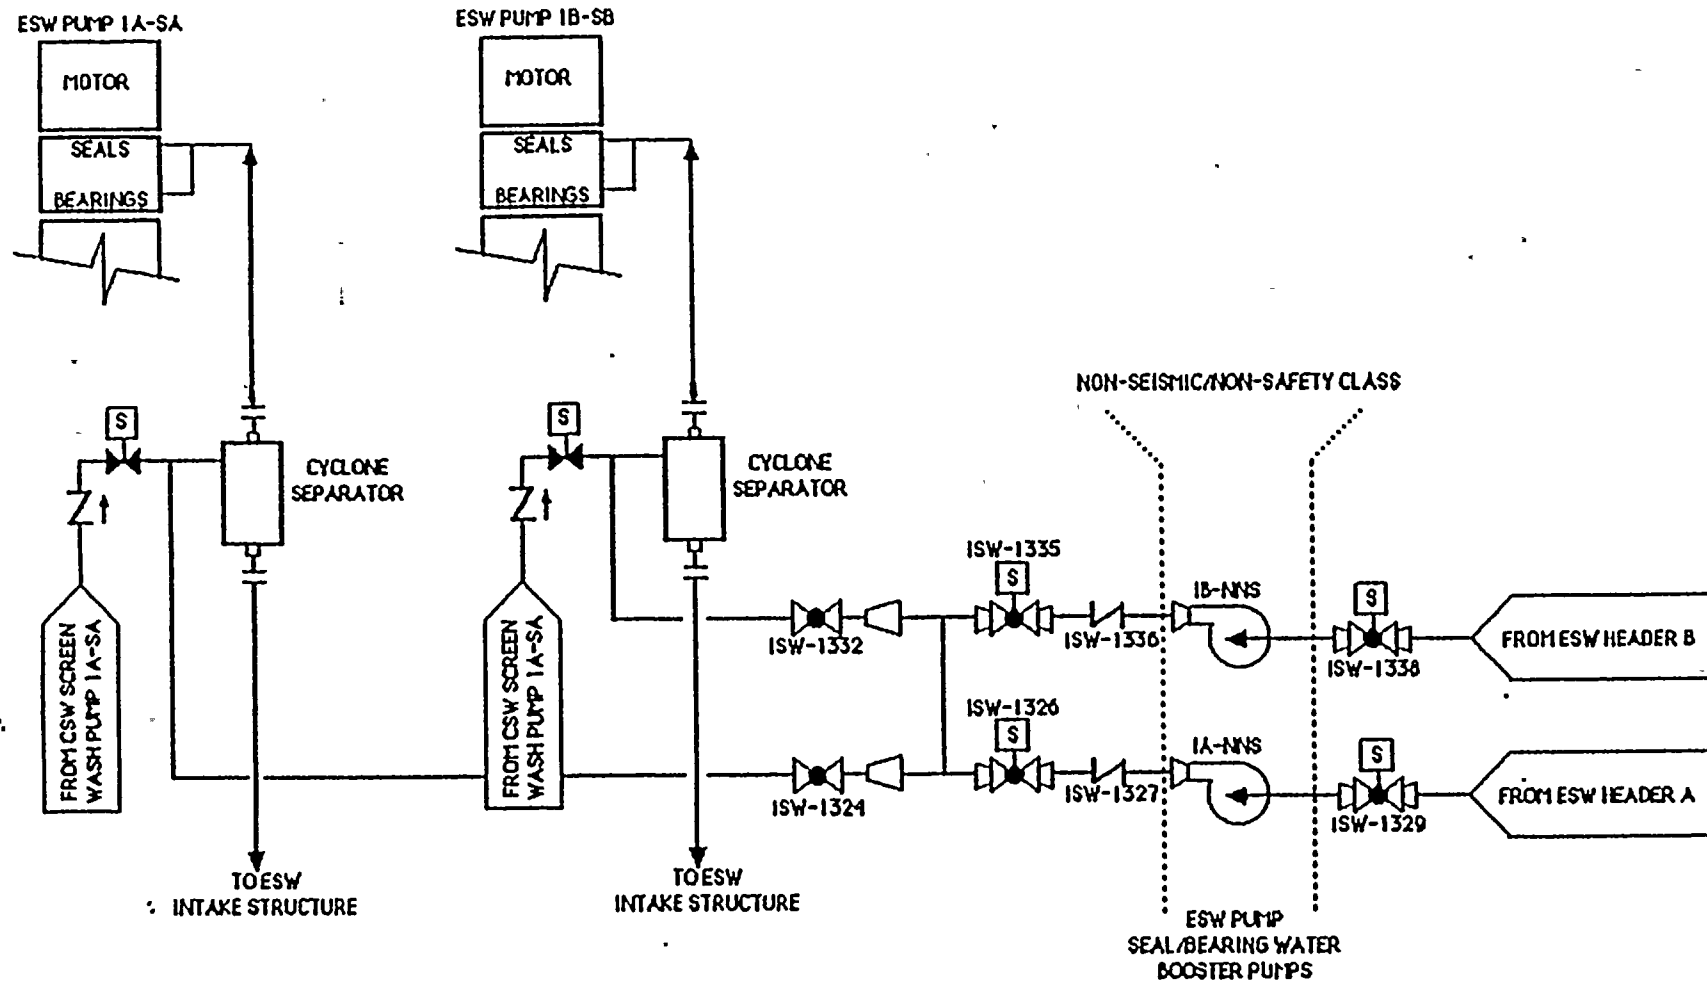
ATTACHMENT A
 ESW PUMP SEAL/ BEARING WATER SUPPLY
 Ref. Dwg.: CAR 2165-S-0936 Rev. 8

Refer to Attachment A, which shows the Emergency Service Water (ESW) pump seal and bearing water supply configuration. The ESW pumps are normally not in service, and start automatically on Safety Injection Actuation, loss of off-site power, or low service water header pressure (indication of failure of normal supply). During this idle condition, one of the ESW Pump Seal/Bearing Water Booster pumps draws water from the ESW header and supplies clean water via a cyclone separator to the ESW pumps' seals and bearings to prevent accumulation of debris between the bearing and the shaft sleeves of the ESW pump which can result from the stagnating water in the ESW pump intake bay. This flow helps to increase the life of the bearing, but interruption of this flow would not damage either the bearings or the seals.

When the ESW pump is started, the booster pumps trip and the valves close to isolate the nonsafety piping from the safety-related piping. Seal and bearing water is then provided by the safety-related ESW Screen Wash pumps which tie into the seal water supply header downstream from the isolation valves.

On February 8, 1988, surveillance test OST-1215, Emergency Service Water System Operability, was in progress. During testing, two solenoid operated, fail close valves, numbers 1SW-1335 and 1SW-1338, failed to close on demand. These valves are manufactured by Target-Rock, model number 79Q-024 (EIIS:BI:ISV). In addition, check valve 1SW-1336 was not properly seating. This valve is manufactured by Rockwell, model number H6283-BV985 (EIIS:BI:ISV).

On February 12, 1988, a concern was raised regarding the configuration of the safety-related ESW pump seal water supply. The two trains are cross-connected without capability to automatically isolate, causing the potential for a single passive failure to affect both ESW pumps. Valve 1SW-1324 was closed to separate the two safety trains while an evaluation was conducted. This evaluation was completed on February 25, 1988, and concluded that the seal water supply design was not in accordance with the requirement in the Final Safety Analysis Report (FSAR) that the ESW system be protected from passive failures. The evaluation also concluded that maintaining one of the two manual isolation valves (1SW-1332 or 1SW-1324) closed was acceptable to comply with the FSAR requirements.

The valve failures have been attributed to debris accumulation, discovered during disassembly of the check valve 1SW-1336. As described above, the source of water for this system is the ESW header during ESW pump idle periods, when the normal service water pumps are in service supplying water from the cooling tower basin to the ESW headers. Accumulation of debris in the basin is expected, since raw lake water is the supply.

The design of the seal water supply for the ESW pumps did not consider the requirements in the FSAR for the system to be protected from all passive failures. ANSI Standards 58.9-1981 and 51.1-1983 allow exclusion of piping from passive failure considerations when the probability of such failures coincident with a demand for the system to function is sufficiently small. The seal water piping meets this criteria, but the FSAR requirement is that passive failures must be a design consideration.

1. The failed valves were repaired and retested, and the ESW system was returned to operable status on February 9, 1988.
2. The two safety trains of ESW seal water supply were isolated on February 12, 1988, and will remain isolated pending design changes to the system.
3. A change to the system configuration is being considered for implementation which will simplify the system configuration and ensure the ESW seal water supply meets the FSAR requirements.
4. A review of other similar applications of small valves required to isolate safety-related lines where poor water quality is expected is being conducted.
