SUBJECT: LER 88-014-00:on 880512,voluntary rept of RWCU sys resin  
 tank spill due to RWCU valves being open. W/8 ltr.

## LICENSEE EVENT REPORT (LER)

FACILITY NAME (1)  
Washington Nuclear Plant - Unit 2

TITLE (4)  
Voluntary Report of Reactor Water Cleanup (RWCU) System Resin Tank Spill Due To RWCU Valves Being Open - Cause Unknown

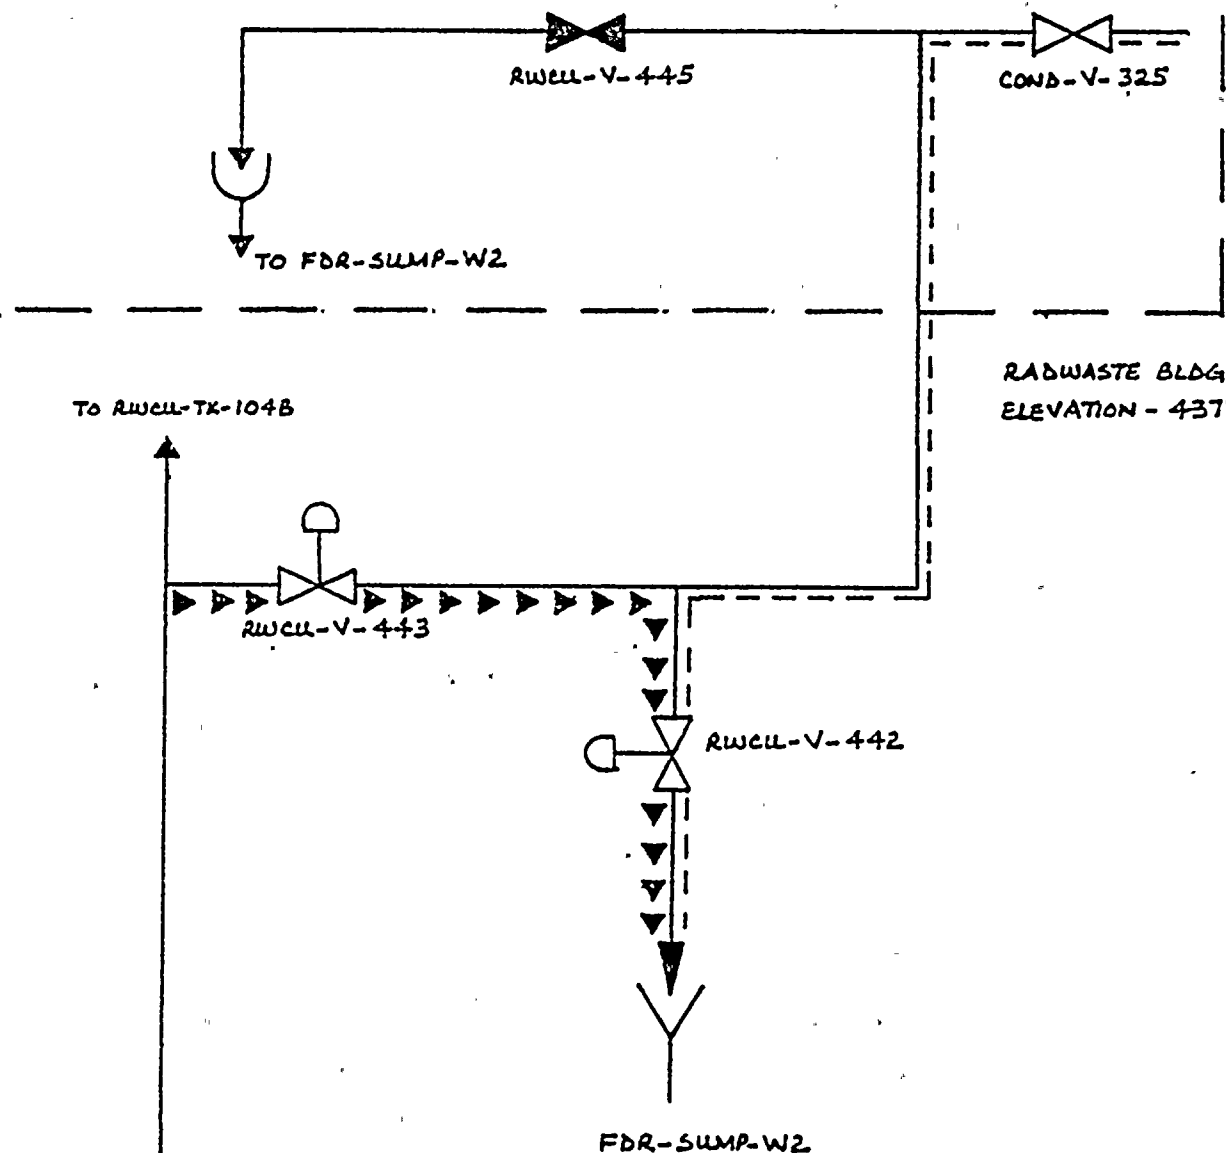
FIGURE 1

1. The immediate cause of this event was valves RWCU-V-442 and RWCU-V-443 being open. The root cause for the valves being open is indeterminate. As shown in Figure 1, this configuration created the following unknown leakage paths:

- o RWCU-V-442 and RWCU-V-443 Open (Resin Leakage Path)

With both valves open, and the start of RWCU-P-28, RWCU resin slurry was pumped through the valves to the drain system. As a result of RWCU-TK-104B level changes, it is estimated that 1,000 gallons was inadvertently drained from the tank. This equates to a resin loss of approximately 25-30 cubic feet. The bulk of the resin was contained in the liquid radwaste processing system.

o RWCU-V-442 Open (Condensate Leakage Path)

Condensate water was supplied through COND-V-325, down a 1/2" pipe and through RWCU-V-442 to the drain. It is estimated that the leakage through this flow path was 3.4 gpm.

► RESIN LEAKAGE PATH  
— CONDENSATE LEAKAGE PATH

1. RWCU-V-442 and 443 were tagged shut and de-energized.
2. PPM 2.11.1 was deviated to include RWCU-V-442 on the valve checklist. The required condition for both RWCU-442 and 443 on the valve checklist is "closed."
3. The RWO involved in this event was counseled on the importance of monitoring the status of operational tasks, including procedural compliance and believing Plant instrumentation unless proven otherwise.
