SUBJECT: LER 88-006-01:on 880213,low reactor pressure vessel level
 reactor protective sys actuation occurred.

FACILITY NAME (1) Washington Nuclear Plant - Unit 2										DOCKET NUMBER (2) 0 5 0 0 0 3 9 7 1 OF 1 0										PAGE (3) 1 OF 1 0											
TITLE (4) Low Reactor Pressure Vessel Level Reactor Protective System Actuation As a Result of Procedural Inadequacy																															
EVENT DATE (5)			LER NUMBER (6)				REPORT DATE (7)			OTHER FACILITIES INVOLVED (8)																					
MONTH	DAY	YEAR	YEAR	SEQUENTIAL NUMBER	REVISION NUMBER	MONTH	DAY	YEAR	FACILITY NAMES					DOCKET NUMBER(S)																	
0	2	1	3	8	8	8	8	0	0	6	0	1	0	9	0	2	8	8	0	5	0	0	0								
OPERATING MODE (9) 3			THIS REPORT IS SUBMITTED PURSUANT TO THE REQUIREMENTS OF 10 CFR §: (Check one or more of the following) (11)																												
POWER LEVEL (10) 0 0 0			20.402(b)				20.405(c)				<input checked="" type="checkbox"/> 50.73(a)(2)(iv)				73.71(b)

Subject: NUCLEAR PLANT NO. 2
LICENSEE EVENT REPORT NO. 88-06-01

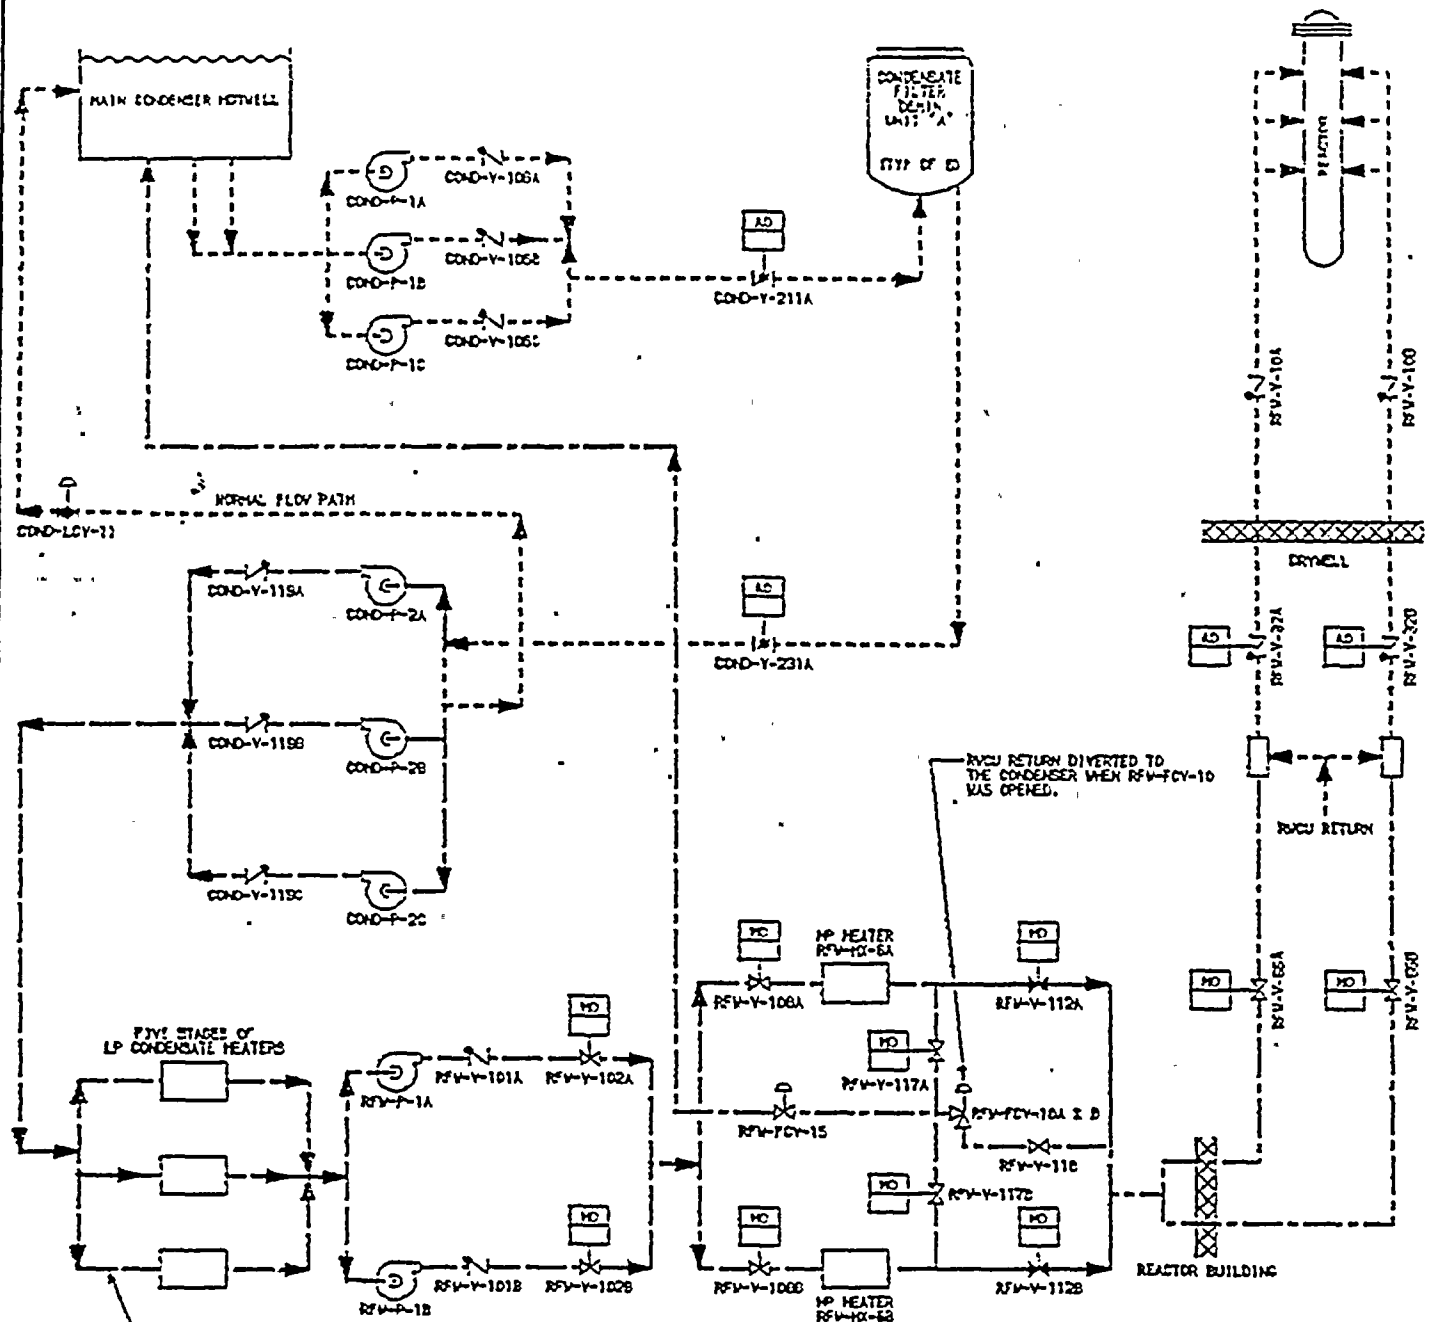
FIGURE 1
CONDENSATE AND FEEDWATER FLOWPATH

3. The immediate cause of the low RPV level RPS actuation was determined to be the opening of the Startup Flow Control Valve RFW-FCV-10A while RPV pressure was 250 psig greater than Reactor Feedwater System pressure. Because the Long Cycle Cleanup Valve RFW-FCV-15 had been previously opened to the condenser hotwell, opening RFW-FCV-10A resulted in a rapid diversion of water inventory from the RPV through the RWCU System backwards through RFW-FCV-10A to the condenser via RFW-FCV-15. The cause of this loss was unknown during the event.

5. The following were evaluated as contributing factors to the event:
 - o The condensate pump recirculation control valve COND-LCV-11 was inoperable due to high piping vibration experienced during previous use. This valve controls the preferred flowpath of condensate through the condensate filter demineralizers and back to the condenser hotwell when clean up of the feedwater system is desired. Inability to use this cleanup flow path necessitated the use of RFW-FCV-15, the Long Cycle Cleanup Flow Control Valve. During the event, the use of RFW-FCV-15 provided an unexpected diversion flowpath of water from the RPV via the RWCU System to the condenser hotwell. Normally RWCU flow would return to the RPV via the feedwater inlet piping.

LONG CYCLE FLOW PATH USED BECAUSE OF PIPE VIBRATION PROBLEMS ASSOCIATED WITH COND-LEV-11

7. The condensate pump minimum flow valve COND-LCV-11 will be modified during the upcoming 1988 refueling and maintenance outage to rectify the previously experienced vibration problems.
