SUBJECT: LER 88-031-00: on 880902, found that due to single failure  
 control room HVAC sys could operate in recirculation mode.  
 W/8 ltr.

FACILITY NAME (1)  
Washington Nuclear Plant - Unit 2DOCKET NUMBER (2)  
0 5 0 0 0 3 9 7PAGE (3)  
1 OF 0 7TITLE (4) Single Failure Could Cause Control Room HVAC to Operate in an Unanalyzed  
Operation Mode Due to DesignEVENT DATE (5)  
MONTH DAY YEAR YEAR  
0 9 0 2 8 8 8 8

Subject: NUCLEAR PLANT NO. 2  
LICENSEE EVENT REPORT NO. 88-031

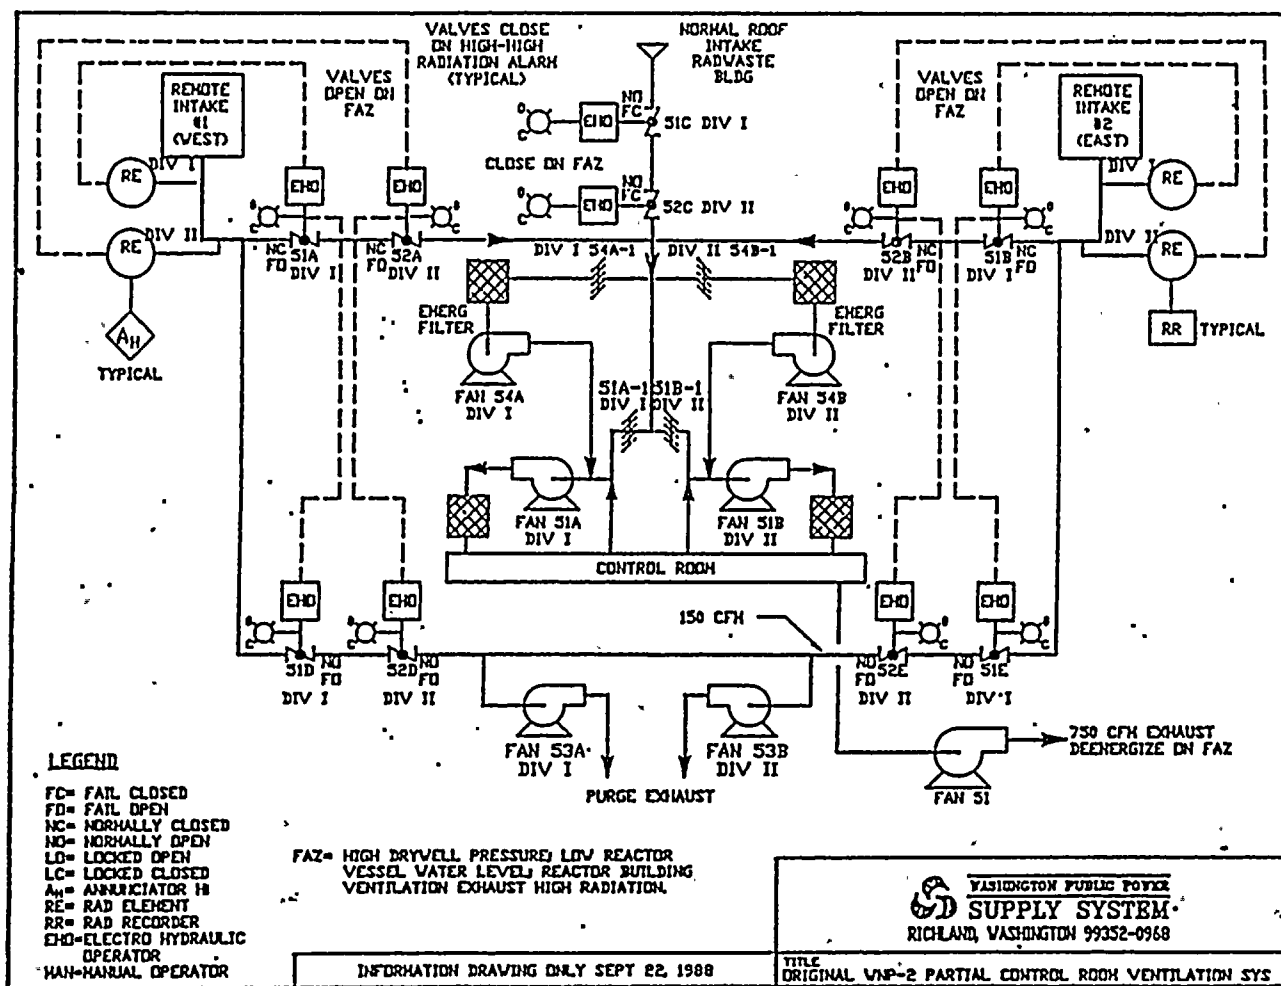
Figure 1 Pre-Event Control Room HVAC

The following brief description of the Control Room HVAC System (before modification) for normal operation and emergency operation during a Loss of Coolant Accident (LOCA) is presented to aid in understanding the event and the changes made to the system. Figure 1 is a partial diagram of the Control Room HVAC System prior to the event. The Control Room HVAC System consists of two redundant systems for both normal and emergency operation. During normal operation, 1000cfm of fresh air from the normal roof intake Radwaste Building is mixed with 20,000cfm of recirculated air (through fan 51A or 51B). Seven hundred and fifty (750) cfm is exhausted from the control room through fan 51 and the remaining 250cfm pressurizes the control room and is exfiltrated. Also during normal operation, the remote air intake isolation valves (51A and B and 52A and B) are closed and the radiation monitor purge line valves (51D and E and 52D and E) are open with radiation monitor purge line fans 53A and B operating. During a LOCA when any of the following trip levels are reached 1) High drywell pressure ("F" signal), 2) Low low reactor water level ("A" signal) or 3) Reactor building ventilation exhaust high radiation ("Z" signal) the following actions occur:

The event described in LER 88-005 was for leakage around the emergency filters in excess of the technical specification allowable limit. During the engineering evaluation committed to in LER 88-005 to determine the effect of the excess leakage on control room habitability, a design engineer determined that postulated single failures could cause some combination of remote air intake line isolation valves to fail to open or to re-isolate and; thus, isolate both remote air intake lines. If this condition existed during LOCA conditions, the Control Room HVAC would be running in a recirculation mode only since the normal roof intake is also isolated. In the recirculation mode the 20,000cfm would continue to be drawn from the control room and recirculated back to the control room; however, without the fresh air input the control room would not be pressurized. In a neutral pressure condition the inleakage to the control room would increase and this condition is not analyzed.

The cause of this event was the failure of the Plant Architect/Engineer (Burns & Roe Inc.) to provide a system design for which a single failure could not isolate both remote air intakes and cause the Control Room HVAC System to operate in the recirculation mode, or to analyze the recirculation mode of operation. The root cause of this event is a lack of communication between the Architect/Engineer design groups.
