SUBJECT: LER 88-034-00: on 880909, pipe failure caused by introduction  
 of liquid Nitrogen into primary containment supply purge.  
 W/8 ltr.

## LICENSEE EVENT REPORT (LER)

FACILITY NAME (1) Washington Nuclear Plant - Unit 2										DOCKET NUMBER (2) 0 5 0 0 0 3 9 7 1										PAGE (3) 1 OF 0 9	
TITLE (4) Pipe Failure Caused By Introduction of Liquid Nitrogen into the Primary Containment Supply Purge Piping Due to Personnel/Design/Maintenance Problems																					
EVENT DATE (5)			LER NUMBER (6)			REPORT DATE (7)			OTHER FACILITIES INVOLVED (8)												
MONTH	DAY	YEAR	YEAR	SEQUENTIAL NUMBER	REVISION NUMBER	MONTH	DAY	YEAR	FACILITY NAMES						DOCKET NUMBER(S)						
0 9	0 9	8 8	8 8	0 3 4	0 0	1 2 2	1 8 8								0 5 0 0 0						
OPERATING MODE (9)		THIS REPORT IS SUBMITTED PURSUANT TO THE REQUIREMENTS OF 10 CFR §: (Check one or more of the following) (11)																			
POWER LEVEL (10)		1		20.402(b)				20.405(c)				50.73(a)(2)(iv)				73.71(b)

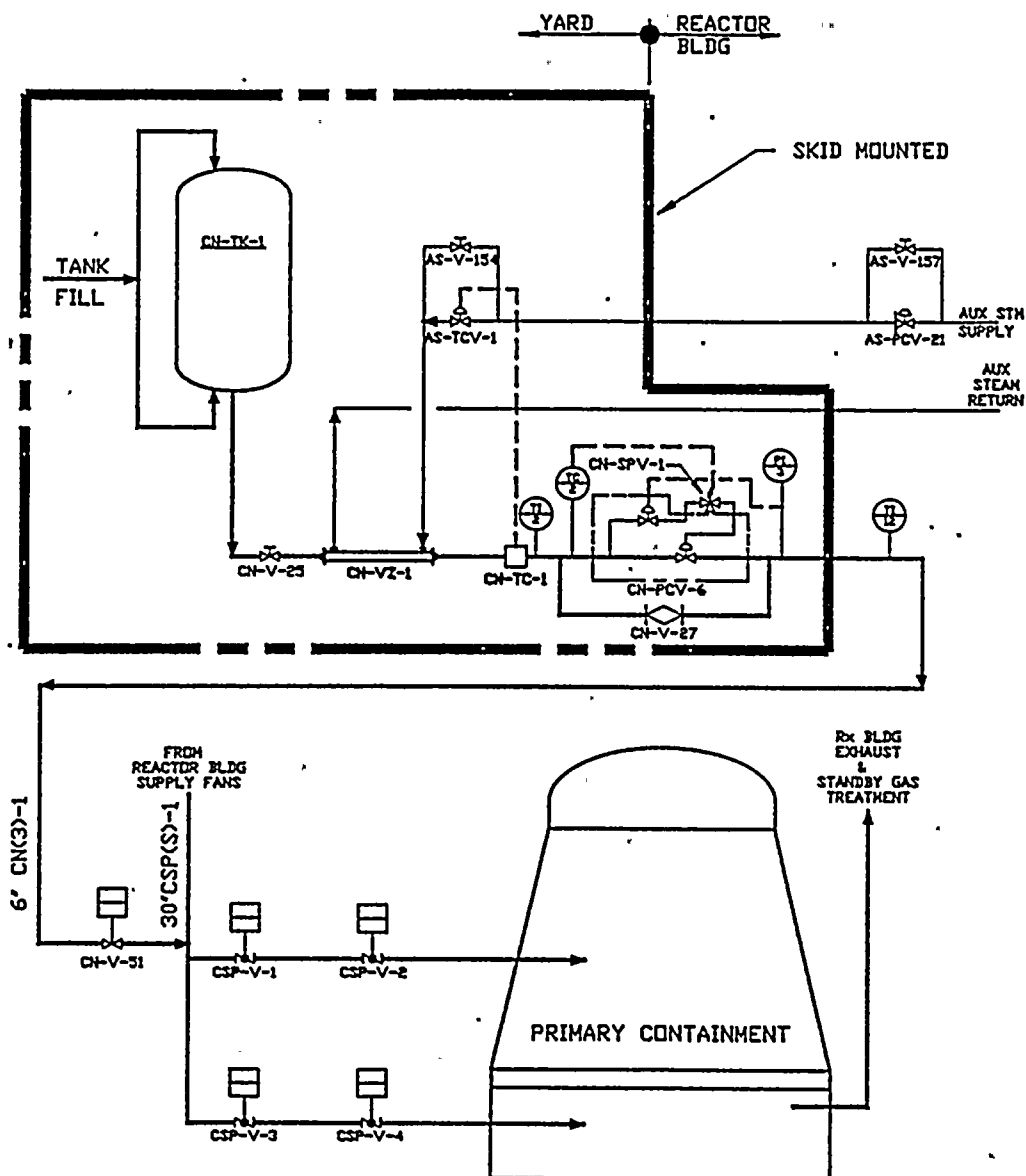
FIGURE 1 CONTAINMENT NITROGEN INERTING

Reference Figure 1. Liquid nitrogen supplied from the Liquid Nitrogen Storage Tank (CN-TK-1) is piped to a steam-heated Nitrogen Vaporizer (CN-VZ-1) which converts the liquid nitrogen to gaseous nitrogen. Steam is supplied to CN-VZ-1 by the Plant Auxiliary Steam (AS) System. The auxiliary steam pressure to the vaporizer is controlled by Auxiliary Steam Pressure Control Valve AS-PCV-21 and the temperature of the gaseous nitrogen exiting the vaporizer is controlled at 100°F by Auxiliary Steam Temperature Control Valve AS-TCV-1. The gaseous nitrogen pressure is controlled at 30 psi by Containment Nitrogen Pressure Control Valve CN-PCV-6 which also closes to isolate the system if the nitrogen temperature reaches 0°F. The isolation signal is from Containment Nitrogen Temperature Controller CN-TC-2. The nitrogen gas is piped via the 6-inch Containment Nitrogen Supply line and the 30-inch Containment Supply Purge lines to the containment.
