SUBJECT: LER 88-037-00:on 881130,plant Tech Specs initiated shutdown  
 because of containment supply purge valve air leak.

FACILITY NAME (1) Washington Nuclear Plant - Unit 2										DOCKET NUMBER (2) 0 5 0 0 0 3 9 7 1										PAGE (3) 1 OF 0 6	
TITLE (4) Plant Technical Specification-Initiated Shutdown Because of Containment Supply Purge Valve Air Leak Due to Seal Failure - Cause Unknown																					
EVENT DATE (5)			LER NUMBER (6)				REPORT DATE (7)			OTHER FACILITIES INVOLVED (8)											
MONTH	DAY	YEAR	YEAR	SEQUENTIAL NUMBER	REVISION NUMBER	MONTH	DAY	YEAR	FACILITY NAMES						DOCKET NUMBER(S)						
11	30	88	88	037	00	12	3	88							0 5 0 0 0						
OPERATING MODE (9) 1		THIS REPORT IS SUBMITTED PURSUANT TO THE REQUIREMENTS OF 10 CFR §: (Check one or more of the following) (11)																			
POWER LEVEL (10) 1100		20.402(b)				20.405(c)				60.73(a)(2)(iv)				73.71(b)

Subject: NUCLEAR PLANT NO. 2  
LICENSEE EVENT REPORT NO. 88-037

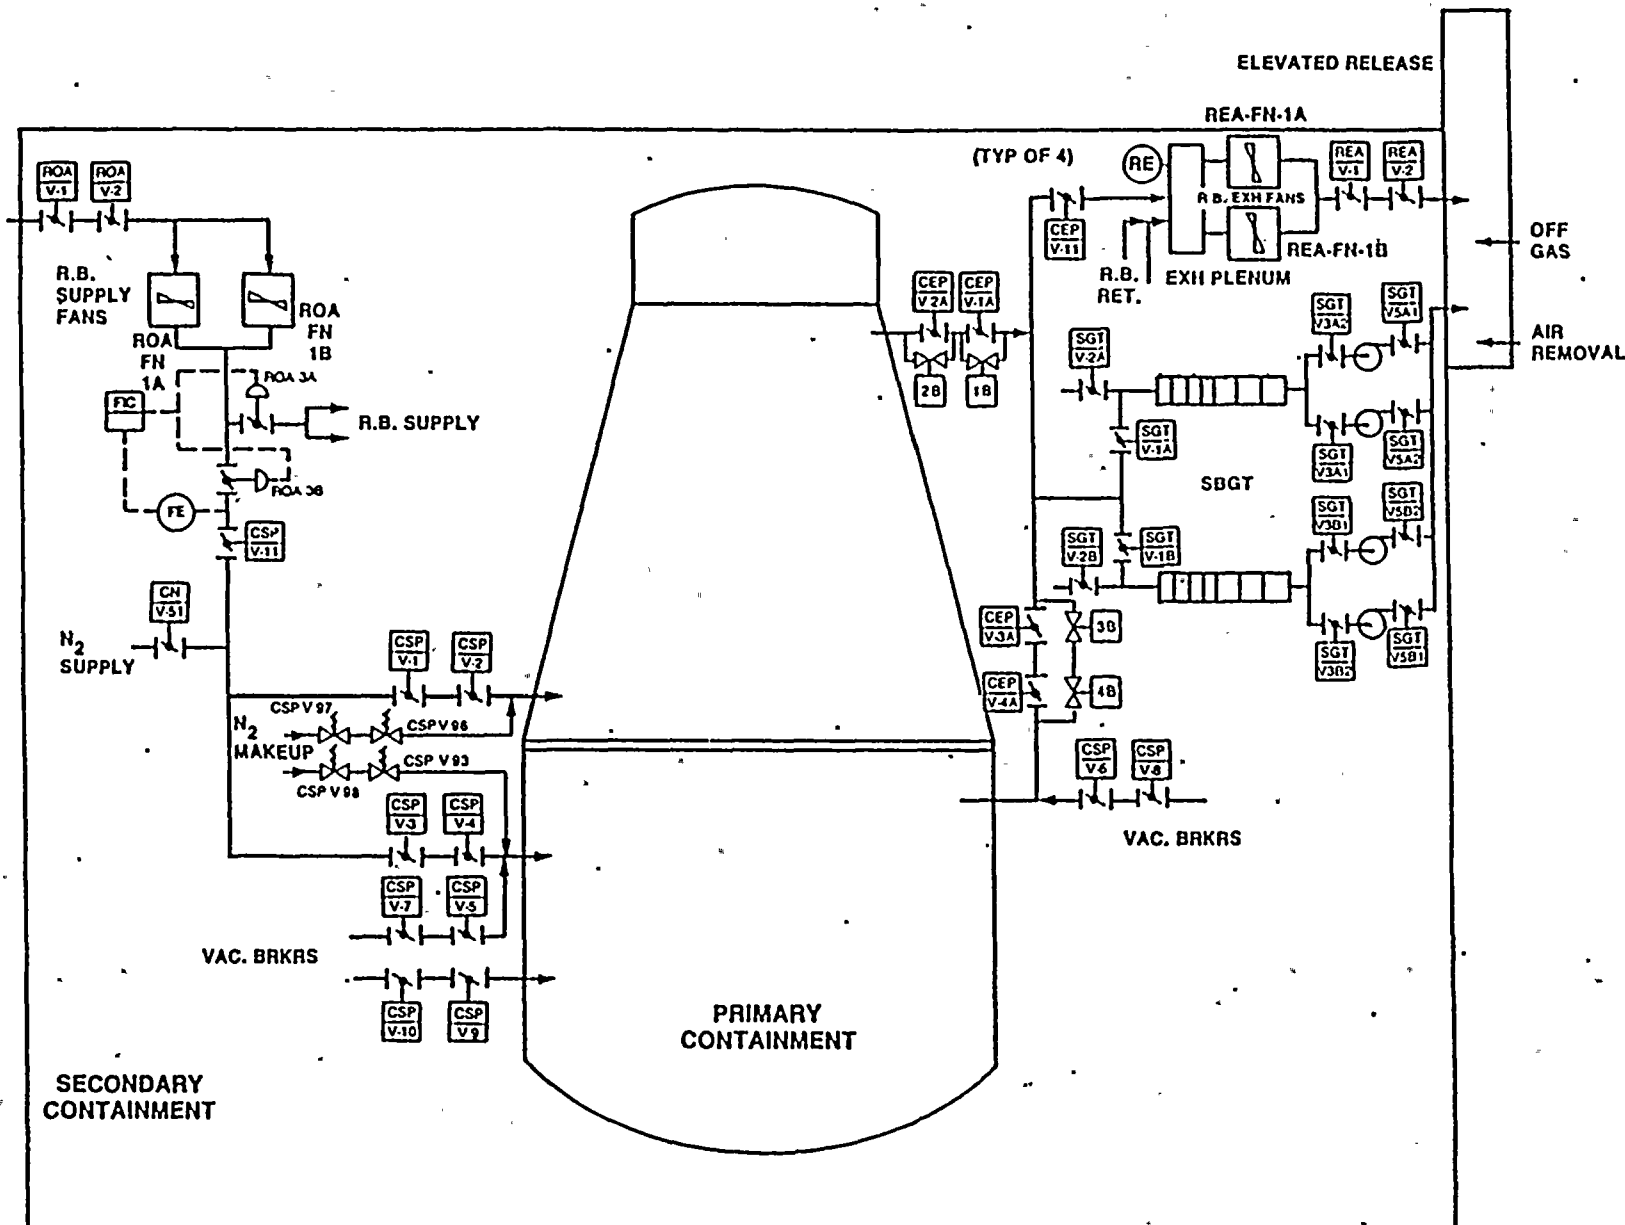
FIGURE 1

There are three Reactor Building-to-Wetwell relief lines each containing a 24-inch vacuum breaker (check) valve and an air-operated butterfly valve. The check valves are CSP-V-7,8 and 10; the butterfly valves are CSP-V-5,6 and 9 (Reference Figure 1). These valves prevent a vacuum from developing in the primary containment due to condensing steam. Actuation of the butterfly valves is controlled by the differential pressure between the suppression chamber and the Reactor Building. Both types of valves are set to open at 0.5 psid.
