SUBJECT: LER 89-001-01: on 890112, unanalyzed failure modes for
 containment nitrogen sys caused by inadequate DP.
 W/8 ltr.

LICENSEE EVENT REPORT (LER)

FACILITY NAME (1) Washington Nuclear Plant - Unit 2										DOCKET NUMBER (2) 0 5 0 0 0 3 9 1 7										PAGE (3) 1 OF 0 6	
TITLE (4) Unanalyzed Failure Modes for Containment Nitrogen System Caused By Inadequate Design Procedures																					
EVENT DATE (5)			LER NUMBER (6)				REPORT DATE (7)			OTHER FACILITIES INVOLVED (8)											
MONTH	DAY	YEAR	YEAR	SEQUENTIAL NUMBER	REVISION NUMBER	MONTH	DAY	YEAR	FACILITY NAMES			DOCKET NUMBER(S)									
0	1	1	2	8	9	8	9	0	0	1	0	3	2	7	8	9	0 5 0 0 0				
OPERATING MODE (9)		THIS REPORT IS SUBMITTED PURSUANT TO THE REQUIREMENTS OF 10 CFR §: (Check one or more of the following) (11)																			
POWER LEVEL (10)		20.402(b)														20.405(c)		50.73(a)(2)(iv)		73.71(b)	
0		20.405(a)(1)(i)														50.38(c)(1)		50.73(a)(2)(v)		73.71(c)

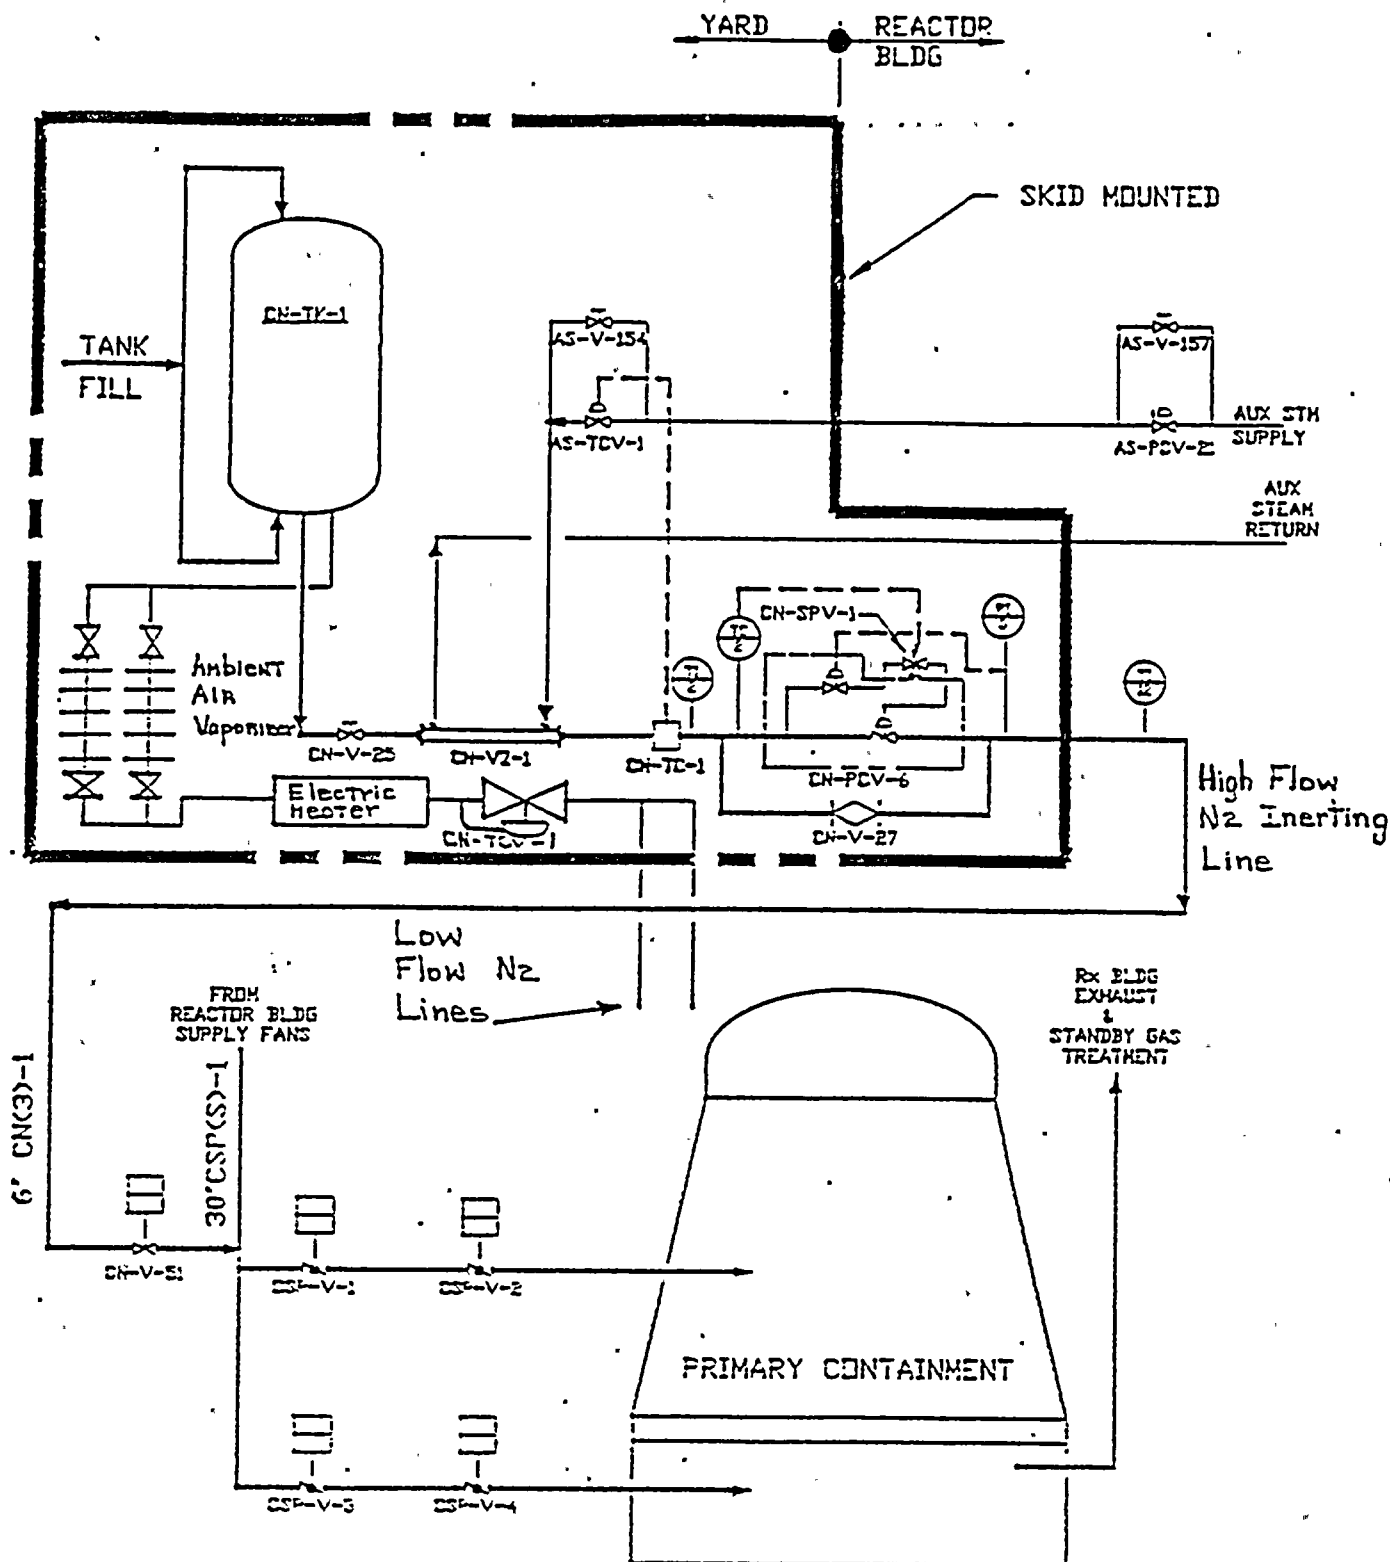
FIGURE 1 CONTAINMENT NITROGEN INERTING

On January 12, 1989 as a result of an engineering evaluation of the Containment Nitrogen Inerting (CN) system, four new failure modes of this non-safety related system were identified. This condition was discovered during performance of corrective action for the event reported in LER 88-034-00 "Pipe Failure Caused by Introduction of Liquid Nitrogen into the Primary Containment Supply Purge Piping Due to Personnel/Design/Maintenance Problems". An engineering review of the CN System design, being performed to investigate potential failure modes, found four new failure modes which could result in the degradation of safety related equipment as summarized below (see attached diagram Figure 1):

- a) Failure Mode 1 - Loss of auxiliary steam or nitrogen pressure control (failure of high N2 flow pressure control valve CN-PCV-6) resulting in liquid nitrogen being introduced into the "high flow" inerting header. This header is not capable of withstanding cryogenic temperatures.

- b) Failure Mode 2 - A break in the "low flow" line or loss of electric heater on the "low flow" line when this line is supplied from the bottom of the Liquid Nitrogen Tank CN-TK-1. Again, liquid nitrogen is introduced into piping not designed for cryogenic temperatures.

- c) Failure Mode 3 - A tornado missile that causes failure of the exposed CN-TK-1 and associated piping outside the buildings that results in release of large quantities of liquid nitrogen which might starve the emergency diesel generators of oxygen.

- d) Failure Mode 4 - Non-mechanistic rupture of the Liquid Nitrogen Storage Tank CN-TK-1 or the liquid lines beneath the tank that might result in oxygen starvation of the emergency diesel generators.
