SUBJECT: LER 89-004-00: on 890226, mobile crane located near safety-related structures & components w/o safety evaluation.
 W/8 ltr.

LICENSEE EVENT REPORT (LER)

FACILITY NAME (1) Washington Nuclear Plant - Unit 2															DOCKET NUMBER (2) 0 5 0 0 0 3 9 1 7										PAGE (3) 1 OF 0 1 6								
TITLE (4) Mobile Crane Near Safety Related Structures and Components without a Safety Evaluation Due to Lack of Procedures																																	
EVENT DATE (5)			LER NUMBER (6)						REPORT DATE (7)			OTHER FACILITIES INVOLVED (8)																					
MONTH	DAY	YEAR	YEAR		SEQUENTIAL NUMBER		REVISION NUMBER	MONTH	DAY	YEAR	FACILITY NAMES						DOCKET NUMBER(S)																
																	0 5 0 0 0																
0	2	2	6	8	9	8	9	0	0	4	0	0	0	3	3	1	8	9							0 5 0 0 0								
OPERATING MODE (9)			THIS REPORT IS SUBMITTED PURSUANT TO THE REQUIREMENTS OF 10 CFR §: (Check one or more of the following) (11)																														
4			20.402(b)						20.405(c)						50.73(a)(2)(iv)						73.71(b)												
POWER LEVEL (10)			20.405(a)(1)(i)						50.38(c)(1)						<input checked="" type="checkbox"/> 50.73(a)(2)(v)						73.71(c)

Subject: NUCLEAR PLANT NO. 2
LICENSEE EVENT REPO

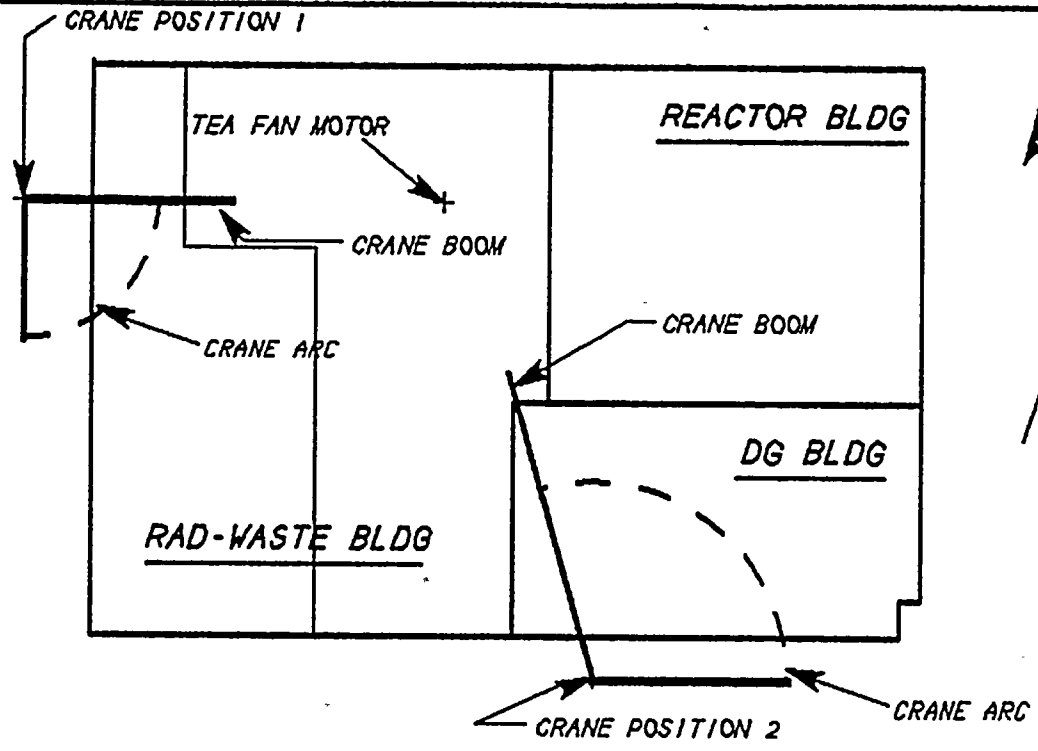
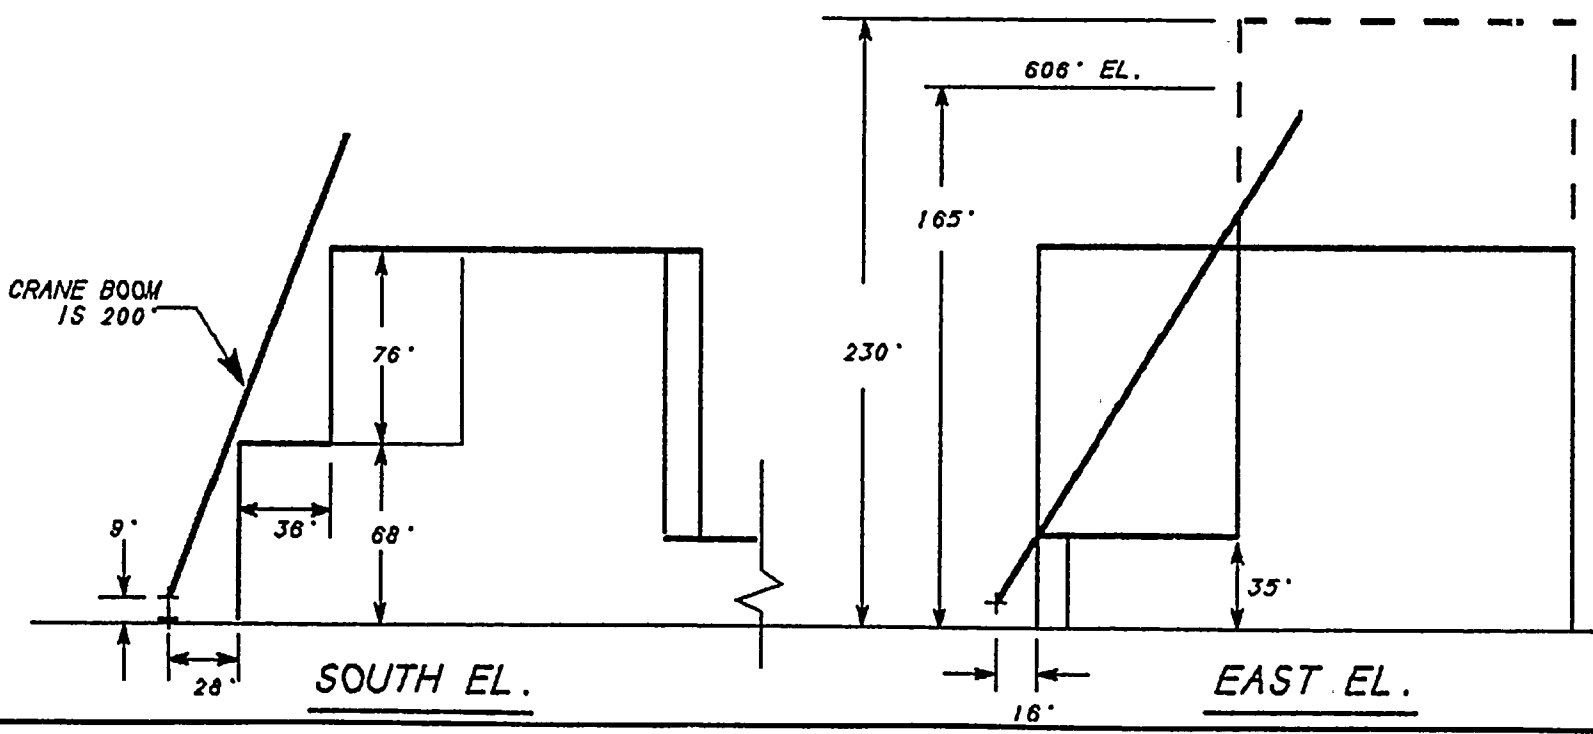
FIGURE 1

The boom was swung over the Radwaste Building and the Diesel Generator (DG) Building in separate attempts to reach a Turbine Exhaust Air (TEA) fan motor on the roof of the Radwaste Building. After approximately 30 minutes in the area, Plant Technical personnel realized the crane was over safety related structures and components and the crane was immediately moved outside of the protected area.
