SUBJECT: LER 89-009-00:on 880529,reactor protection sys actuation
 due to low control rod drive scram air header pressure.
 W/8 ltr.

LICENSEE EVENT REPORT (LER)

Subject: NUCLEAR PLANT NO. 2
LICENSEE EVENT REPORT NO. 89-009

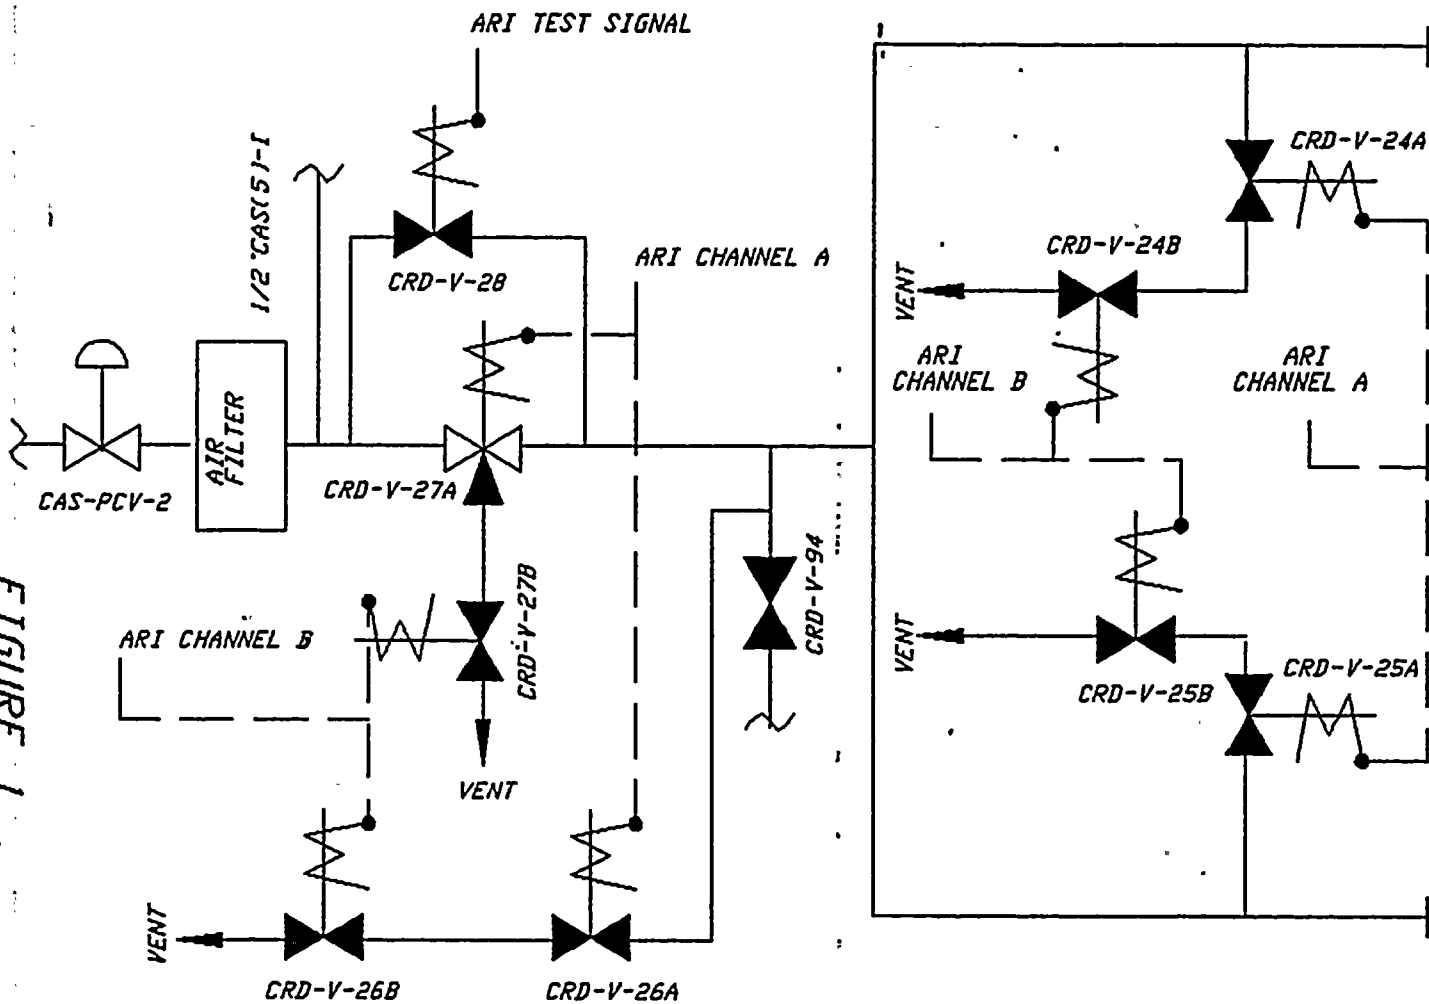
FIGURE 1

NOTE: PARTIAL REPRESENTATION OF CONTROL AIR SYSTEM AND CONTROL ROD DRIVE SYSTEM
