SUBJECT: Part 21 rept re defect in Limitorque valve motor operator
 Model SMB-2 w/soft worm shaft clutch gear assembly.

April 26, 1989
G02-89-070

Subject: **NUCLEAR PLANT NO. 2**
 10CFR PART 21 REPORT

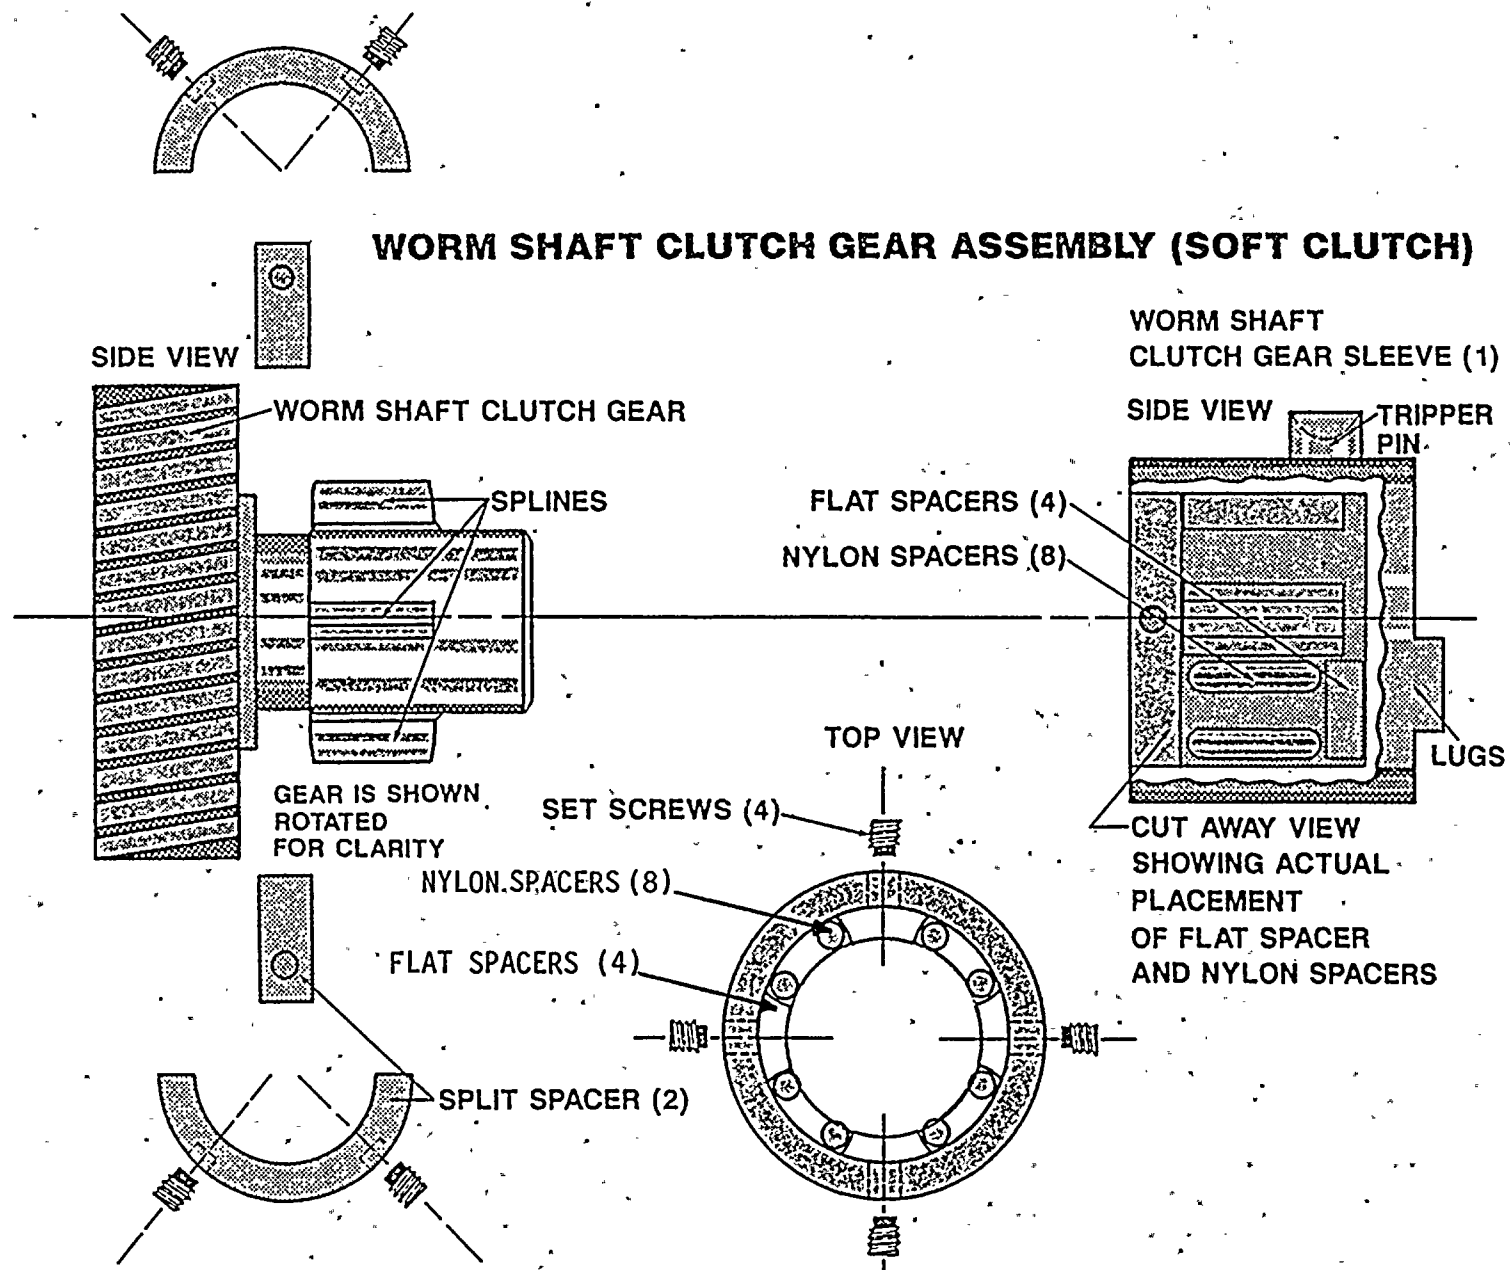
FIGURE 1

When the valve motor operator (HPCS-MO-15) was manufactured, the split spacer (See Figure 1) of the worm shaft clutch gear assembly was not installed as required. This is a deviation in a delivered component which was installed and operated at WNP-2. This defect caused the motor operator to fail such that the valve would not operate, except by manual operation (which was very difficult).

The nature of the failure is as follows. With the split spacer not installed (See Figure 1), the set screws installed through the worm shaft clutch gear sleeve had no surface to press against and hold the worm shaft clutch gear assembly together. When the worm shaft clutch was positioned for manual operation the worm shaft clutch gear sleeve worked its way off the worm shaft clutch gear (See Figure 2). When the motor operator was re-engaged the worm shaft clutch gear sleeve would catch on the worm shaft clutch gear splines which forced the sleeve lugs against the clutch, and the clutch against the handwheel clutch pinion assembly. Because the clutch is spring loaded, both the motor and manual clutch lugs would slide over each other causing excessive wear. In addition, the worm shaft clutch gear was pressed against the split ring and split ring retainer. Eventually the split ring retainer failed and the split ring fell into the valve motor operator assembly. After this occurred, the clutch gear and clutch gear sleeve separated sufficiently to allow the sleeve to spin freely (i.e. not catch on the splines). In this condition the motor operator would not work. At the time the motor operator failed, the handwheel manual operation was sporadic due to the wear on the clutch/manual lugs.

Worm Shaft Components SMB - 0 thru SMB - 4

- 1) During the upcoming Refueling and Maintenance Outage the safety related valves listed in Appendices A and B will be manually operated (See discussion below).
- 2) The Plant procedure for maintenance and repair of Limitorque valve motor operators will be revised to include instructions for inspecting the worm shaft clutch gear assembly anytime a motor operator is disassembled.
- 3) Cautions will be added to appropriate Plant procedures regarding disposition of valves found difficult to operate manually (See discussion following).

Even with the split spacer not installed this type of failure requires additional circumstances. When positioned for motor operation the worm shaft clutch gear and sleeve are held together by the clutch spring pressure and cannot separate. Only when positioned for manual operation, when the spring pressure on the worm shaft clutch gear assembly is relieved, can the gear and sleeve separate. The safety related valves listed in Appendices A and B are normally positioned for motor operation and are only manually engaged during maintenance and ASME Section XI Valve Position Indication (VPI) testing. A characteristic of this failure was the degradation of the handwheel clutch pinion assembly which made manual operation difficult. If during the above maintenance and testing activities a valve is found difficult to operate manually, the worm shaft clutch gear assembly will be inspected.

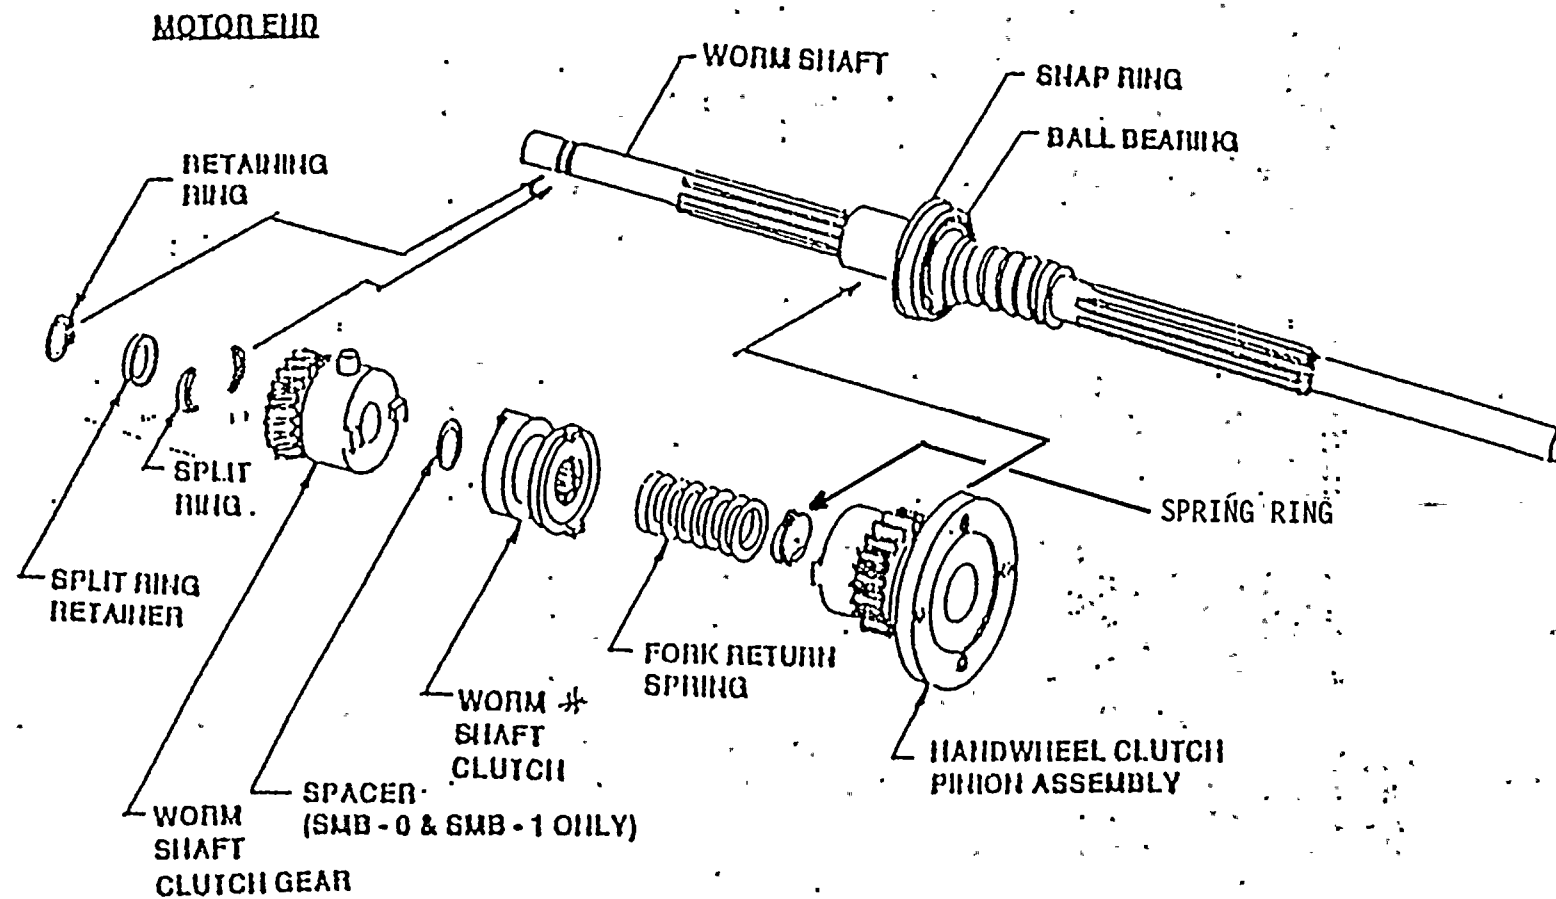
FIGURE 2

*Worm shaft clutch shown
180° out of position
