SUBJECT: Part 21 rept re defect discovered in valve motor operator of
 RCIC inboard containment isolation valve RCIC-V-63.

June 2, 1989
G02-89-104

Subject: NUCLEAR PLANT NO. 2
 LICENSE NO. NPF-21
 10CFR PART 21 REPORT

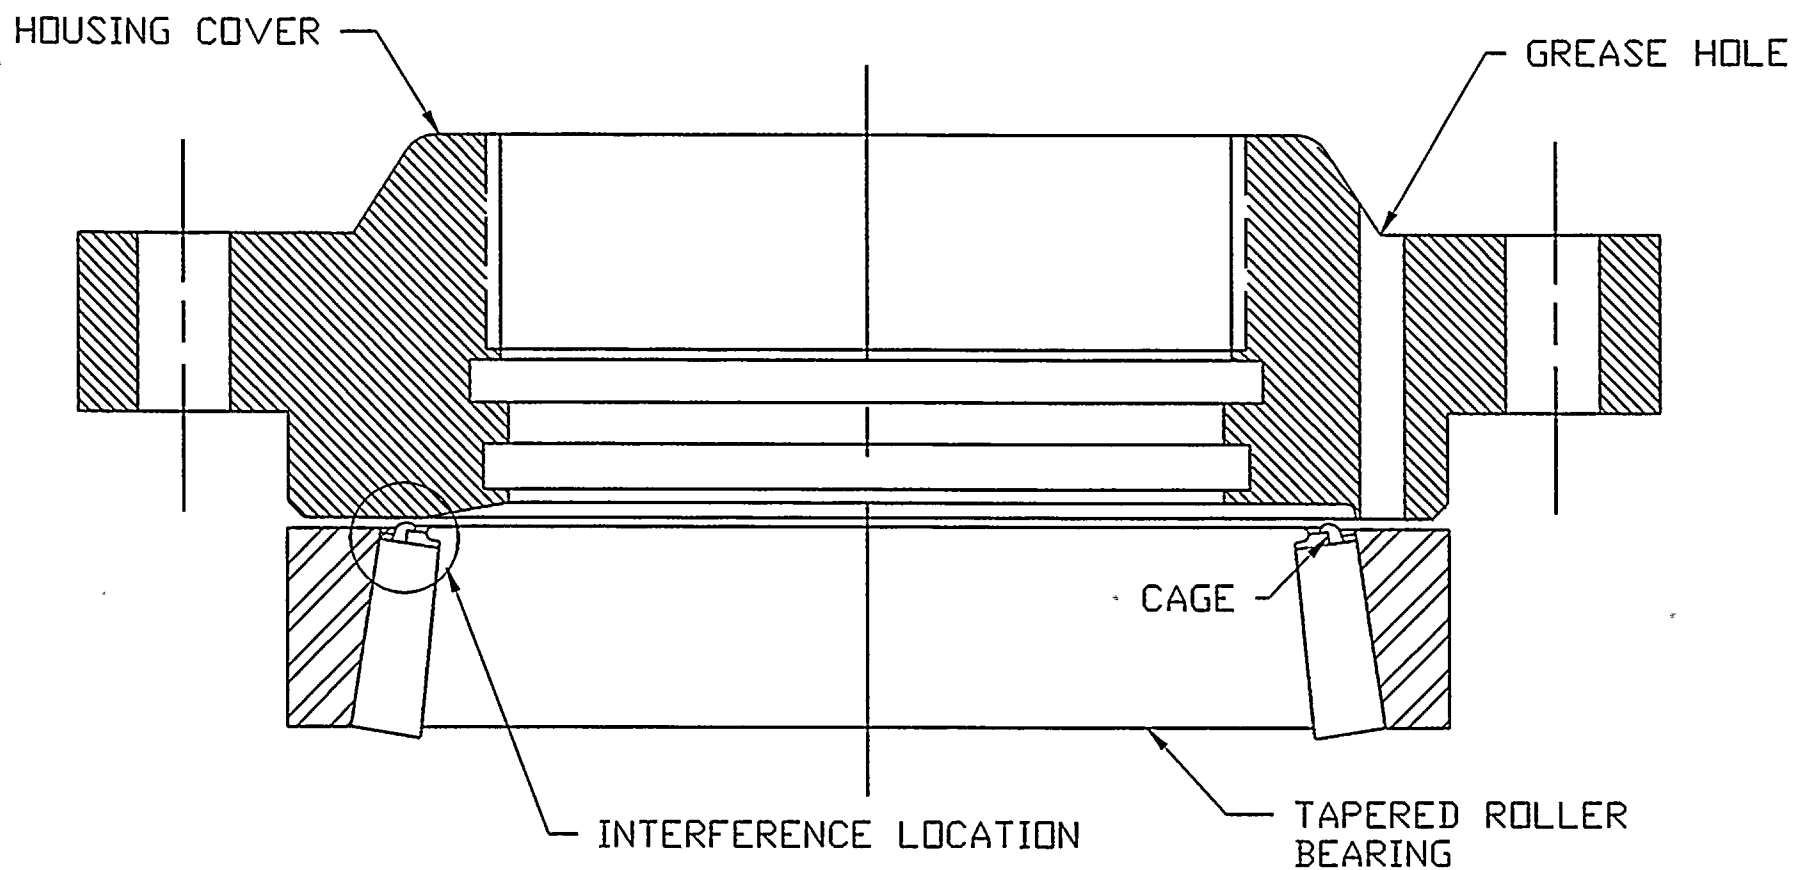
FIGURE 1

The defect is in the casting of the upper housing cover of the motor operator. Excess material was left following the casting process on the inside of the upper housing cover. The excess material causes the upper housing cover to exert pressure on the drive sleeve of the upper thrust bearing and prevent free rotation of the bearing. This is a deviation in a delivered component which was installed and operated at WNP-2. An unusual diagnostic test signature for RCIC-V-63 valve/motor operator was obtained during the 1988 Refueling and Maintenance Outage (May - June 1988). The motor current was higher than normal, but within name plate rating, in relation to developed stem thrust to the valve. This defect can cause a decrease in the developed stem thrust to the valve in relation to motor power.

The nature of the failure is as follows: The upper housing cover is made from a casting which has a machined surface which sits on the outer ring of the upper thrust bearing exerting no force on the bearing (see Figure 1). The bearing has a cage which holds the bearing rollers in place. The cage extends above the bearing by approximately .1 inches and the housing cover is designed to provide a recess of 7.32 inches in diameter and .188 inches deep so that the bearing can rotate freely. In the defective housing of RCIC-MO-63 the clearance was less than .1 inch at the cage diameter causing the cage to rub against the housing cover. Therefore, a portion of the motor thrust was diverted to turn the bearing instead of the valve. The torque switch of the motor operator is set to provide the stem thrust necessary for the valve to operate under specified conditions. With some of the motor thrust diverted to turn the bearing, it is possible that the stem thrust at the valve would not be sufficient to operate the valve under all required conditions.

SECTION VIEW OF THRUST BEARING AND HOUSING COVER

- a) The upper housing cover of RCIC-MO-63 will be machined to remove the excess material to provide the required recess of 7.32 inch diameter and .18 inch depth. Also, the upper thrust bearing will be replaced before reassembling the motor operator.
- b) On May 31, 1989 Limitorque was contacted and asked if this problem had been previously identified and, if so, what was the extent of the problem. Limitorque responded that they had never seen this problem before. Limitorque also stated that the SMB-2 covers would not be used to make any other Model SMB upper housing covers; therefore, if this problem is due to casting defect it would be limited to the Model SMB-2 motor operators.
