SUBJECT: LER 89-005-00:on 890311,multiple control rod drifts caused
 by momentary low scram air header pressure due to trips..
 W/8 ltr.

Subject: NUCLEAR PLANT NO. 2
LICENSEE EVENT REPORT NO. 89-005

FACILITY NAME (1) Washington Nuclear Plant - Unit 2										DOCKET NUMBER (2) 0 5 0 0 0 3 9 7										PAGE (3) 1 OF 1 0																		
TITLE (4) Multiple Control Rod Drifts Caused by Momentary Low Scram Air Header Pressure Due to Multiple Rapid Half-Scram Trips and Resets																																						
EVENT DATE (5)						LER NUMBER (6)						REPORT DATE (7)						OTHER FACILITIES INVOLVED (8)																				
MONTH			DAY			YEAR			YEAR			SEQUENTIAL NUMBER			REVISION NUMBER			MONTH			DAY			YEAR			FACILITY NAMES						DOCKET NUMBER(S)					
0 3 1 1			8 9			8 9			-			0 0 5			-			0 0 6			1 6 8 9									0 5 0 0 0								
OPERATING MODE (9)						THIS REPORT IS SUBMITTED PURSUANT TO THE REQUIREMENTS OF 10 CFR §: (Check one or more of the following) (11)																																
POWER LEVEL (10) 0 7 8						20.402(b)						20.405(c)						50.73(a)(2)(iv)						73.71(b)

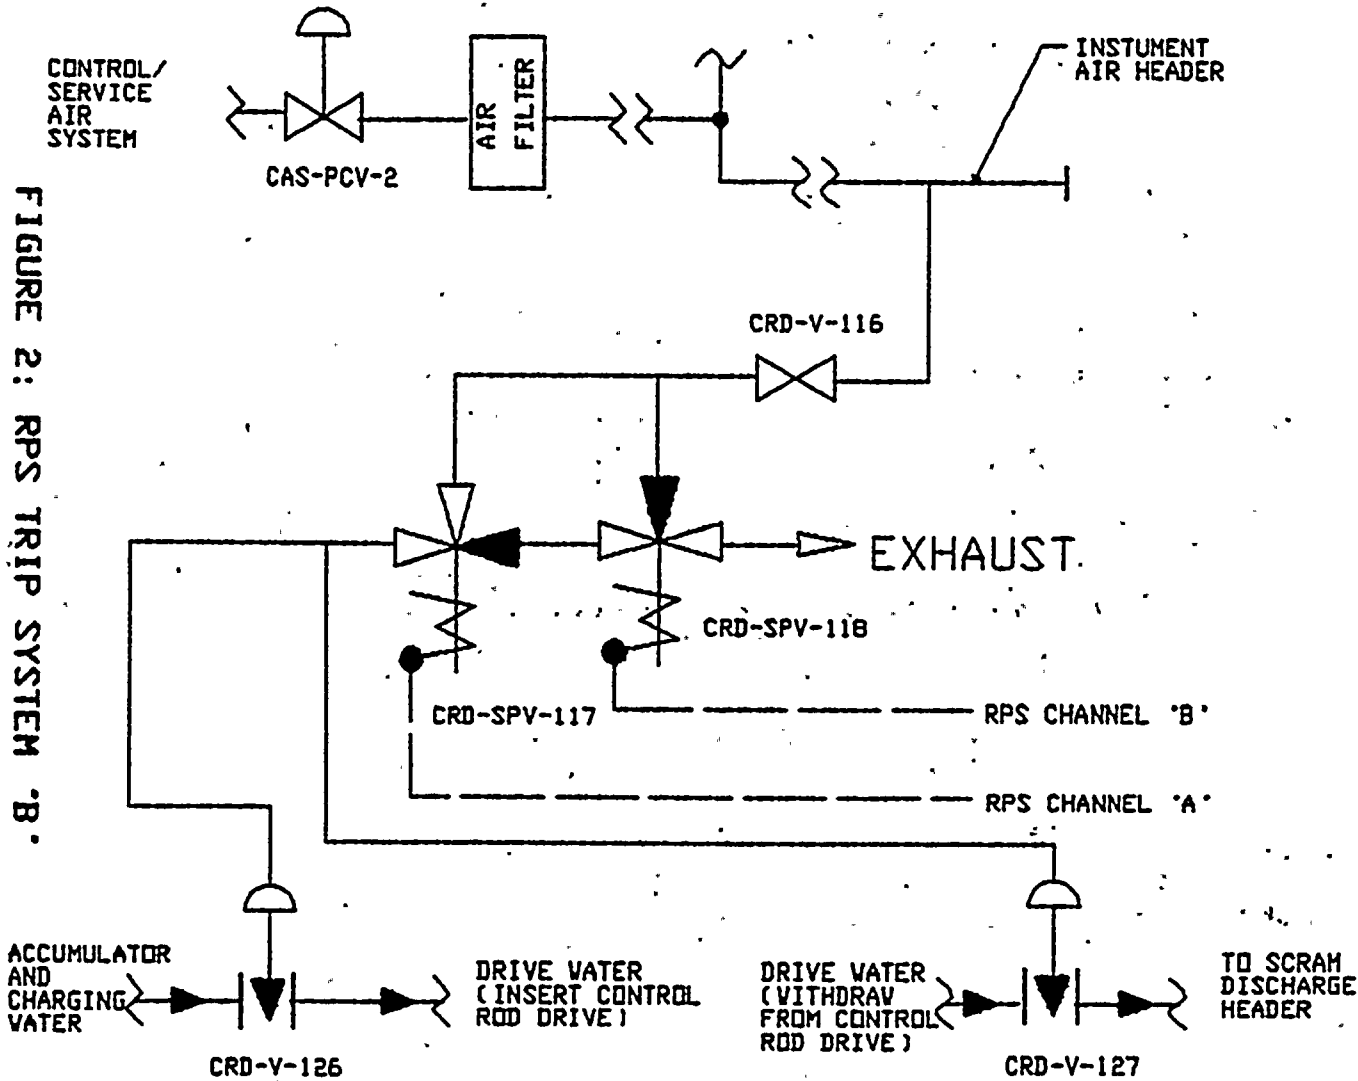
FIGURE 2: RPS TRIP SYSTEM 'B' TRIP

The RPS scram contactor (K14 relay) de-energizes when the radiation monitor trips. The RPS reset pushbutton re-energizes the scram contactor when no trip signal exists. While the reset pushbutton is depressed, the tripping and resetting of the radiation monitor also cycles the scram contactor. Cycling of the scram contactor cycles the CRD scram air pilot valve (CRD-SPV-118) on each HCU. See Figure 1 for piping schematic of the scram pilot valves and the scram valves for one HCU in the normal operation configuration and Figure 2 for the RPS Trip System "B" half-scam configuration. Energizing the CRD-SPV-118 to the vent position vents a small portion of the instrument air piping between the scram air pilot valves (CRD-SPV-117 and CRD-SPV-118) to atmosphere. While the solenoid valve is rapidly changing position, a scram air header vent path is also established for a short time.

The cause of the rod drift event was the rapid cycling of the RPS relays/solenoids during the period of time the RPS reset pushbuttons were depressed, thus allowing the scram air header (local effect only) to vent to atmosphere.
