SUBJECT: LER 89-005-00:on 890311,multiple control rod drifts caused  
 by momentary low scram air header pressure. W/8 ltr.

Subject: NUCLEAR PLANT NO. 2  
LICENSEE EVENT REPORT NO. 89-005

FACILITY NAME (1) Washington Nuclear Plant - Unit 2										DOCKET NUMBER (2) 0 5 0 0 0 3 9 7					PAGE (3) 1 OF 1 0	
TITLE (4) Multiple Control Rod Drifts Caused by Momentary Low Scram Air Header Pressure Due to Multiple Rapid Half-Scram Trips and Resets																
EVENT DATE (5)			LER NUMBER (6)				REPORT DATE (7)			OTHER FACILITIES INVOLVED (8)						
MONTH	DAY	YEAR	YEAR	SEQUENTIAL NUMBER	REVISION NUMBER	MONTH	DAY	YEAR	FACILITY NAMES				DOCKET NUMBER(S)			
0	3	1	1	8	9	8	9	0	0	5	0	0	0	0	0	0
OPERATING MODE (9)		THIS REPORT IS SUBMITTED PURSUANT TO THE REQUIREMENTS OF 10 CFR §: (Check one or more of the following) (11)														
1		20.402(b)				20.405(c)				50.73(a)(2)(iv)				73.71(b)		
POWER LEVEL (10)		20.405(a)(1)(i)				50.38(c)(1)				50.73(a)(2)(v)				73.71(c)		
0 7 8		20.405(a)(1)(ii)				50.38(c)(2)				50.73(a)(2)(vi)				X OTHER (Specify in Abstract below and in Text, NRC Form 366A)

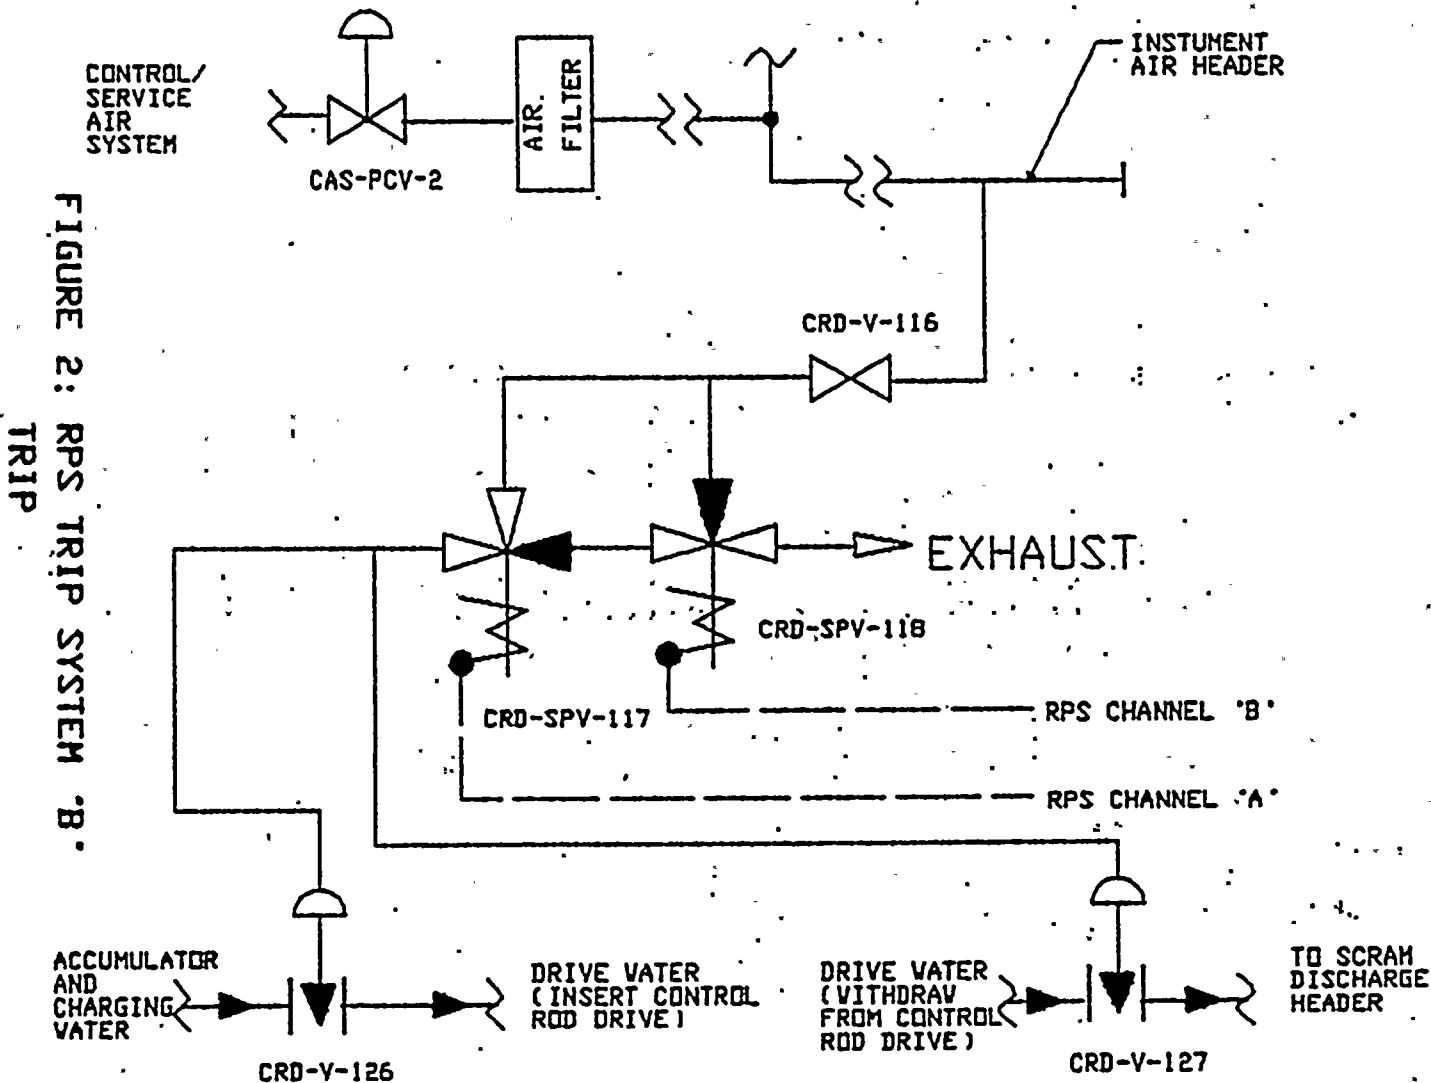
FIGURE 2: RPS TRIP SYSTEM 'B' TRIP

The RPS scram contactor (K14 relay) de-energizes when the radiation monitor trips. The RPS reset pushbutton re-energizes the scram contactor when no trip signal exists. While the reset pushbutton is depressed, the tripping and resetting of the radiation monitor also cycles the scram contactor. Cycling of the scram contactor cycles the CRD scram air pilot valve (CRD-SPV-118) on each HCU. See Figure 1 for piping schematic of the scram pilot valves and the scram valves for one HCU in the normal operation configuration and Figure 2 for the RPS Trip System "B" half-scam configuration. Energizing the CRD-SPV-118 to the vent position vents a small portion of the instrument air piping between the scram air pilot valves (CRD-SPV-117 and CRD-SPV-118) to atmosphere. While the solenoid valve is rapidly changing position, a scram air header vent path is also established for a short time.
