SUBJECT: LER 89-030-00: on 890728, high pressure core spray inoperable  
 due to suppression pool pump suction valve failure.  
 W/8 ltr.

Subject: NUCLEAR PLANT NO. 2  
LICENSEE EVENT REPORT NO. 89-030

FACILITY NAME (1) Washington Nuclear Plant - Unit 2														DOCKET NUMBER (2) 0 5 0 0 0 3 1 9 7 1						PAGE (3) OF 0 8								
TITLE (4) High Pressure Core Spray System Inoperable Caused by Suppression Pool Pump Suction Valve Failure Due to Motor Operator Manufacturing Error																												
EVENT DATE (5)			LER NUMBER (6)					REPORT DATE (7)			OTHER FACILITIES INVOLVED (8)																	
MONTH	DAY	YEAR	YEAR	SEQUENTIAL NUMBER	REVISION NUMBER	MONTH	DAY	YEAR	FACILITY NAMES						DOCKET NUMBER(S)													
0	7	2	8	8	9	8	9	0	0	3	0	0	0	0	8	2	5	8	9	0	5	0	0	0				
OPERATING MODE (9)			THIS REPORT IS SUBMITTED PURSUANT TO THE REQUIREMENTS OF 10 CFR §: (Check one or more of the following) (11)																									
1			20.402(b)					20.405(c)					50.73(a)(2)(iv)					73.71(b)										
POWER LEVEL (10)			0 7 8					20.405(a)(1)(i)					50.73(a)(2)(v)					73.71(c)

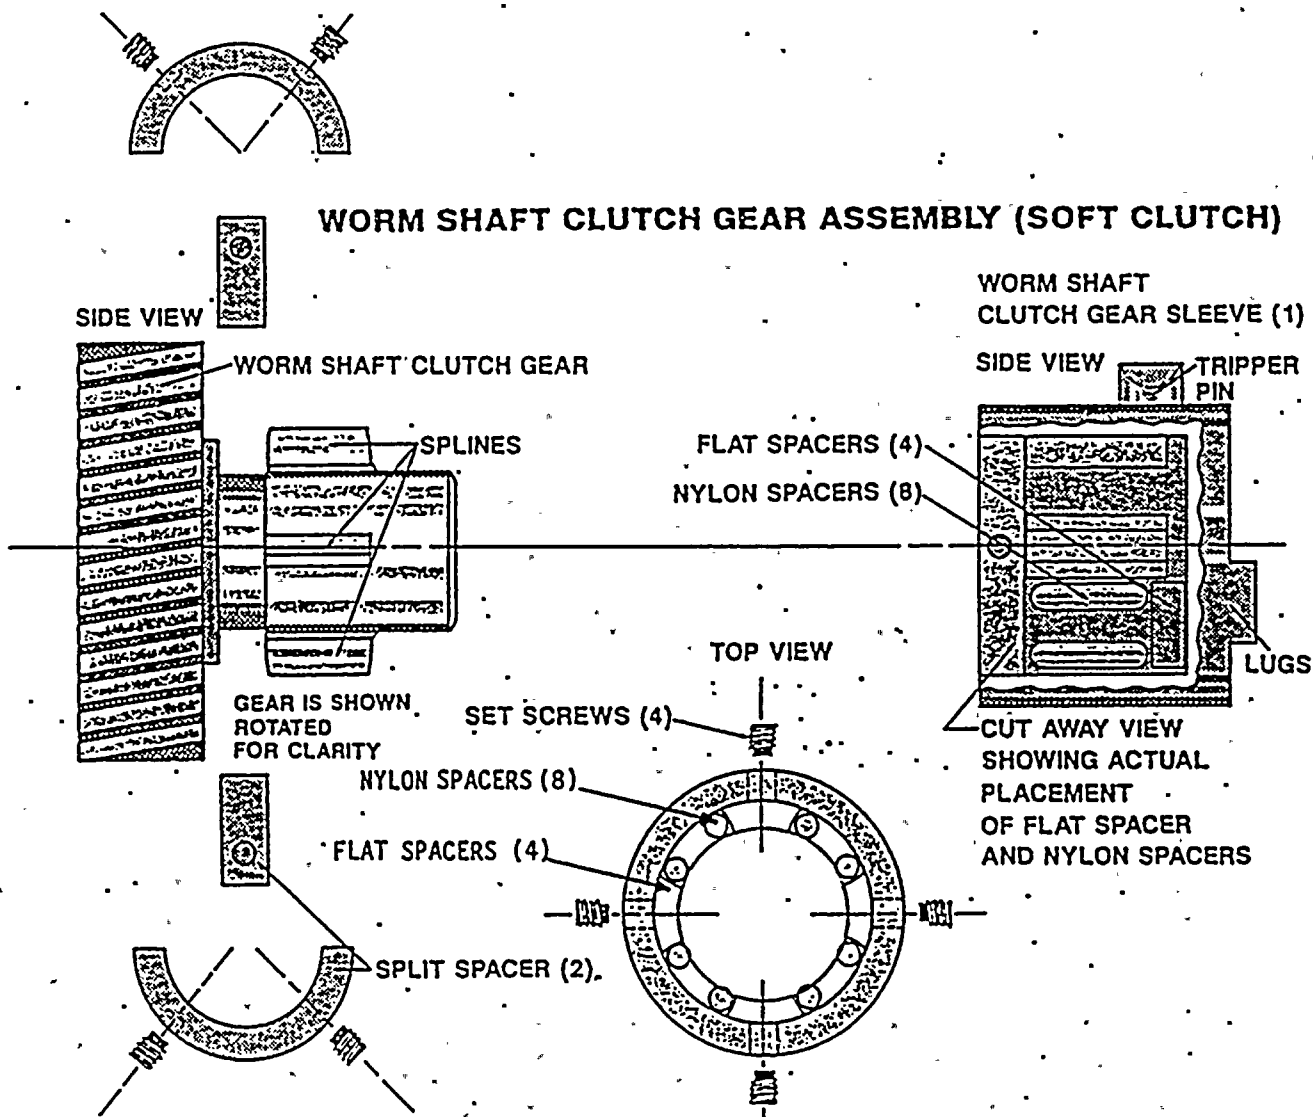
FIGURE 1

1. This event is reportable per 10 CFR 50.73(a)(2)(v) as a condition that alone could have prevented the fulfillment of the safety function of the HPCS. This event was reported as a 10CFR Part 21 Report on April 26, 1989.
2. There were no structures, components, or systems inoperable in addition to the HPCS-V-15 valve prior to the event which contributed to the event.
3. The root cause of the inoperability of the HPCS-V-15 valve is that the motor operator (HPCS-MO-15) was not made per design by the manufacturer (Limatorque Corporation). When the valve motor operator (HPCS-MO-15) was manufactured, the split spacer of the worm shaft clutch gear assembly was not installed, as required per design (See Figure 1).

The failure mechanism is described as follows. With the split spacer not installed (See Figure 1), the set screws installed through the worm shaft clutch gear sleeve had no surface to press against and hold the worm shaft clutch gear assembly together. When the worm shaft clutch was positioned for manual operation the worm shaft clutch gear sleeve worked its way off the worm shaft clutch gear (See Figure 2). When the motor operator was re-engaged the worm shaft clutch gear sleeve would catch on the worm shaft clutch gear splines which forced the sleeve lugs against the clutch, and the clutch against the handwheel clutch pinion assembly. Because the clutch is spring loaded, both the motor and manual clutch lugs would slide over each other causing excessive wear. In addition, the worm shaft clutch gear was pressed against the split ring and split ring retainer. Eventually the split ring retainer failed and the split ring fell into the valve motor operator assembly. After this occurred, the clutch gear and clutch gear sleeve separated sufficiently to allow the sleeve to spin freely (i.e. not catch on the splines). In this condition the motor operator would not work. At the time the motor operator failed, the handwheel manual operation was sporadic due to the wear on the clutch/manual lugs.

1. During the R4 Refueling and Maintenance Outage, the safety related valves with a Limitorque motor operator that potentially have and actually have a soft-clutch were manually operated.
2. The Plant procedure for maintenance and repair of Limitorque valve motor operators will be revised to include instructions for inspecting the worm shaft clutch gear assembly anytime a motor operator is disassembled.

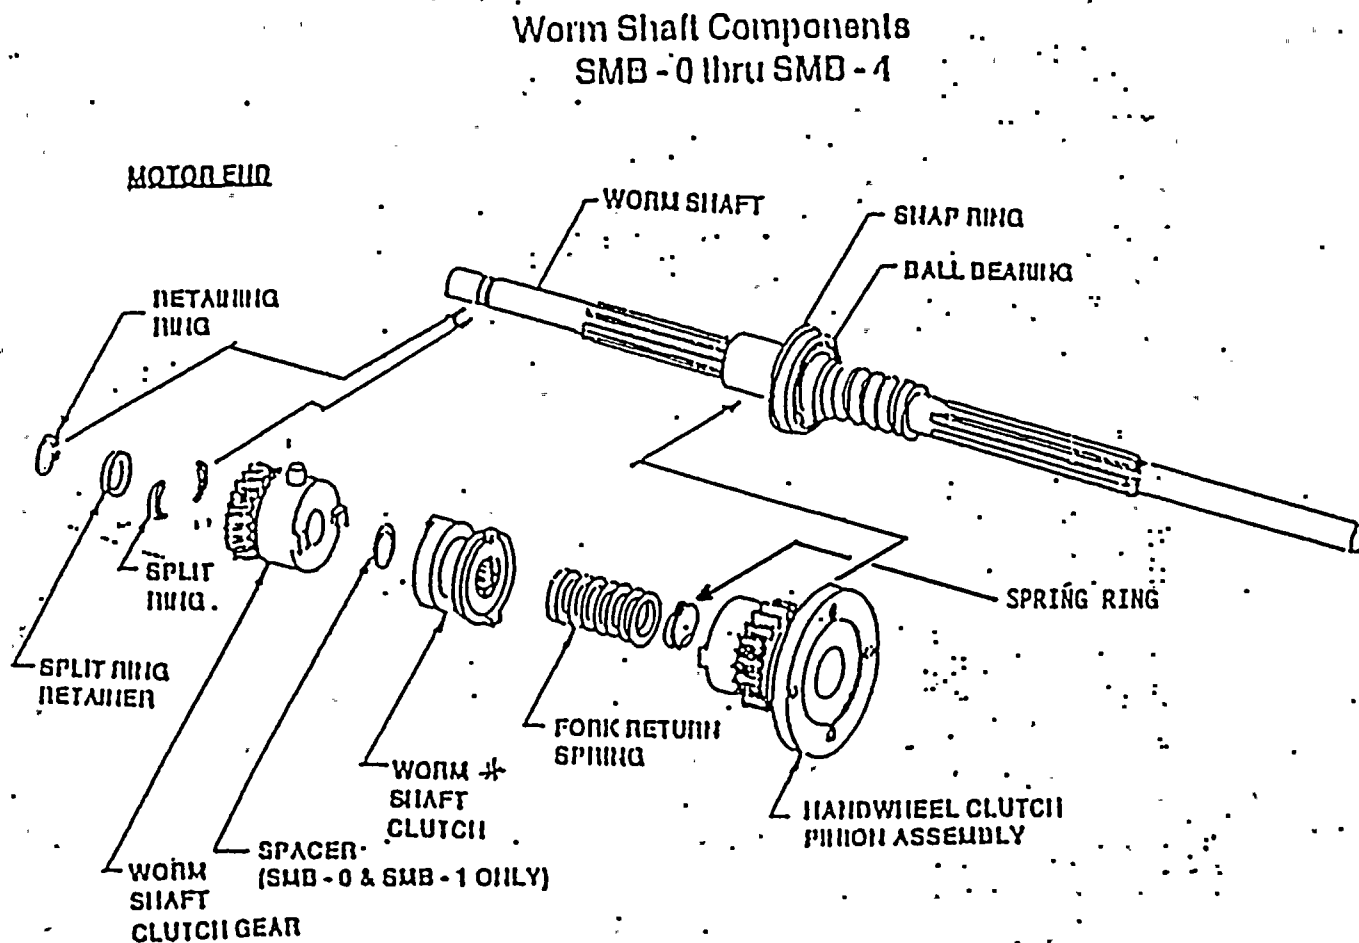
FIGURE 2

\*Worm shaft clutch shown 180° out of position
