WASHINGTON PUBLIC POWER SUPPLY SYSTEM

Subject: NUCLEAR PLANT NO. 2
LICENSEE EVENT REPORT NO. 90-003

LICENSEE EVENT REPORT (LER)

| TITLE (4) High Pressure Core Spray System Pump Suction Valve Switchover During Surveillance Testing Due to Instrument Indicated Level Excursion | | | | | | | | | | | | | | | | | | | | | |

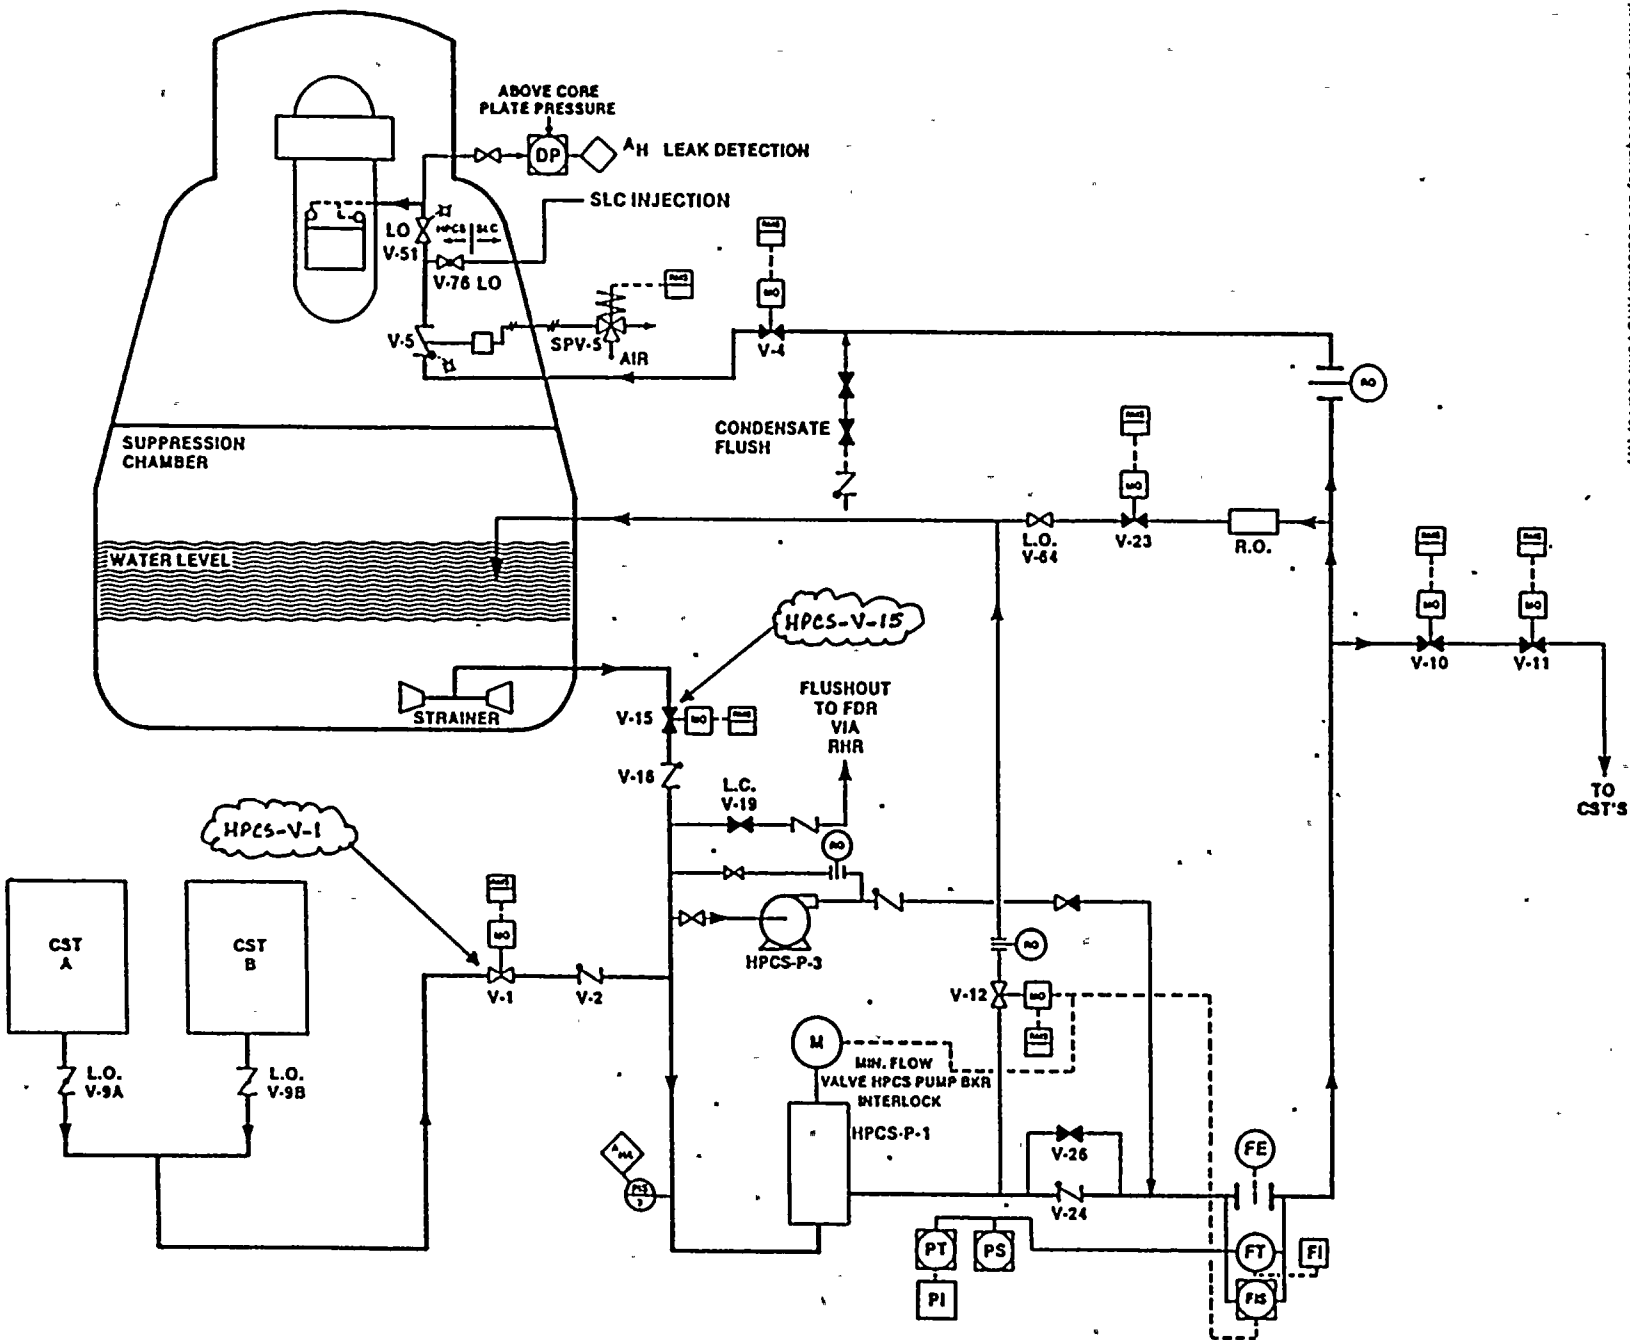
FIGURE 1. HPCS

Plant Equipment Operators (non-licensed) were draining the reference leg for Suppression Pool Narrow Range Level Transmitter CMS-LT-1 in accordance with the procedure, when level indication increased from +1" to +8". Plant configuration at the time was such that HPCS suction was lined up to the Condensate Storage Tanks (the normal line up, with HPCS-V-1 open) and Suppression Pool Suction Valve HPCS-V-15 was closed (reference Figure 1).

When the instrument level excursion occurred, it caused an Engineered Safety Feature suction valve transfer (due to a sensed high Suppression Pool level) and by design, HPCS-V-1 automatically closed and HPCS-V-15 automatically opened.

Plant Operators (Licensed) restored the system to pre-event lineup status (HPCS-V-1 was opened and HPCS-V-15 was closed).

Plant Procedure (PPM) 2.4.2 has been changed to transfer HPCS suction from the Condensate Storage Tanks (normal lineup) to the Suppression Pool prior to draining Suppression Pool level transmitter reference legs.
