SUBJECT: LER 88-037-01:on 881130,plant TS initiated shutdown because
 of CSPV air leak due to seal failure.

Subject: NUCLEAR PLANT NO. 2
LICENSEE EVENT REPORT NO. 88-037-01

TITLE (4) Plant Technical Specification-Initiated Shutdown Because of Containment Supply
Purge Valve Air Leak Due to Seal Failure - Cause Unknown

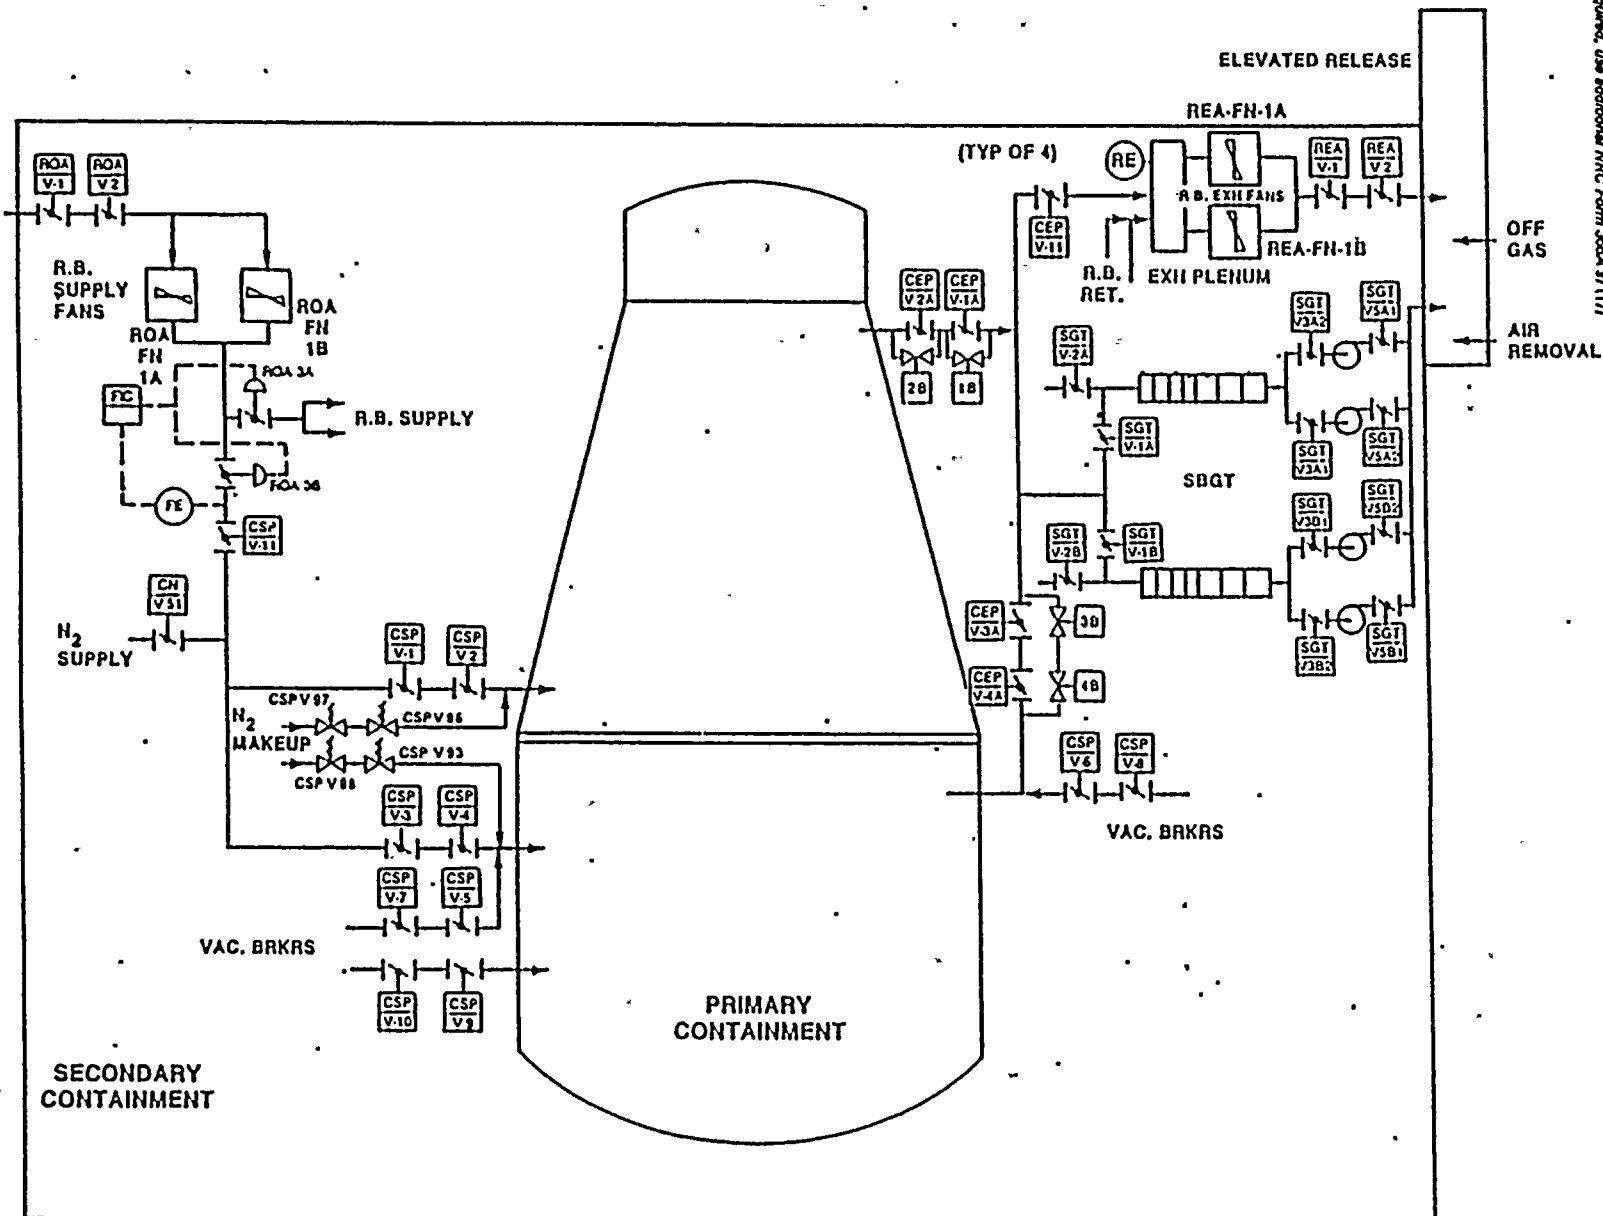
There are three Reactor Building-to-Wetwell relief lines each containing a 24-inch vacuum breaker (check) valve and an air-operated butterfly valve. The check valves are CSP-V-7, 8 and 10; the butterfly valves are CSP-V-5, 6 and 9 (Reference Figure 1). These valves prevent a vacuum from developing in the primary containment due to condensing steam. Actuation of the butterfly valves is controlled by the differential pressure between the suppression chamber and the Reactor Building. Both types of valves are set to open at 0.5 psid.
