SUBJECT: LER 91-004-00: on 910328, two deficiencies noted in Thermolog application on critical cable tray running through Div 1 area. Caused by inadequate installation of Thermolog. Fire tour of cable spreading room retained. W/910426 ltr.

Subject: NUCLEAR PLANT NO. 2  
LICENSEE EVENT REPORT NO. 91-004

Washington Nuclear Plant - Unit 2

TITLE (4) INADEQUATE FIRE PROTECTION (THERMOLAG) OF DIVISION II SAFE SHUTDOWN CABLES  
DUE TO INADEQUATE INSTALLATION AND INSPECTION

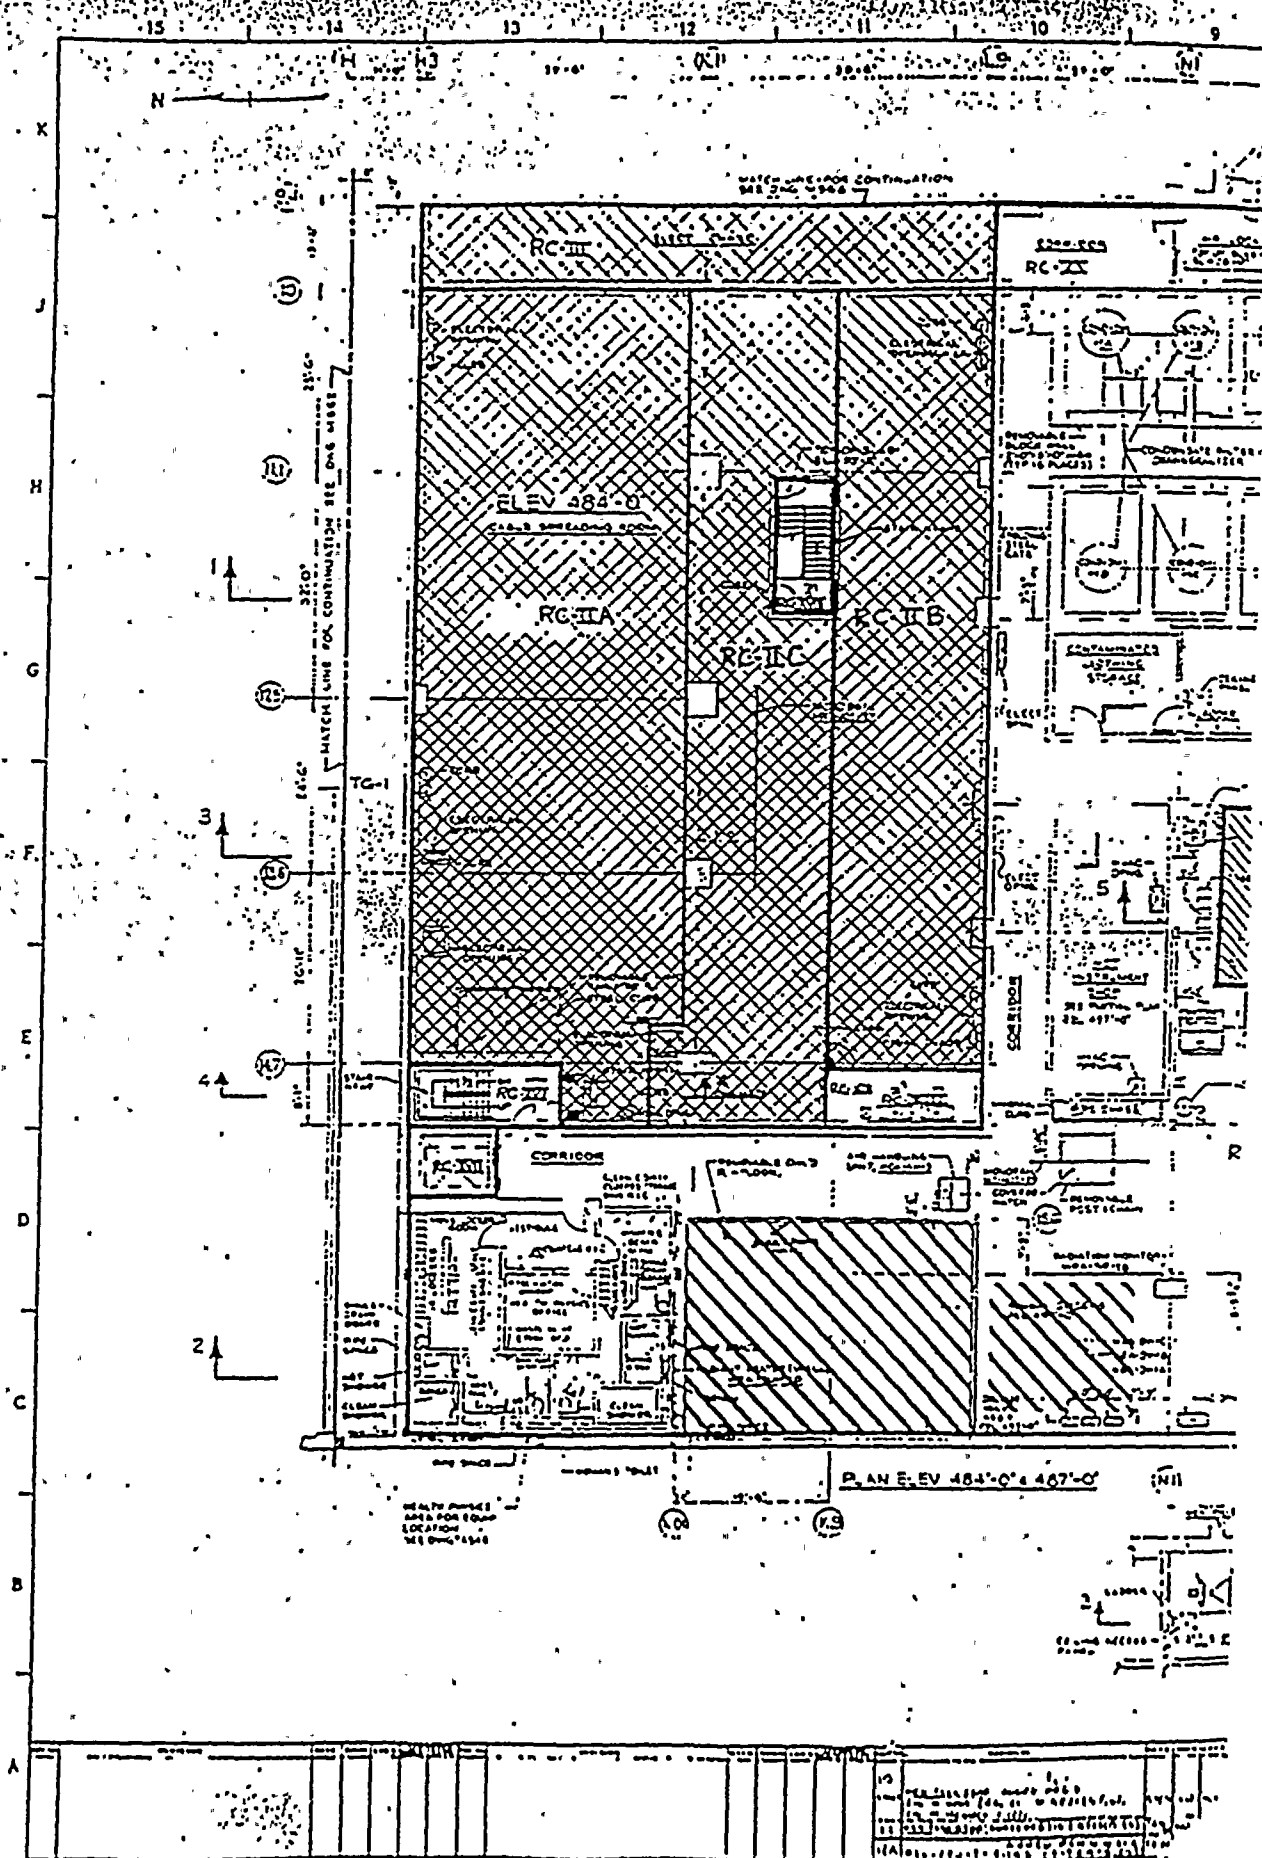
The Cable Spreading Room at WNP-2 is divided into three fire areas, RC-IIA, RC-IIC, and RC-IIB, from North to South, respectively. (See attached sketch). RC-IIA contains primarily critical Division I equipment and cabling that is not fire protected in this zone. However, in this zone, there are Appendix R Division II Safe Shutdown components and cabling which do require one hour fire protection.

Two deficiencies were noted. One concerned inadequate Thermolag thickness on the side rail of the cable tray. The second deficiency was an incomplete transition between Thermolag board and Thermolag spray application, which resulted in a rectangular opening of approximately 6 square inches. Both deficiencies are located within fire area RC-IIA. Either defect could allow a fire in RC-IIA (Division I fire area) to compromise Division II Safe Shutdown equipment.

1. Thermolag deficiencies will be repaired. Retain fire tour of Cable Spreading Room until deficiencies are repaired.
2. Instruct personnel involved in inspection of Thermolagged components in the importance of checking all cable tray surfaces for any degradation.
