SUBJECT: LER 91-017-00:on 910708,ground fault occurred in off-site  
 500 kV sys.Caused by substation personnel error & substation  
 equipment design deficiency.Plant operators returned unit to  
 startup power source.W/910807 ltr.

Subject: NUCLEAR PLANT NO. 2  
LICENSEE EVENT REPORT NO. 91-017

FACILITY NAME (1) Washington Nuclear Plant - Unit 2										DOCKET NUMBER (2) 0 5 0 0 0 3 9 1 7										PAGE (3) 1 OF 0 6																													
TITLE (4) AUTO START OF EMERGENCY DIESEL GENERATORS WHILE ON BACKFEED. UNDERVOLTAGE WAS INITIATED BY A 500KV GRID DISTURBANCE. ROOT CAUSES ARE PERSONNEL ERROR AND EQUIPMENT DESIGN																																																	
EVENT DATE (5)										LER NUMBER (6)										REPORT DATE (7)										OTHER FACILITIES INVOLVED (8)																			
MONTH			DAY			YEAR			YEAR			SEQUENTIAL NUMBER			REVISION NUMBER			MONTH			DAY			YEAR			FACILITY NAMES										DOCKET NUMBER(S)												
0 7			0 8			9 1			9 1			0 1			7 0			0 0			0 8			0 7			9 1													0 5 0 0 0 0 0 0 0 0									
OPERATING MODE (9)										THIS REPORT IS SUBMITTED PURSUANT TO THE REQUIREMENTS OF 10 CFR §: (Check one or more of the following) (11)

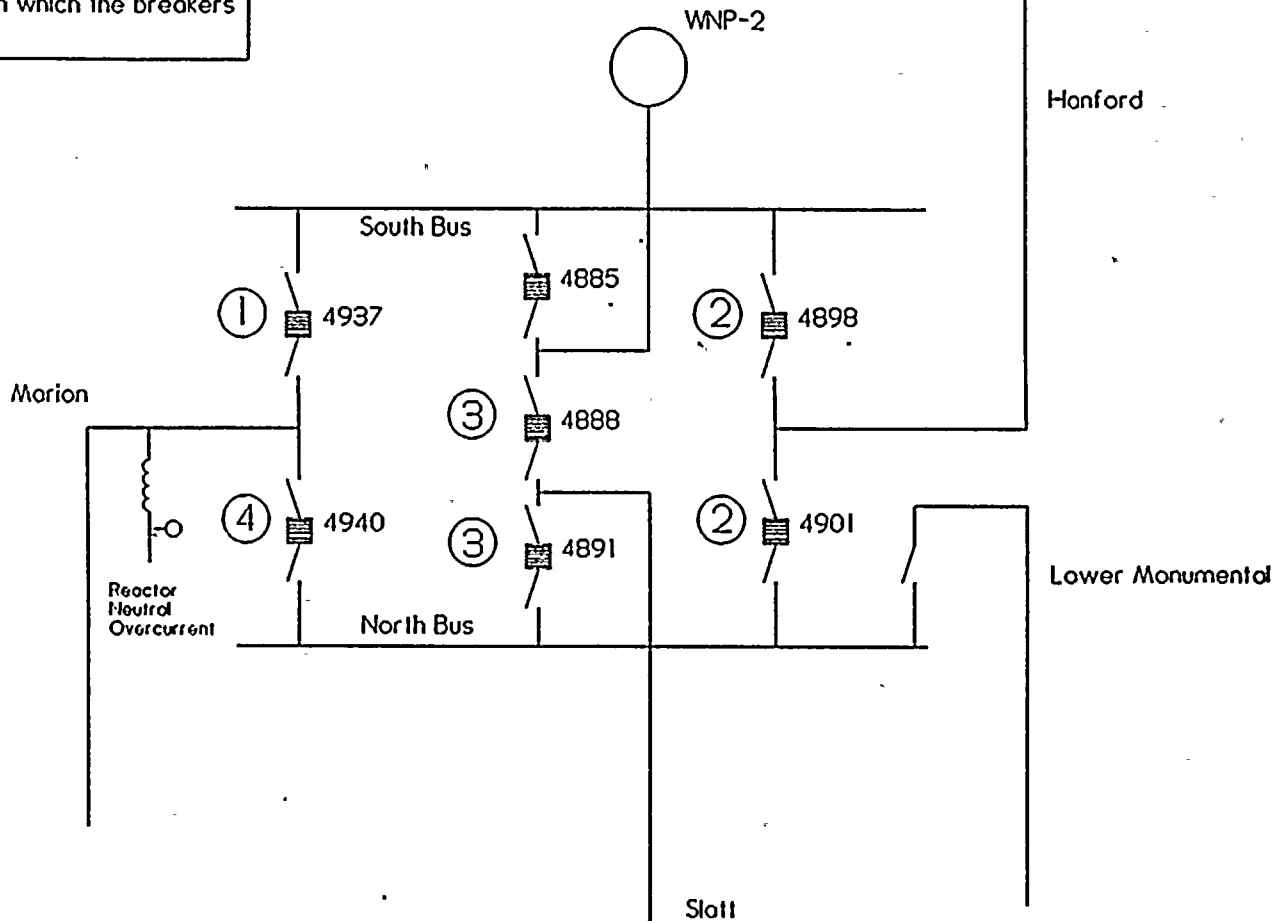
# Ashe Substation

The disturbance was a ground fault on the Marion line feeding the substation. (See Figure 1 for schematic drawing of Ashe substation. The numbers in circles indicate the opening sequence for the substation breakers.) Misalignment of two protective relay selector switches at the substation precluded the BPA primary relays from immediately isolating the faulted line. The switches allowed breaker 4937 to open but not breaker 4940. Backup relaying (line relays) isolated the Hanford line (by opening breakers 4898 and 4901) and then the Slatt line (via breakers 4888 and 4891). Finally the fault was cleared when a neutral overcurrent relay timed out and opened breaker 4940. The fault was completely isolated in less than one second.

WNP-2 backfeed de-energized when the Slatt line isolated by opening breakers 4891 and 4888. Since the Hanford, Slatt and Marion line relays are not designed to trip breaker 4885, WNP-2 was left connected to the de-energized South bus through 4885. Breaker 4885 was not required to open to isolate the fault and did not open. However, for automatic transfer of station power from the 500KV backfeed configuration to the 230KV Startup transformer (TRS) to function, both 4885 and 4888 must open. As a result, auto-transfer to the Startup source did not occur. The resultant loss of power to critical plant buses was detected by undervoltage protective relays. The loss of voltage relay scheme then transferred Division 1 and 2 critical bus power to the Backup transformer (TRB) within four seconds. Concurrently, the loss of voltage relays started the Division 1 and 2 Diesel Generators. The High Pressure Core Spray Diesel Generator was out of service for maintenance at the time of the event.

The Root Causes of this event are personnel error on the part of substation operations personnel and equipment design deficiency. These root causes are confirmed by both substation operator (BPA) and Supply System investigations. It is believed the selector switches remained misaligned after planned breaker work. Substation personnel failed to use procedurally prescribed methods for changing component status and logging such actions. Since the relay selector switches had been out of service for approximately 19 days, the BPA investigation specifically addressed their procedural controls over substation activities and log keeping. The controls were found to be satisfactory.

Equipment design is less than adequate since there was no indication in the substation control room that the switches were out of its normal position. Further there were no features of the switch which would obviously indicate, locally, that it was out of position.

BPA will implement modifications to 1) automatically record relay selector switch activity; 2) annunciate and alert the substation operator if a relay selector switch are out of its normal position; and color coding the selector switches to facilitate visual determination of their position.
