ROOT CAUSE ANALYSIS FOR UNSATISFACTORY LICENSED OPERATOR REQUALIFICATION PROGRAM

Prepared by: J.J. Muth and D.J. Schumann

TITLE: UNSATISFACTORY LICENSED OPERATOR REQUALIFICATION PROGRAM

STATEMENT: Operator Performance in Severe Accident Conditions Less than Adequate

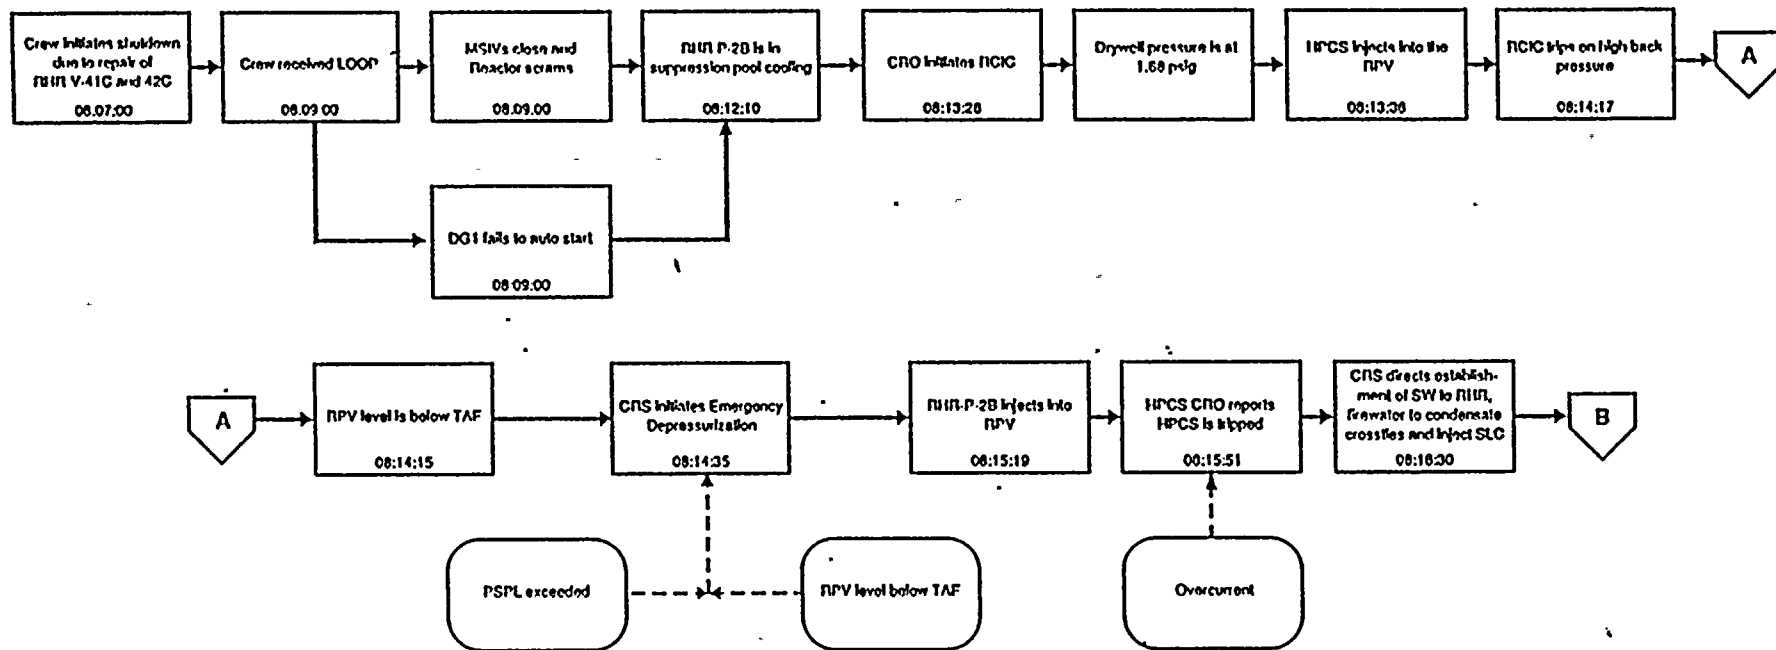
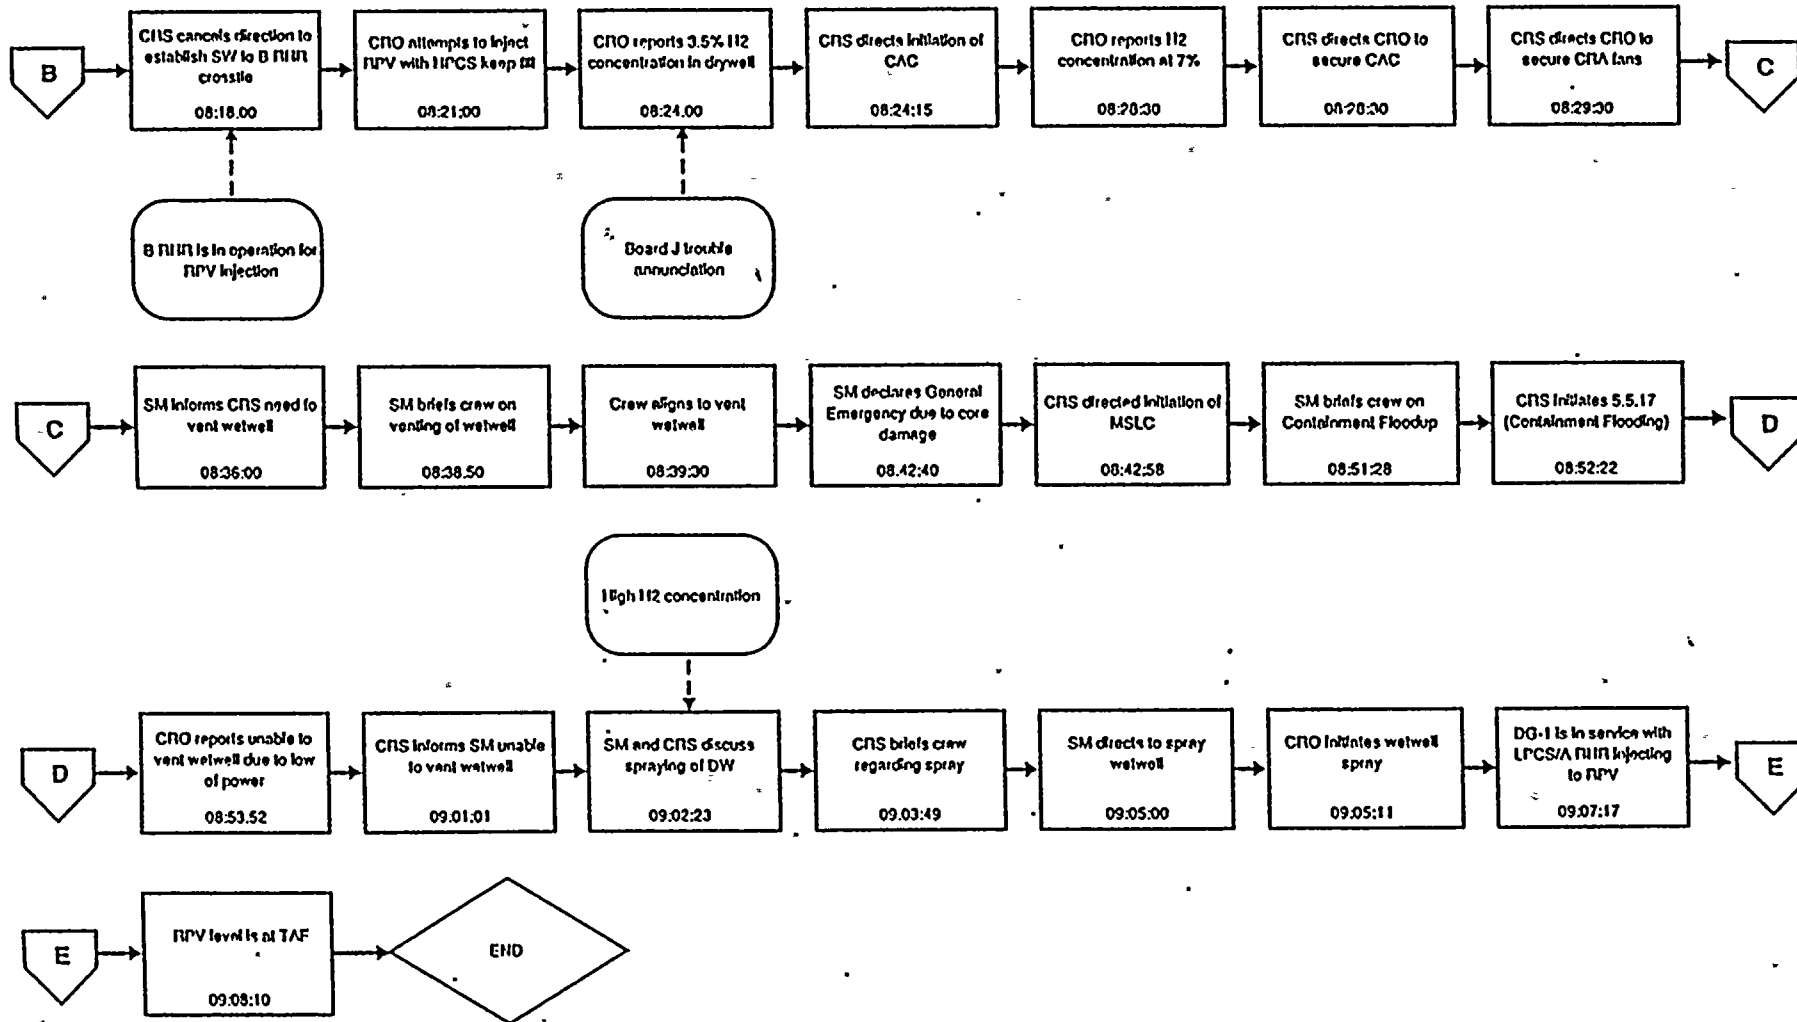
Crew X/Scenario 3 LOOP/DG1 Failure/LOCA/H2

The crew is in process of a plant shutdown when a LOOP occurs. The reactor automatically scrams, MSIVs isolate and DG1 fails to start, leaving bus SM7 without power. The CRS directs the lineup of RHR "B" for Suppression Pool cooling and initiation of RCIC for level control. Drywell pressure reaches 1.68 psig and HPCS injects into the RPV. RCIC trips. With RPV level below the TAF and PSPL exceeded the CRS initiates emergency depressurization. As the vessel depressurizes, HPCS and RHR "B" operate to restore level when HPCS trips. The CRS then directs employment of SLC, Service water to RHR and firewater to condensate cross ties to recover level. Subsequently the CRS cancels the Service water to RHR cross tie order. The CRO reports a 3.5% Hydrogen concentration in the drywell and the CRS directs the initiation of the Containment Atmospheric Control system. When the reported concentration is at 7% the CRS directs that CAC and CRA fans be secured. The Shift Manager informs the CRS that venting of the wetwell is needed (due to the high Hydrogen concentration).

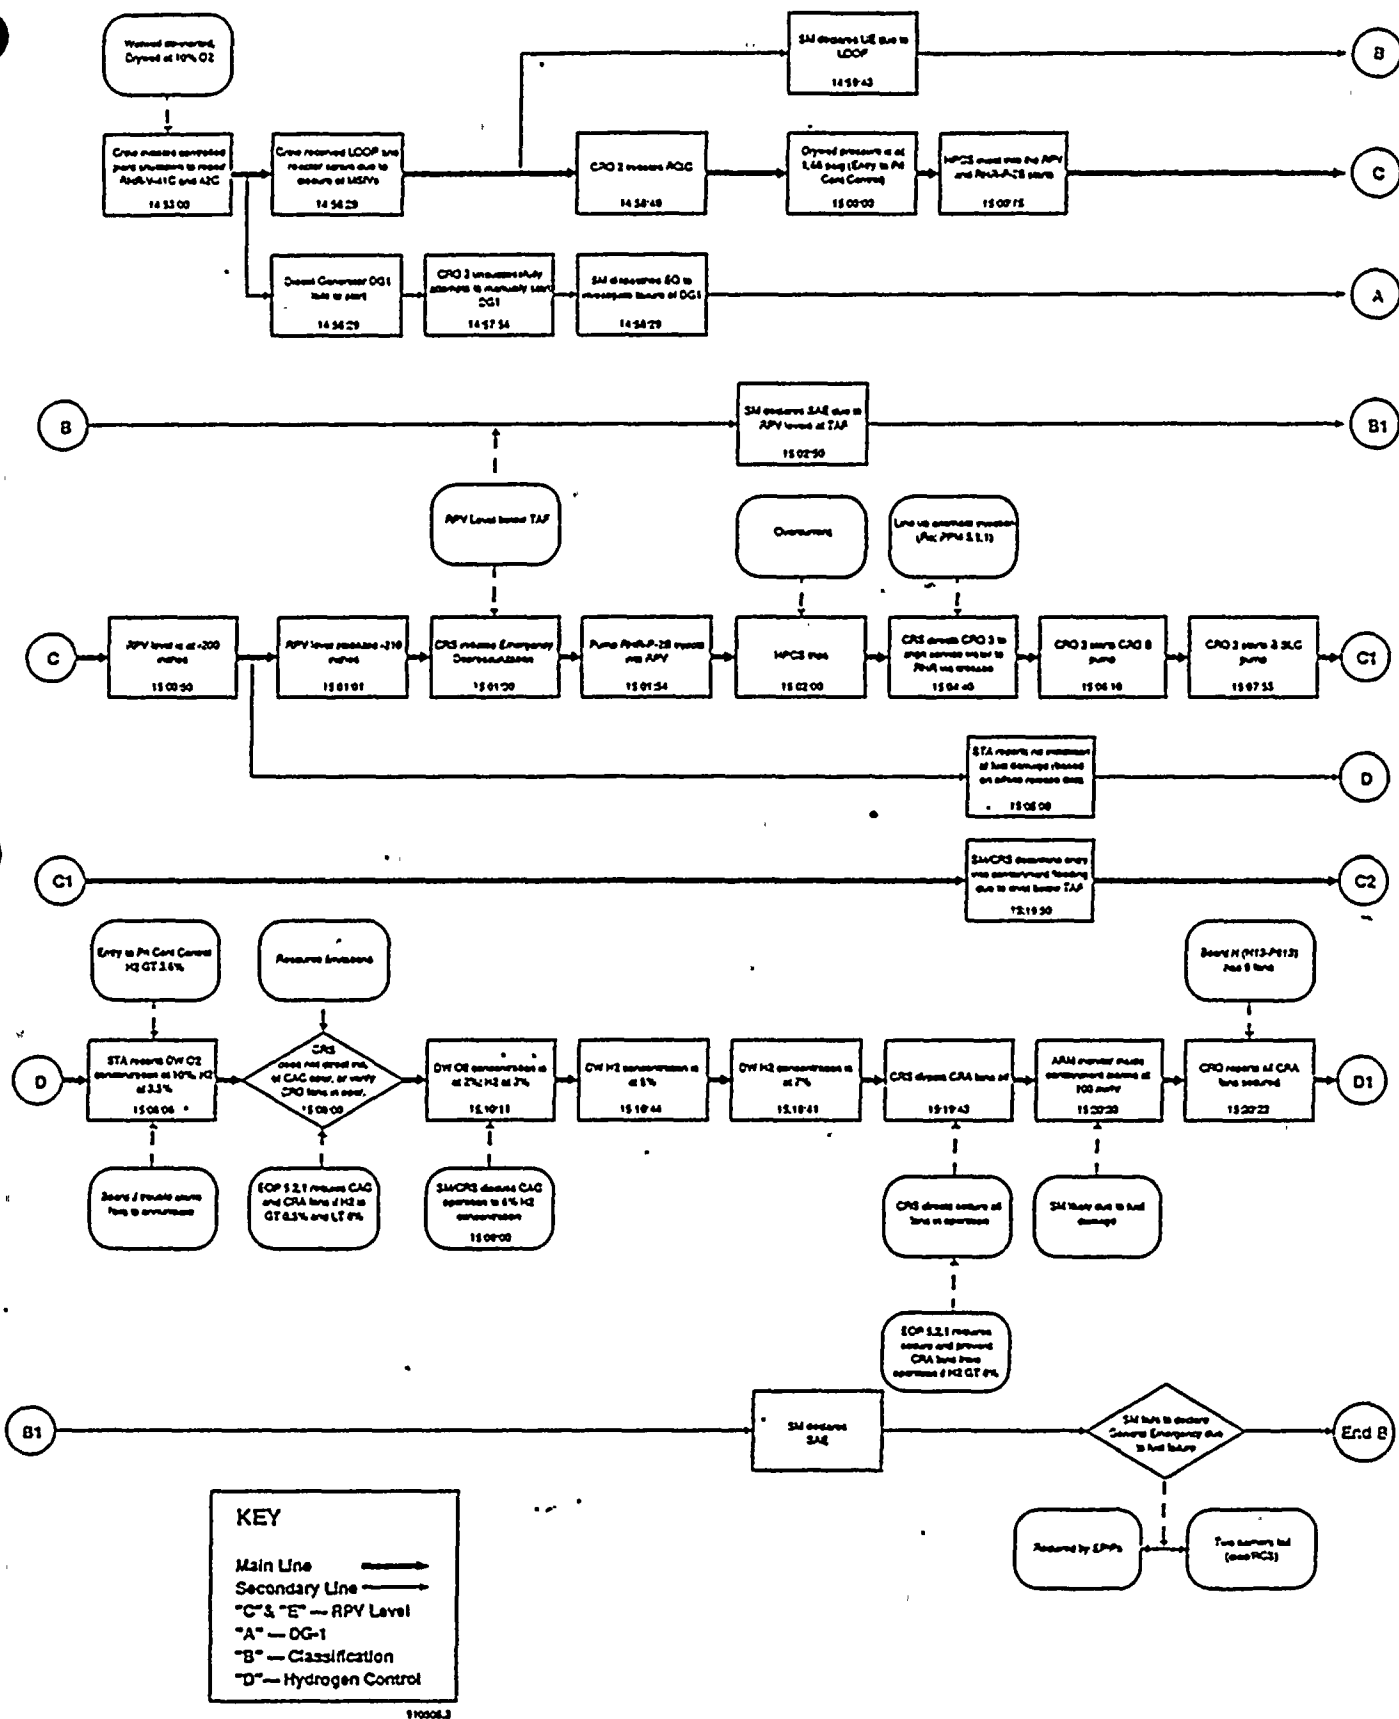
Crew Y/ Scenario 3 Loop/DG1 Failure/LOCA/H2

While implementing a controlled shutdown the crew receives a LOOP. The reactor automatically scrams, the MSIVs isolate and DG1 fails to start. A CRO fails in an attempt to restart DG1 and the CRS dispatches an EO to investigate. To control level RCIC is initiated. A high drywell pressure signal initiates HPCS injection into the RPV. With vessel level at -210 inches the CRS directs initiation of emergency depressurization. HPCS trips and the CRS directs actions to line up alternate sources of injection to the RPV (Service water to RHR cross tie, "B" CRD and SLC pumps) to recover RPV level to the TAF. The CRS receives a series of reports that the Hydrogen concentration is at 3%, 3.5%, 5% and then 7%. There is no direction to initiate CAC. At the 7% level the CRS directs that the CRA fans be secured. A CRO goes to the H13-P813 panel and secures all the CRA fans in operation. After consultations the CRS and Shift Manager decide to initiate containment flooding. RHR "B" is secured to prepare for the Service water to RHR cross connect. The crew also lines up to vent the wetwell but due to the loss of SM7 that evolution is not possible. A CRO also shut down an in-service CRA fan that was overlooked initially. Unable to vent the wetwell, the CRS and Shift Manager discuss the priority of venting the wetwell or flooding the containment via RHR "B". RHR "B" is lined up to spray and the CRS initiates wetwell and then drywell sprays. When DG1 is restored, the CRS directs that LPCS and RHR "A" line up for RPV injection and RHR "B" align for drywell spray. Wetwell spray is terminated. Additionally on the return of DG1, a CRA fan is automatically restarted. When RPV level is restored to the TAF, RHR "B" is aligned to the RPV. Since SM7 is now in-service, the CRS is preparing to line up to vent when the scenario terminates.

The NRC and the Supply System failed crew Y in their respective evaluations.

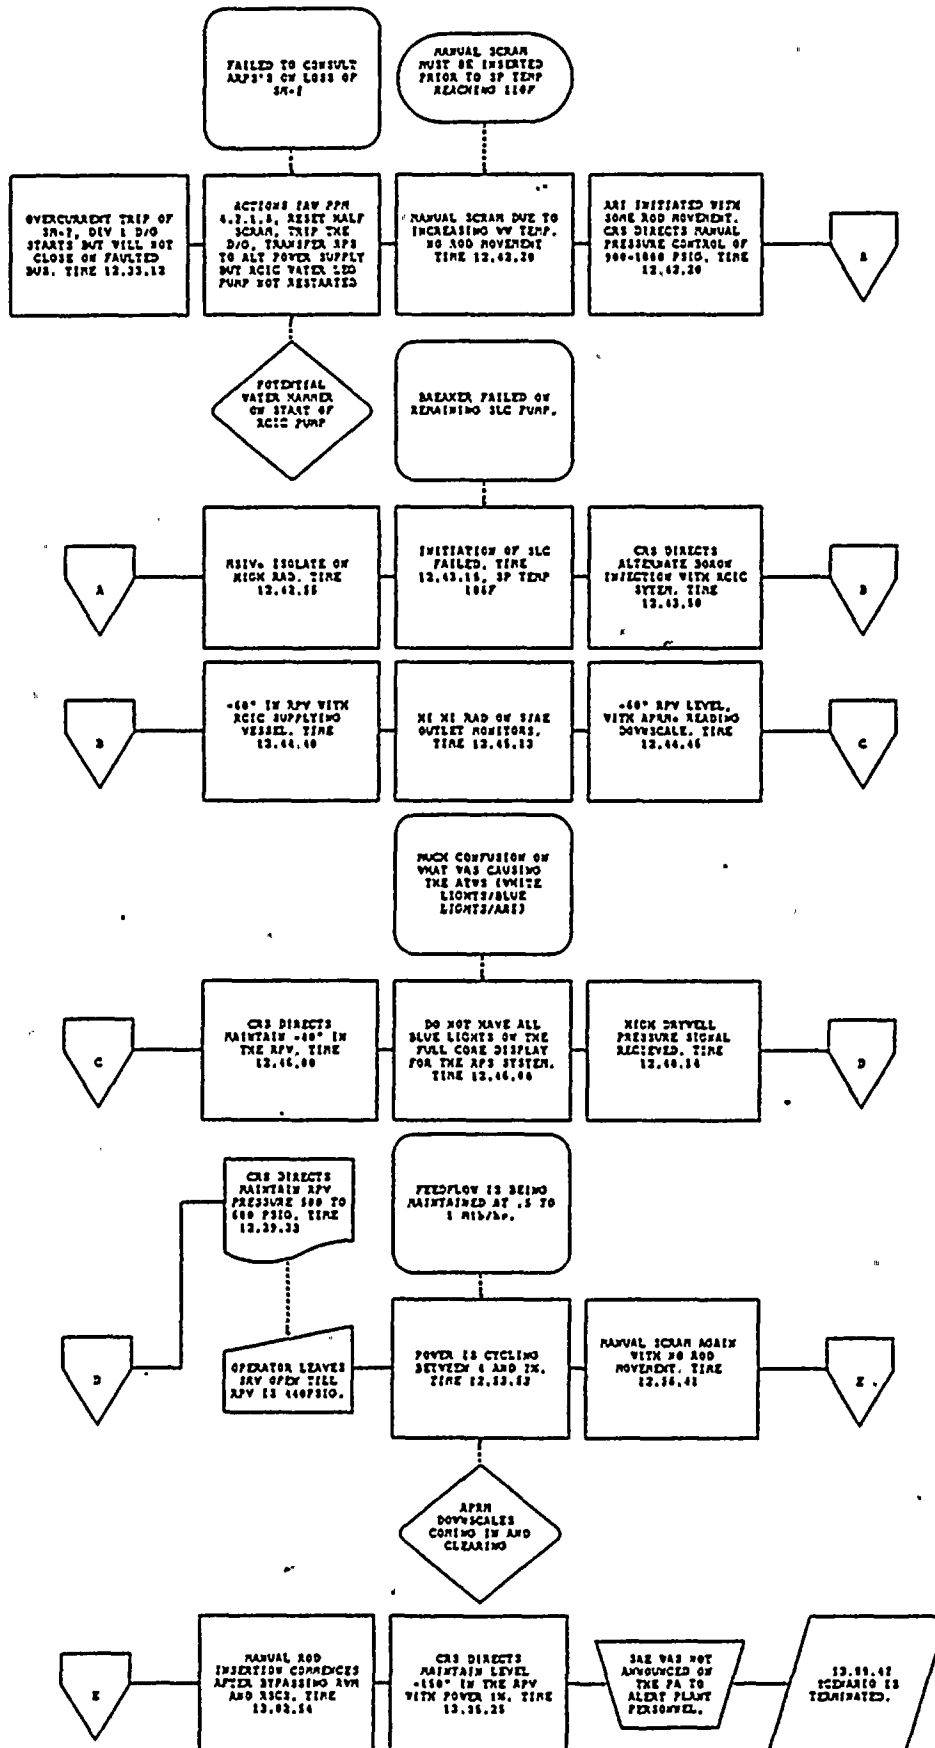
**ATWS WITH A FUEL FAILURE
CREW Z, SCENARIO 1**

Distribution bus SM-7 receives an over-current trip. DG1 starts but fails to close onto the bus. Without consulting the alarm response procedure for the loss of SM-7, the crew takes several actions in accordance with PPM 4.7.1.8, but fails to restart the RCIC water leg pump. A weeping Main Steam Safety Relief Valve fails open and the CRS directs a manual scram due to increasing wetwell temperature. The crew recognizes that there is no rod motion and initiates Alternate Rod Insertion (ARI). The resulting partial rod insertion causes fuel failure that leads to an MSIV isolation on high radiation. The CRS directs that the remaining SLC pump be initiated but the breaker fails. The CRS then directs alternate boron injection with the RCIC system. The CRO places RCIC into service and maintains RPV level at -60 inches. With the APRMs reading down-scale the CRS directs RPV level to be maintained at -80 inches.

The crew observes the absence of blue lights on the full core display and attempts to diagnose the cause of the ATWS but appears confused over the significance of the white light/blue light indications. A high drywell pressure signal is received and the CRS directs that RPV pressure be maintained at 500-600 psig to preclude an inadvertent rapid cold water injection. A CRO leaves an SRV open until RPV pressure is at 440 psig resulting in a feed flow addition and power to cycle between 4 and 7%. A manual scram is attempted with no rod motion. The Rod Worth Minimizer and Rod Sequence Control System are bypassed and the crew initiates manual rod insertion. With power in the 1% region the CRS directs that RPV level be maintained at -150 inches. The scenario then terminates.
