SUBJECT: LER 91-024-00:on 910909,unanalyzed condition associated w/
 postulated main steam line failure outside containment
 discovered by GE.Caused by failure to consider iodine source
 term.Procedure re cold startup changed.W/911010 ltr.

Subject: NUCLEAR PLANT NO. 2
LICENSEE EVENT REPORT NO. 91-024

FACILITY NAME (1)
Washington Nuclear Plant - Unit 2

TITLE (4)
Unanalyzed Condition Associated With Main Steam Line Failure Outside Containment

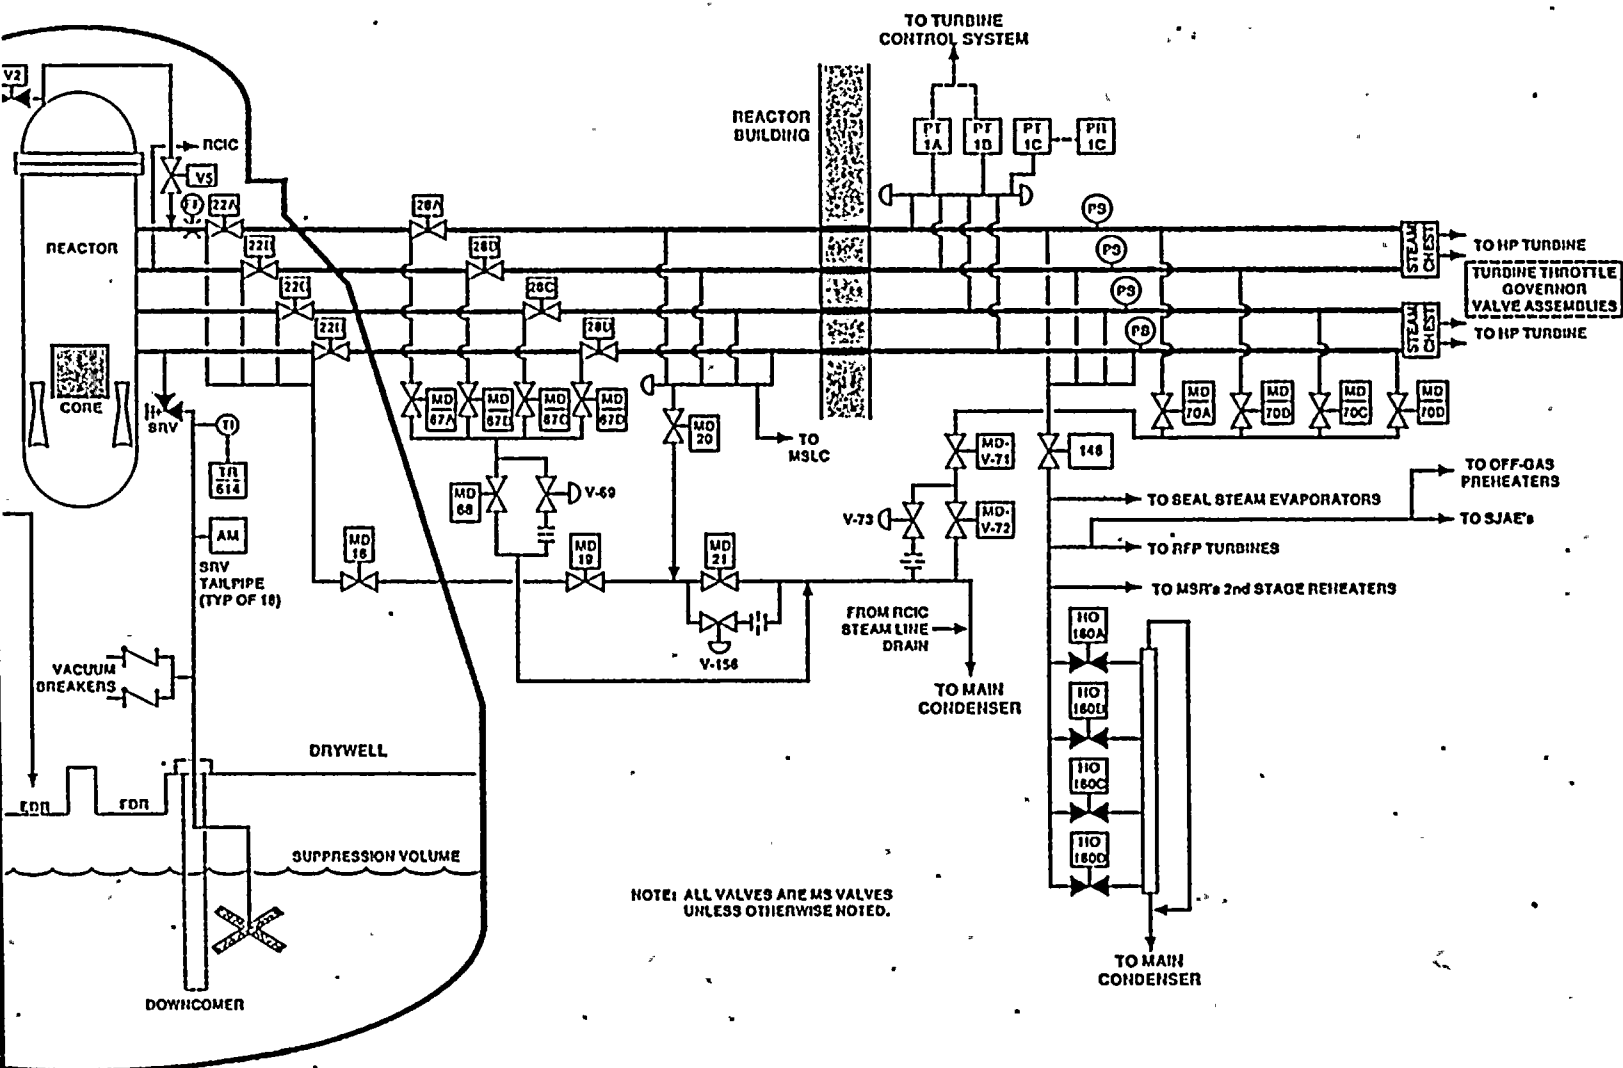
FIGURE 1. MAIN STEAM SYSTEM

The condition discovered involves additional mass release through main steam drain line piping under the above accident scenario. These drain lines are isolated outside primary containment by five main steam line drain valves (MS-V-67A, B, C, D, and MS-V-19). During heatup and cooldown conditions the drain lines that each contain a 67 valve provide a means of removing moisture from their associated main steam lines in the area between the inboard and outboard isolation MSIVs. The fifth drain line that contains MS-V-19 is designed to remove moisture from all main steam lines upstream of the inboard isolation valves. During the postulated accident conditions jet impingement from the steam line break outside containment could cause these valves to fail "as-is" at the time the accident occurred. During the past operating cycles (since early 1984) WNP-2 has been operating with these valves open. If the main steam line break accident had occurred, as described in the FSAR, additional mass could be released through these valves. The highest mass release would occur if blowdown occurred through the line containing MS-V-19 since this is a three inch line while the lines containing the 67 valves are one and one half inch diameter lines. A single failure, plus the consequences of the jet impingement, even on all the MS-V-67 valves and the MS-V-19 valve, can only result in one unisolated blowdown path being available. The single failure is either the failure of an inboard MSIV to close (leading to blowdown through one MS-V-67 valve) or the failure of MS-V-16 (leading to blowdown through MS-V-19).

Any of these lines could result in long term depressurization of the primary system if isolation by downstream non-safety related valves could not be achieved. The depressurization could also result in iodine release from the failed fuel assumed to be present just prior to the event. This iodine release would cause "iodine spiking" usually associated with instrument line breaks in boiling water reactors and steam generator tube ruptures in pressurized water reactors. The long term depressurization aspect of the event described above makes it different from the accident described in Standard Review Plan 15.6.4, Radiological Consequences of Main Steam Line Failure Outside Containment (BWR). Consequently, this scenario would increase the radiological source term for the calculation beyond that evaluated in the FSAR resulting in an unanalyzed condition.

The plant has been operating outside the bounds of the analysis as described in Chapter 15 of the FSAR. However, one factor that would mitigate the significance of this condition involves the capability for isolation using the downstream valves (see attached figure). The long term depressurization resulting from the MS-V-19 or a MS-V-67 valve failing open during a MSLB could have been prevented by closure of MS-V-21 and MS-V-156 (for MS-V-19) or MS-V-68 and MS-V-69 (for a MS-V-67 valve). Credit is not taken for these valves and associated piping in the accident analysis as they are not safely related.

Since the plant was in mode four (cold shutdown) no immediate corrective action was required for the unit. Immediate corrective action was taken to change Plant Procedure PPM 3.1.2, Reactor Plant Cold Startup, to require the drain valves to be closed whenever reactor power is greater than or equal to 5 percent.
