SUBJECT: LER 92-017-00: on 920508, personnel determined that heat removal capability of Train "A" RHR heat exchanger less than design allowable. Caused by insufficient monitoring of Plant components. Corrective actions not required. W/920623 ltr.

# LICENSEE EVENT REPORT (LER)

Washington Nuclear Plant - Unit 2

**FOULING OF RESIDUAL HEAT REMOVAL (RHR) TRAIN "A" HEAT EXCHANGER ON  
STANDBY SERVICE WATER (SSW) SIDE**

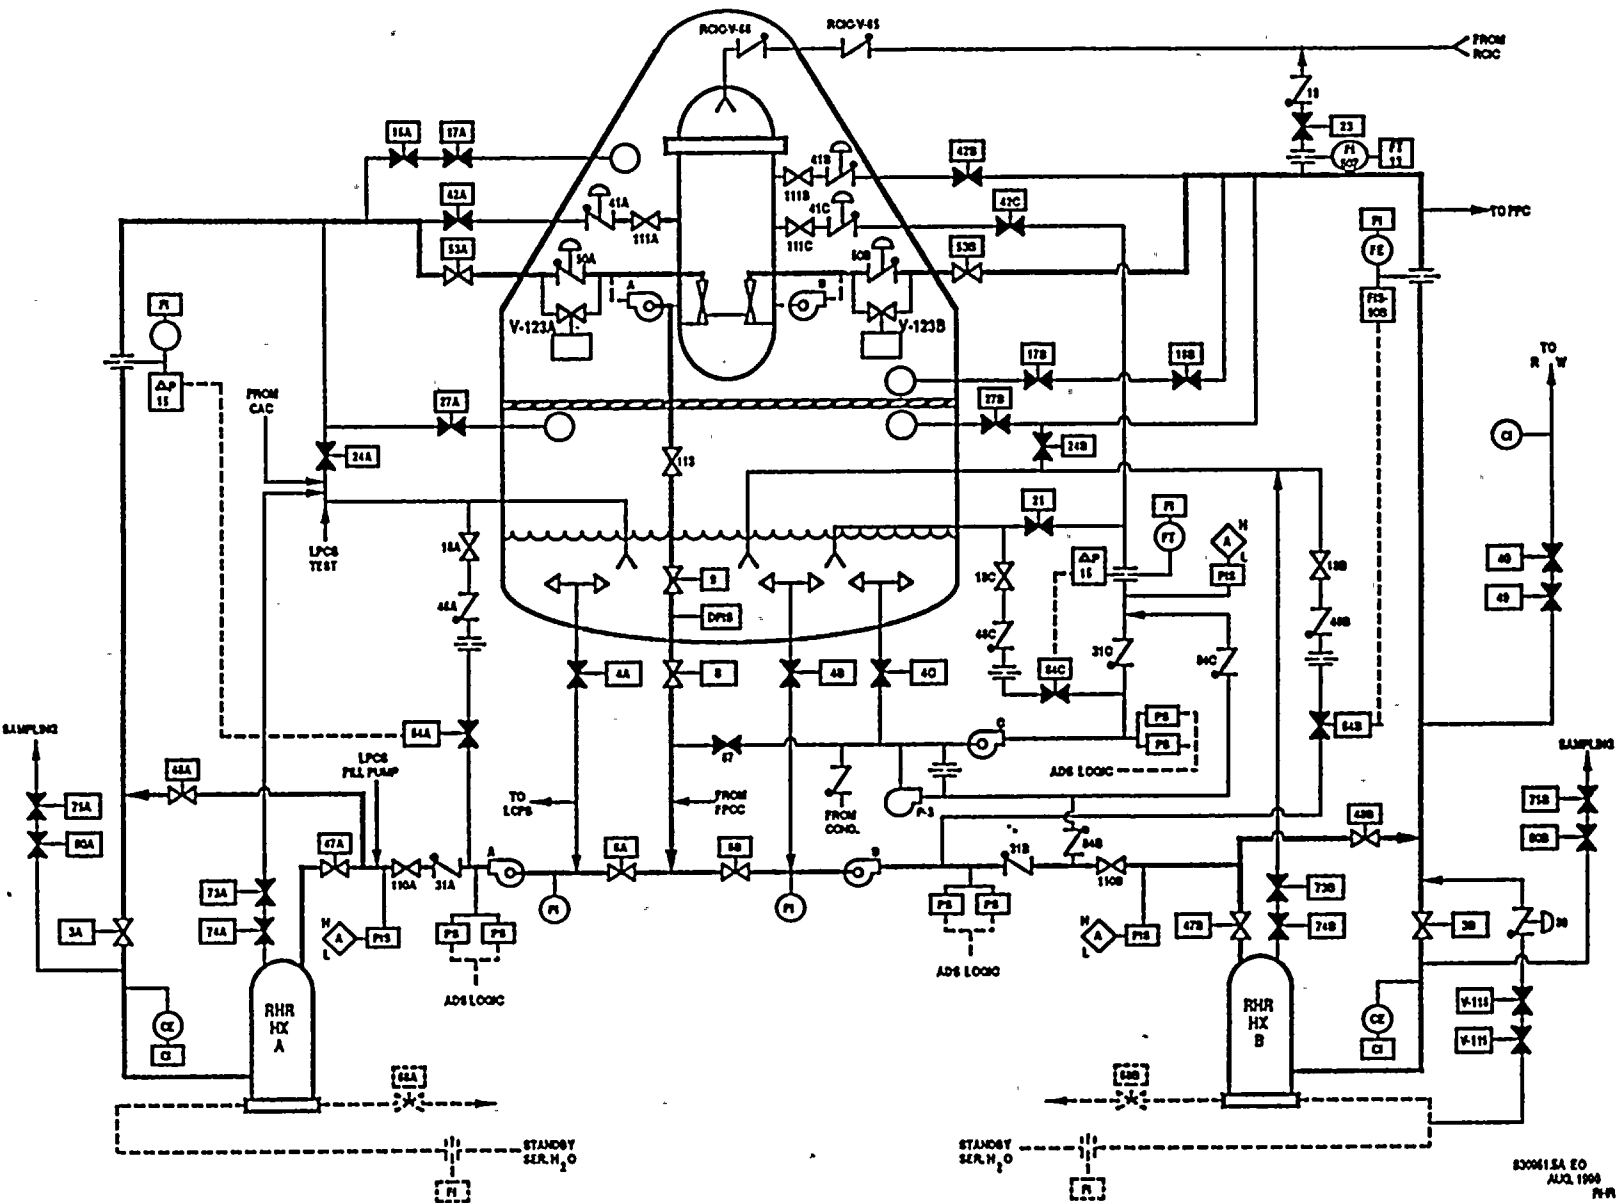
4. The attached Figure 1 depicts the Shutdown Cooling mode of Trains "A" and "B" of the RHR System. Each of the two heat exchangers have a bypass throttle valve (RHR-V-48A/B) and an outlet throttle valve (RHR-V-3A/B) on the shell side. They are used to control the amount of reactor coolant flowing through the heat exchanger. The valves are throttled to achieve the desired heat removal rate for the given heat exchanger.
