# ACCELERATED DISTRIBUTION DEMONSTRATION SYSTEM

SUBJECT: LER 92-032-00: on 920702, unplanned ESF actuation occurred due to decrease in reactor water level resulting from voided feedwater piping. Cause under investigation. Corrective actions will be reported in supplemental LER.W/920803 ltr.

**SUBJECT: NUCLEAR PLANT WNP-2, OPERATING LICENSE NPF-21  
LICENSEE EVENT REPORT NO. 92-032**

TITLE (4)  
**UNPLANNED MANUAL ESF ACTUATION DUE TO DECREASE IN REACTOR WATER LEVEL  
 RESULTING FROM VOIDED FEEDWATER PIPING**

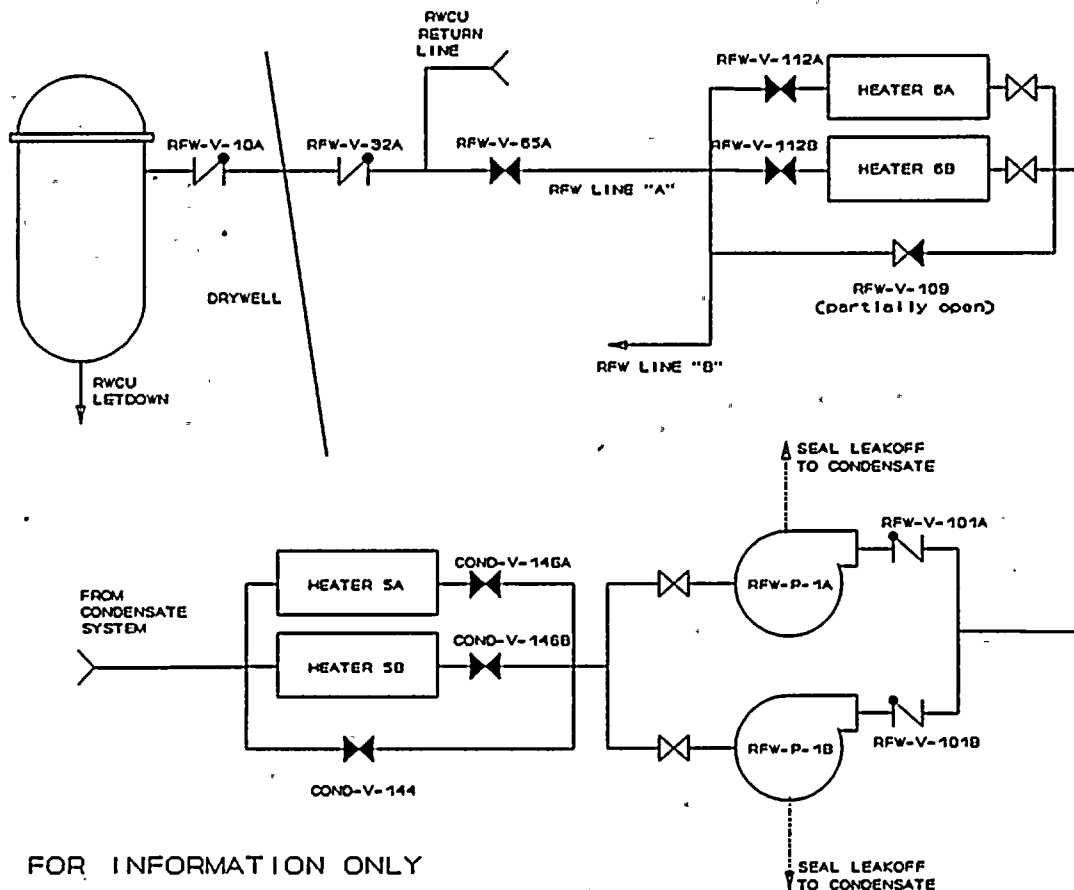
Feedwater System Valve Lineup

RFW-V-65A is a 24" motor operated valve located at the inlet to the reactor pressure vessel for Main Feedwater Line "A" (see attached sketch). RFW-V-65A was in the process of being opened manually in order to support packing ring maintenance when the RWCU high differential flow annunciator was received. Electrical power to the motor operator had been tagged out under a clearance order in order to support maintenance activities.

With the plant in the configuration previously described, water trapped between RFW-V-65A and boundary valves located on the suction side of the feedwater pumps was able to drain past the feedwater pump seals via RFW-V-109 and the feedwater pump discharge check valves (RFW-V-101A, and RFW-V-101B), and into the condensate system.

Since the boundary for RFW-V-65A was moved approximately thirteen hours prior to initiation of this event, and the four feedwater pump seals each draw approximately three gpm, the voided section of piping behind RFW-V-65A valve could have held as much as 4680 gallons. This is greater than the approximately 3400 gallons of water that was added during recovery from this event.
